ORDINARY COUNCIL MEETING

Wednesday, 22nd of March 2023

STRUCTURAL BUILDING INSPECTION REPORT

FERGUSON HALL

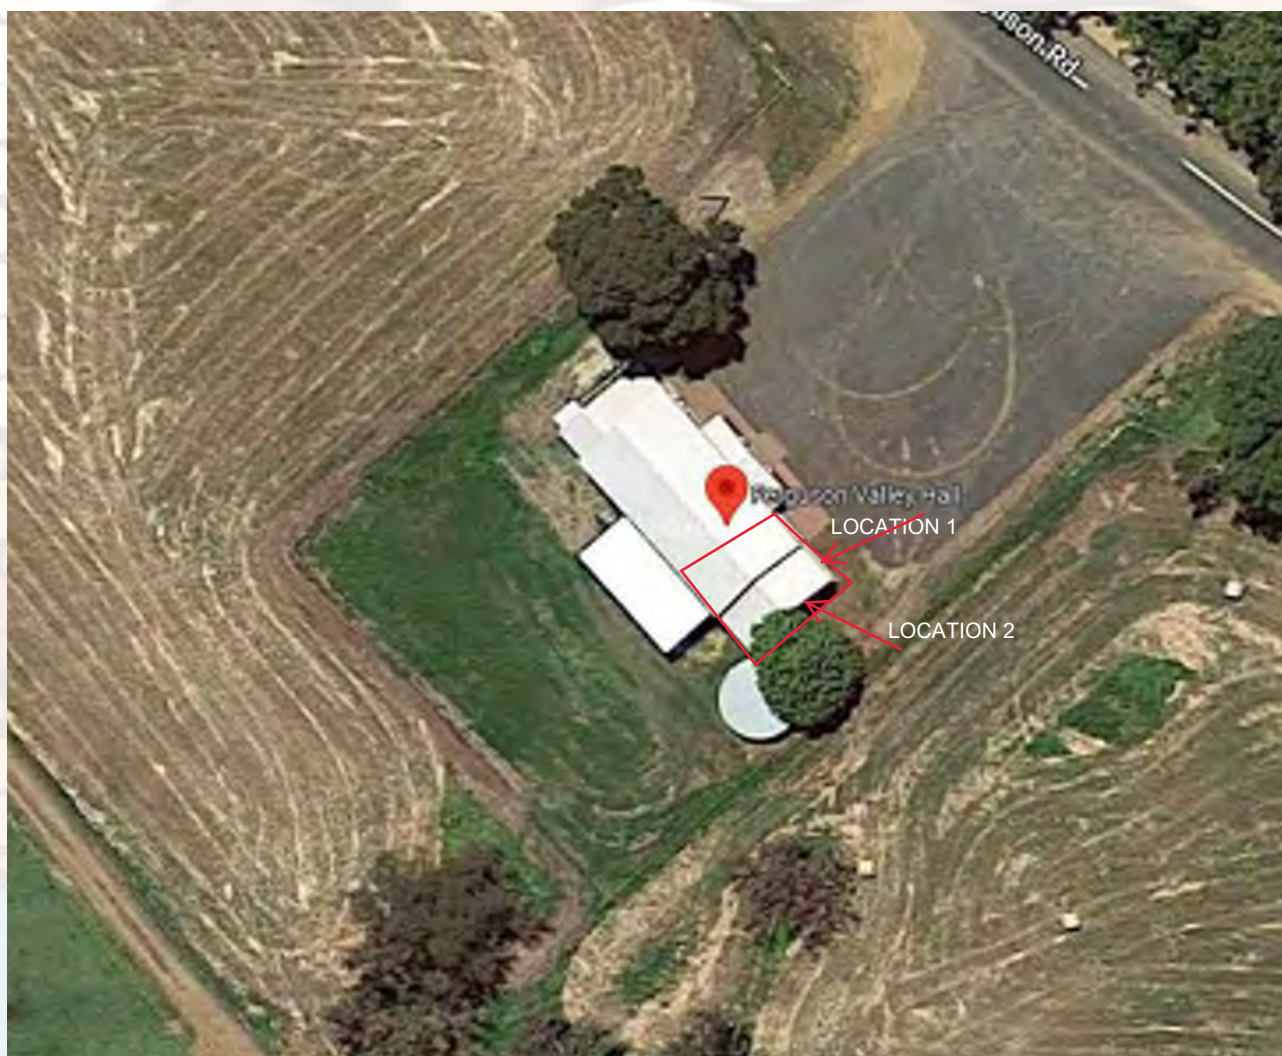
MAP SHOWING PROBALMETIC AREAS THAT WOULD NEED RECTIFICATION SOON

It was also noted that the building is showing settlement on the North-Western Side, marked as Location 1, of the building which is confirmed by the sloping of the floor in the same direction and the same area. Also, some settlement was observed on the Northern side of the building marked as location 2.

Although, there was no significant cracking noted throughout the building but at Location 1 particularly, Joints of wall linings could be seen opening up, and also uneven and sloping floor. If the issue is not addressed on time, it could lead to further deterioration of the building. Also, it was noted that there was no bracing installed on the stumps.

There is no urgency to completely re-stump the whole building at this stage. However, at locations 1 and 2 and where the stumps are out of alignment, it is recommended that some stumps may be replaced immediately to stop the settlement from progressing any further. It is recommended that Duragal Stumps with adjustable piers should be used. The building should be lifted at locations 1 and 2 and at locations where stumps have moved out of alignment, to make the floor even and a new steel stump as mentioned above should be installed adjacent to the old one.

Based on my site visit, it is recommended to lift the building to make the floor level and install Duragal steel stumps adjacent to the existing stumps in locations 1 and 2 and all locations where the stumps are out of alignment. It is also advised to install two sets of bracing in every row to ensure the building can cater to the lateral movement caused by the wind. Also when the restumping of the building is done completely, subsoil drainage should be installed to channel the water flowing away from the subfloor area.

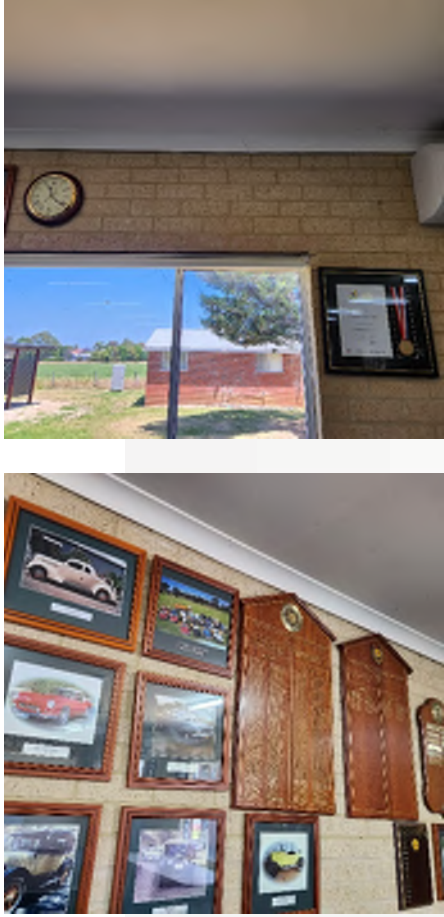
<p>Internal wall finishes: This is a minor defect. With passage of time and age of building, the cornices can deteriorate, crack split and presents gap between the walls. This is a non-structural issue.</p>	<p>Cosmetic Repairs needed.</p>

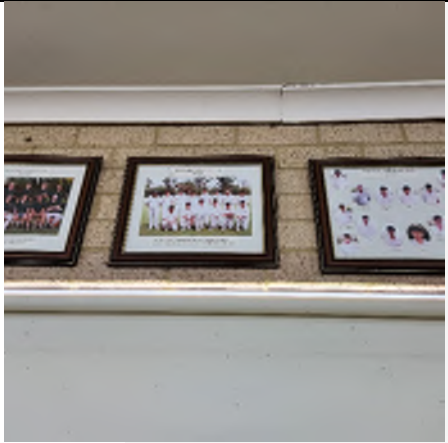
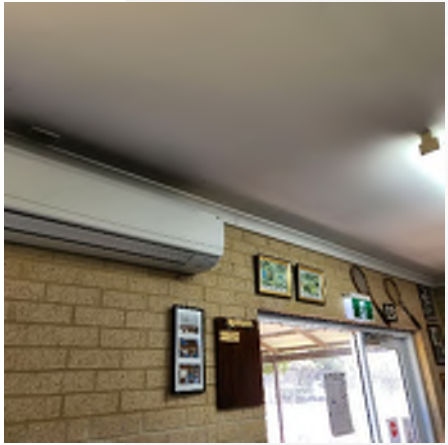
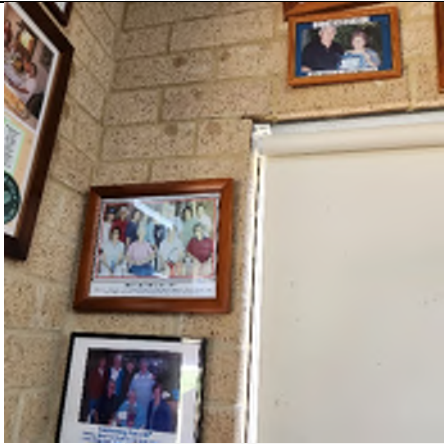
<p>This in its current state is not a major defect that. It is due to settlement but compared to other cracks this is not a major crack and can be observed over next 6 months to see the rate of progress. This can be done by putting markers and measure their width, the width of the crack should be observed at 1st month, 3rd month, and 6 months. If the crack has increased in the width, then rectification should be done, if there is no significant change in the width of the crack, then cosmetic repairs can be done to patch the crack.</p> <p>See Detail 1</p>	<p>If the crack increases in width, Underpinning method is recommended. A reinforced concrete is poured under the existing concrete. The underpinning is done 1m beyond the extent of crack on either side. Other procedure is injection grouting done by specialists' contractor, which is a quick but comparatively expensive solution. checking of compaction to confirm that stable depth, then grouting down to the depth, may provide solution to any possible further settlement issues. Performing these works to settlement areas under the guidance of a structural engineer, and subsequently sighted and signed off, by the certifying engineer, would remove the issue of further settlement potential</p>

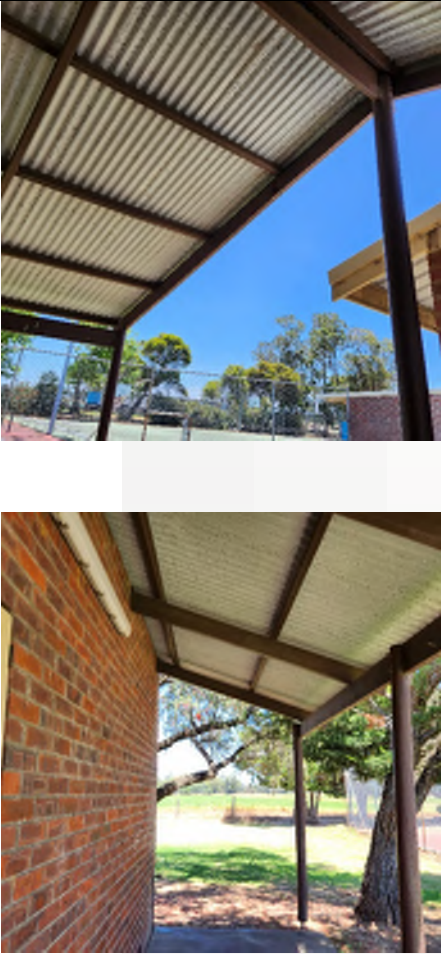
<p>The roof structurally adequate however, A standard detail will be provided so that the builder can rectify the building roof as per AS1684 standards and make it compliant. This should be done once the major defects have been addressed. In its current state, it is deemed as Minor Structural Defect.</p>	<p>Detail 2 is provided for builder to rectify the works.</p>

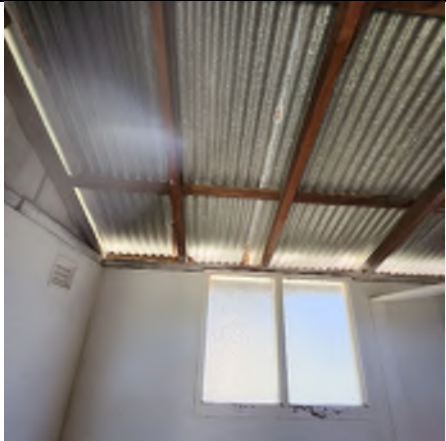
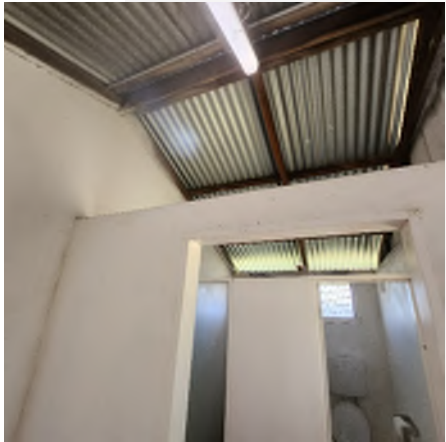
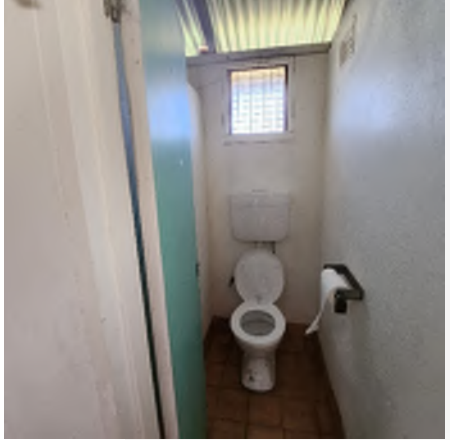
<p>Cracking observed to parts of the Toilet Block walls. This in its current state is not a major defect that. This is because of the load coming from the rafters on to the wall due to wind. The roof need to become compliant with AS1684 for tie downs and perhaps add more purlins. Once the work is done that cosmetically repair the area. Another reason could be settlement due to ground movement, as this is an M class site and the ground movements can be between 40mm-60mm so this can be one possibility. Poor Drainage can be another reason. Observe and go with least aggressive method of rectification i.e Make it compliant to AS1684 and then use other option.</p>	<p>If the crack increases in width, Underpinning method is recommended. A reinforced concrete is poured under the existing concrete. The underpinning is done 1m beyond the extent of crack on either side. Other procedure is injection grouting done by specialists' contractor, which is a quick but comparatively expensive solution. checking of compaction to confirm that stable depth, then grouting down to the depth, may provide solution to any possible further settlement issues. Performing these works to settlement areas under the guidance of a structural engineer, and subsequently sighted and signed off, by the certifying engineer, would remove the issue of further settlement potential</p>

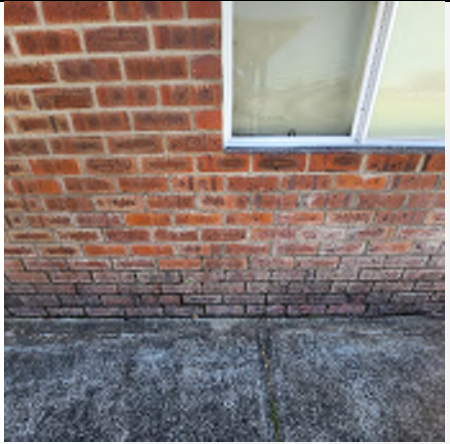
<p>This in its current state is not a major defect that. It is due to settlement but compared to other cracks this is not a major crack and can be observed over next 6 months to see the rate of progress. This can be done by putting markers and measure their width, the width of the crack should be observed at 1st month, 3rd month, and 6 months. If the crack has increased in the width, then rectification should be done, if there is no significant change in the width of the crack, then cosmetic repairs can be done to patch the crack.</p> <p>See Detail 1</p>	<p>If the crack increases in width, Underpinning method is recommended. A reinforced concrete is poured under the existing concrete. The underpinning is done 1m beyond the extent of crack on either side. Other procedure is injection grouting done by specialists' contractor, which is a quick but comparatively expensive solution. checking of compaction to confirm that stable depth, then grouting down to the depth, may provide solution to any possible further settlement issues. Performing these works to settlement areas under the guidance of a structural engineer, and subsequently sighted and signed off, by the certifying engineer, would remove the issue of further settlement potential</p>

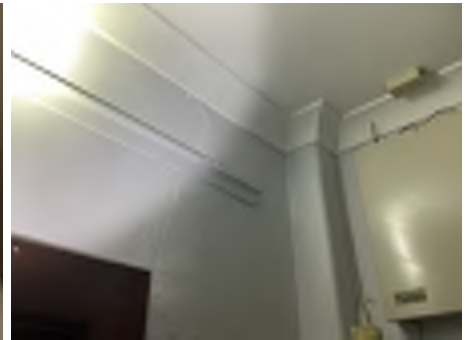
Cracking observed to parts of the internal walls. Recommend a structural engineer be engaged to inspect and provide appropriate advice and recommendations to reduce the risk of further deterioration to the building.

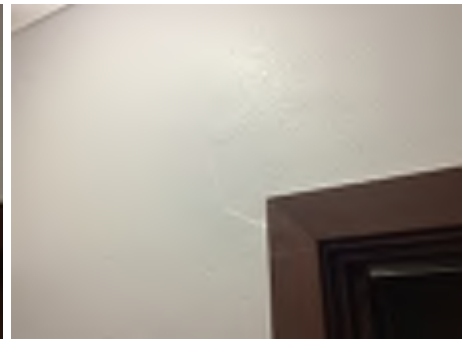
Cracking observed to parts of the internal walls. Recommend a structural engineer be engaged to inspect and provide appropriate advice and recommendations to reduce the risk of further deterioration to the building.

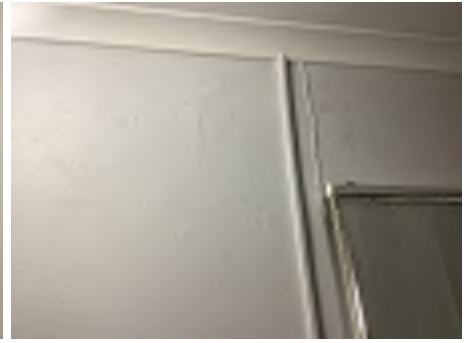
Cracking observed to parts of the internal walls. Recommend a structural engineer be engaged to inspect and provide appropriate advice and recommendations to reduce the risk of further deterioration to the building.

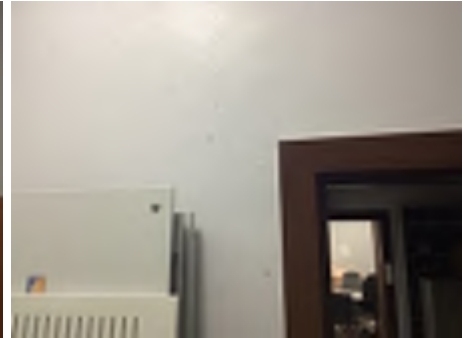
Cracking observed to parts of the internal walls. Recommend a structural engineer be engaged to inspect and provide appropriate advice and recommendations to reduce the risk of further deterioration to the building.

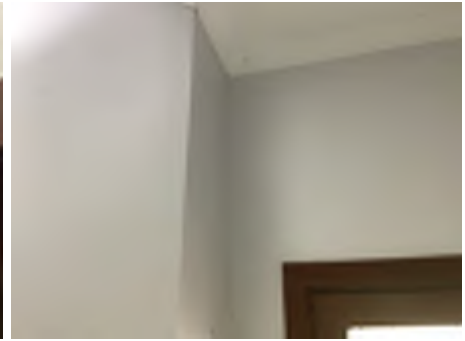
Cracking observed to parts of the internal walls. Recommend a structural engineer be engaged to inspect and provide appropriate advice and recommendations to reduce the risk of further deterioration to the building.

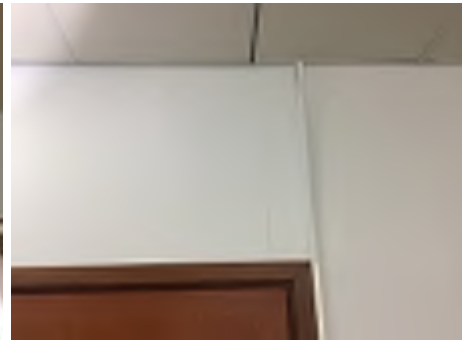
Cracking observed to parts of the internal walls. Recommend a structural engineer be engaged to inspect and provide appropriate advice and recommendations to reduce the risk of further deterioration to the building.

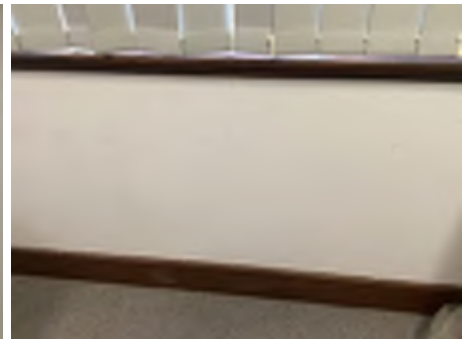
Cracking observed to parts of the internal walls. Recommend a structural engineer be engaged to inspect and provide appropriate advice and recommendations to reduce the risk of further deterioration to the building.

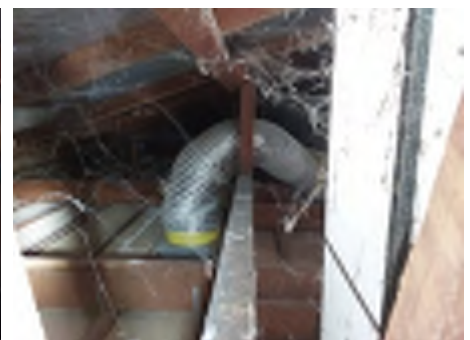
Angled bracing to beams to prevent rotation or movement is not observed to all areas. Recommend engaging a builder to repair to reduce the risk of movement and damage.

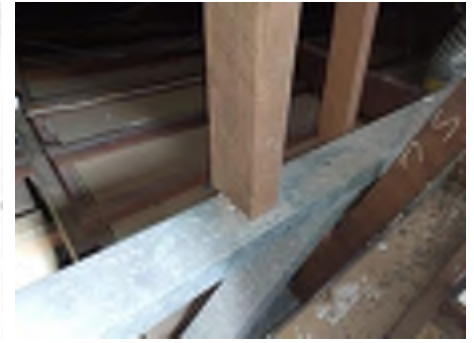
Timber struts bearing onto metal truss beams have no visual fasteners to the beams in some locations. Recommend engaging an engineer to investigate and a builder to repair to reduce the risk of movement and damage.

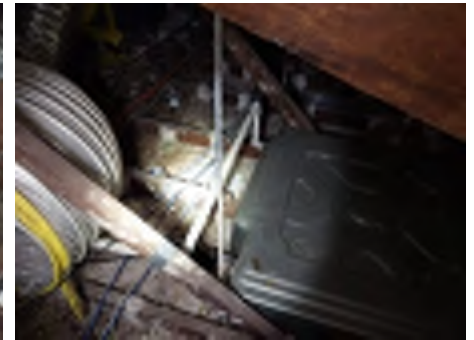
Ceiling timbers cut and not adequately reinforced around the AC position - recommend engaging a builder/ carpenter to repair to reduce the risk of damage.

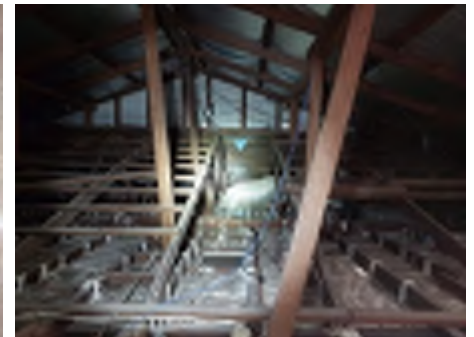
Some of the extension roofing members are propped onto the original roof structure with no additional support observed under the support load point. Recommend engaging an engineer to investigate and a builder to repair to reduce the risk of movement and damage.

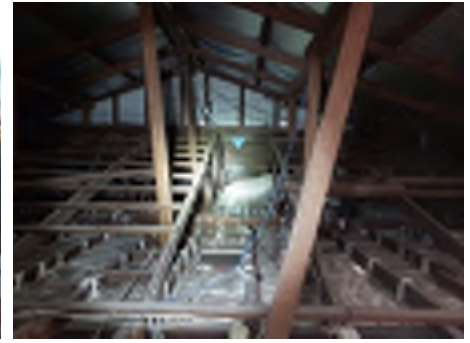
Spans to underpurlins are greater than typically allowed in several areas throughout the roof. Recommend engaging a builder to investigate and repair to reduce the risk of movement and damage.

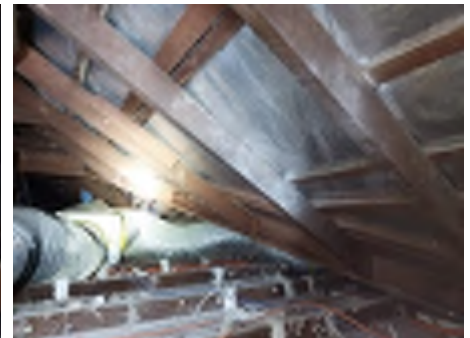
The roof cover appears to have been changed in the past to new roofing iron with modern fasteners. No provision to upgrade supporting timbers and tie downs to the roof to the requirements of the approximate date of the changed roof cover are observed. Recommend engaging an engineer to assess and a builder to install additional timbers, tie downs and strapping or obtaining a signed engineering detail for the roof change as constructed.

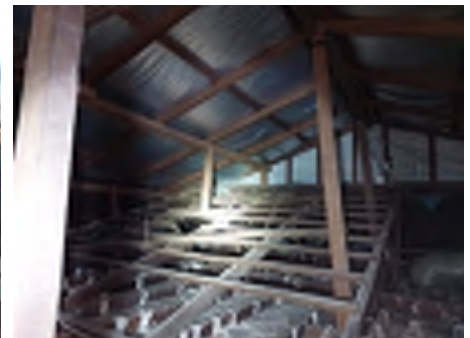
The roof cover appears to have been changed in the past to new roofing iron with modern fasteners. No provision to upgrade supporting timbers and tie downs to the roof to the requirements of the approximate date of the changed roof cover are observed. Recommend engaging an engineer to assess and a builder to install additional timbers, tie downs and strapping or obtaining a signed engineering detail for the roof change as constructed.

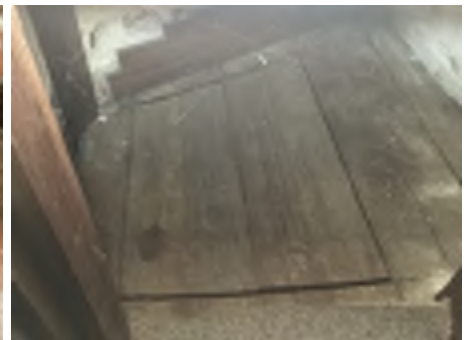
Termite damage observed to the subfloor Timbers around the one visible subfloor hatch. Recommend conducting further, more invasive investigation and engaging a builder to repair to reduce the risk of damage to the structure to reduce the risk of further deterioration.

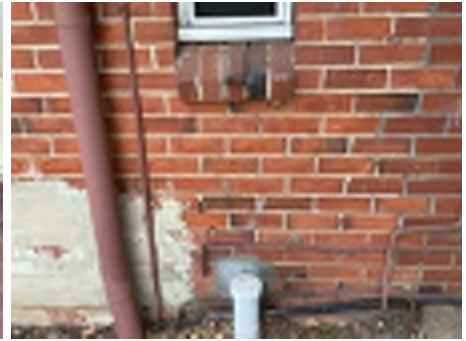
Cracking observed to parts of the external walls. Recommend a structural engineer be engaged to inspect and provide appropriate advice and recommendations to reduce the risk of further deterioration to the building.

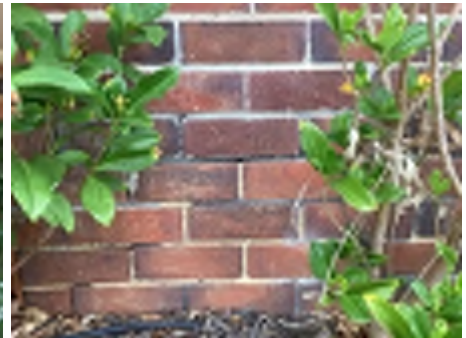
Cracking observed to parts of the external walls. Recommend a structural engineer be engaged to inspect and provide appropriate advice and recommendations to reduce the risk of further deterioration to the building.

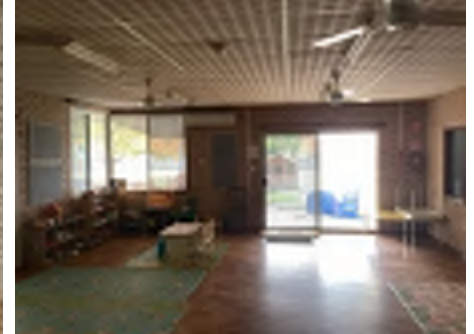
Showing examples of loose ceiling panels

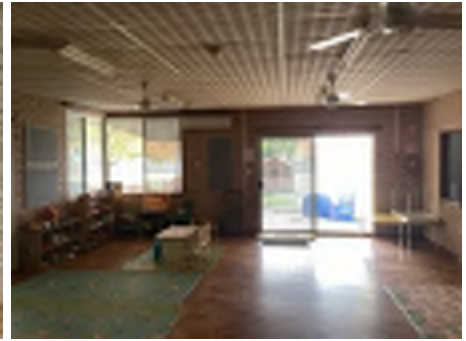
Safety issue only (non structural). It is a requirement of the inspection standard to report observed safety issues within the main body of the report. Some loose ceiling panels are observed. Recommend engaging a builder to repair to reduce the risk of damage and injury.

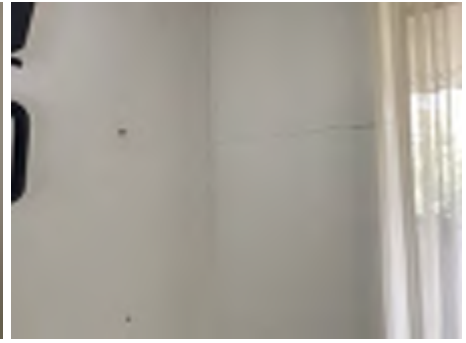
Cracking observed to parts of the internal walls. Recommend a structural engineer be engaged to inspect and provide appropriate advice and recommendations to reduce the risk of further deterioration to the building, To the front community area.

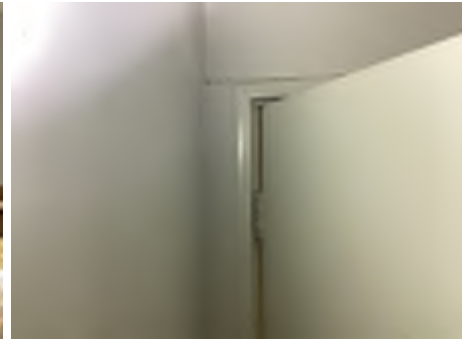
Cracking observed to parts of the internal walls. Recommend a structural engineer be engaged to inspect and provide appropriate advice and recommendations to reduce the risk of further deterioration to the building, To the rear kindergarten area.

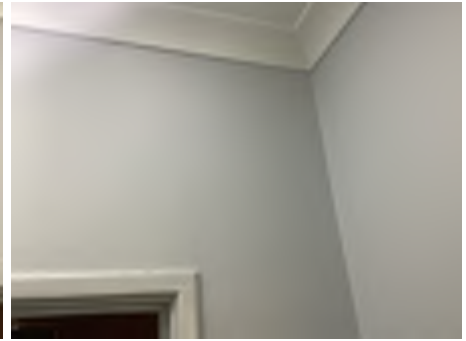
Cracking observed to parts of the internal walls. Recommend a structural engineer be engaged to inspect and provide appropriate advice and recommendations to reduce the risk of further deterioration to the building, To the rear kindergarten area.

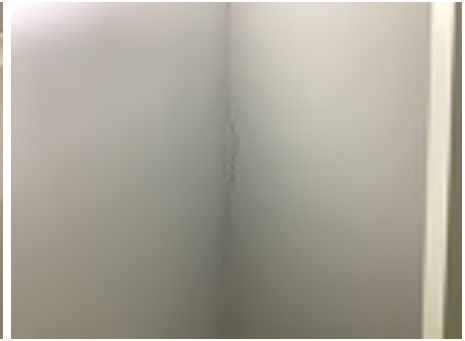
Cracking observed to parts of the internal walls. Recommend a structural engineer be engaged to inspect and provide appropriate advice and recommendations to reduce the risk of further deterioration to the building, To the rear kindergarten area.

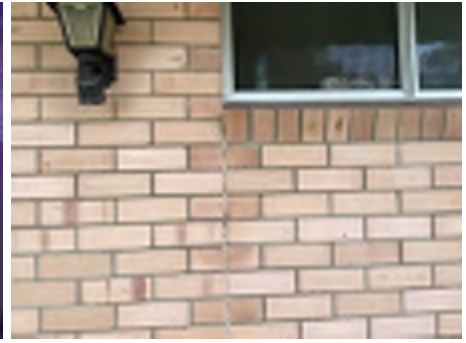
Cracking observed to parts of the external walls. Recommend a structural engineer be engaged to inspect and provide appropriate advice and recommendations to reduce the risk of further deterioration to the building.

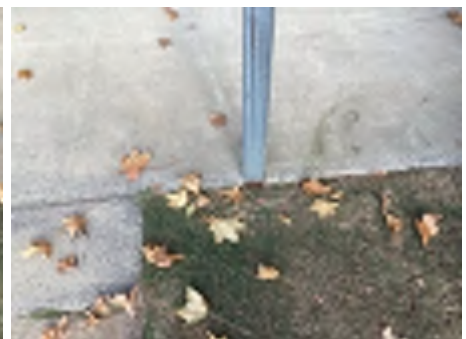
Rusting to steel patio/carport posts, channels and/or purlins - recommend engaging a builder to repair to reduce the risk of deterioration.

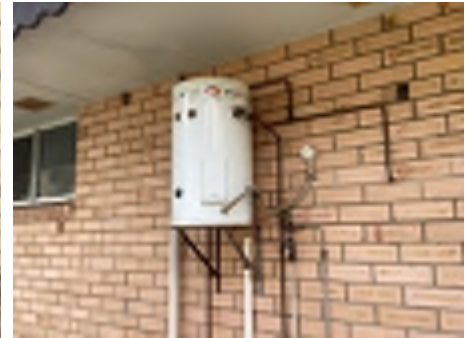
Safety issue only (non structural). It is a requirement of the inspection standard to report observed safety issues within the main body of the report. The rear wall mounted hot water system is not visibly secured with a bracket - recommend engaging an appliance installer to repair to reduce the risk of damage and personal injury.

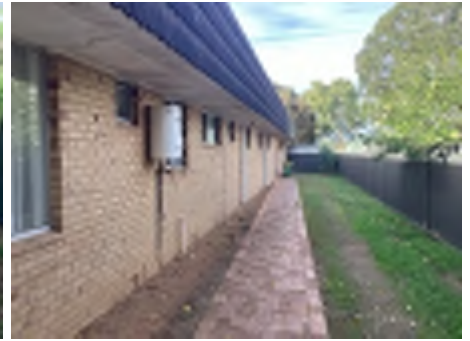
Safety issue only (non structural). It is a requirement of the inspection standard to report observed safety issues within the main body of the report. Unevenness and settling to parts of the pavers. Needs repair/replacing to prevent further deterioration.

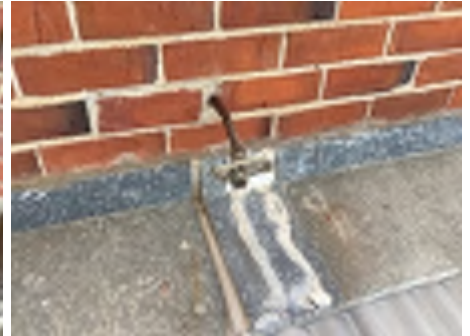
Showing examples of exposed wires

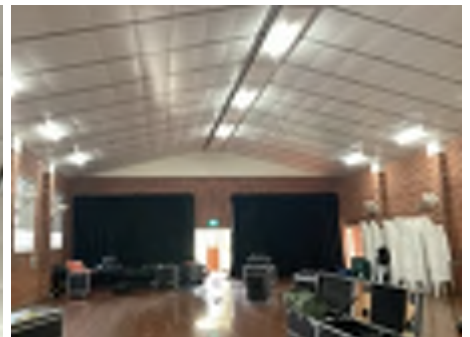
Safety issue only (non structural). It is a requirement of the inspection standard to report observed safety issues within the main body of the report. Loose ceiling panels observed to several areas. Recommend engaging a builder to repair to reduce the risk of panels dislodging and causing damage or injury.

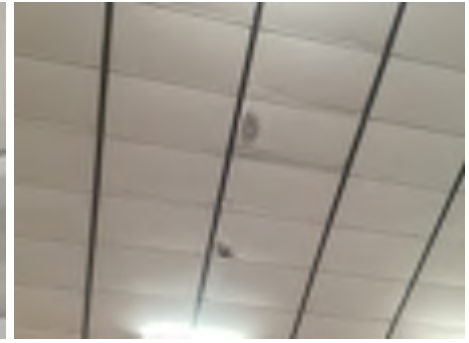
Safety issue only (non structural). It is a requirement of the inspection standard to report observed safety issues within the main body of the report. Possible Mould like material observed to other ceilings through the structure in wet areas and main hall area. Recommend engaging a mould technician to investigate if the material is hazardous and a builder to repair as required to reduce the risk of illness or further deterioration.

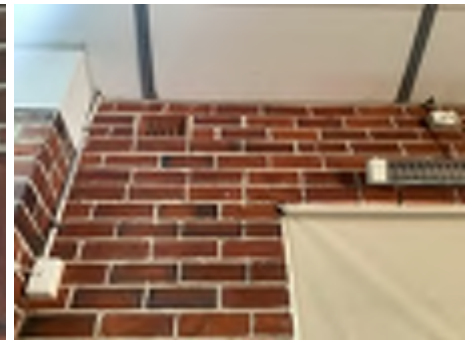
Cracking observed to parts of the internal walls. Recommend a structural engineer be engaged to inspect and provide appropriate advice and recommendations to reduce the risk of further deterioration to the building. To various locations in both halls and the storage area over the entrance.

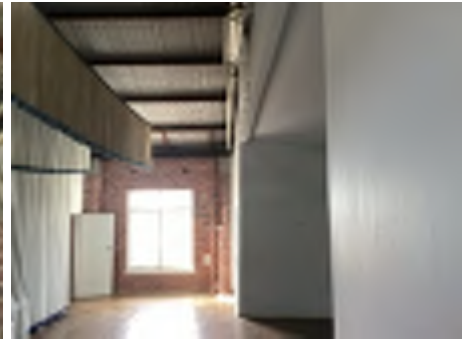
Leaning and distorted walls to the area behind the stage where the cladding section of the building has subsided. Recommend engaging an engineer to investigate and a builder to repair to reduce the risk of further movement or failure of the structure.

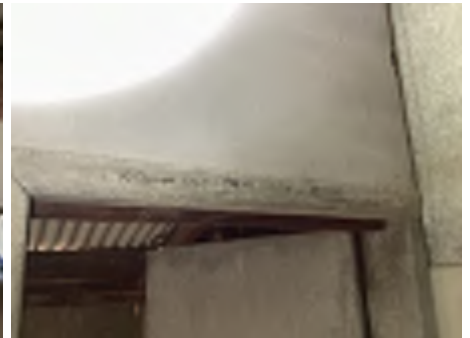
Safety issue only (non structural). It is a requirement of the inspection standard to report observed safety issues within the main body of the report. Exposed material that is visibly consistent with asbestos is located in the storage room over the entrance and to the gable end cladding over the stage. Recommend engaging a an asbestos technician to investigate and a builder to conduct repairs as required to reduce the risk of serious illness.

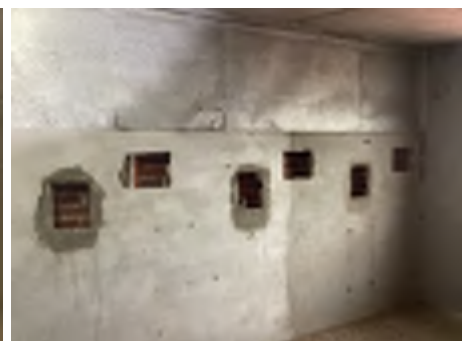
Safety issue only (non structural). It is a requirement of the inspection standard to report observed safety issues within the main body of the report. Exposed material that is visibly consistent with asbestos is located in the storage room over the entrance and to the gable end cladding over the stage. Recommend engaging a an asbestos technician to investigate and a builder to conduct repairs as required to reduce the risk of serious illness.

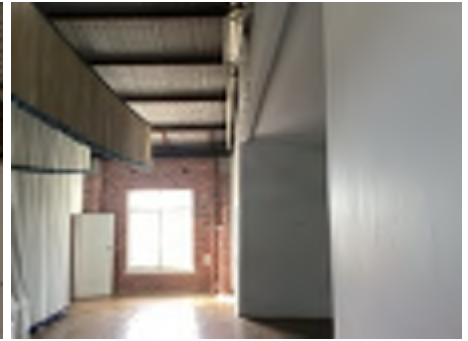
Safety issue only (non structural). It is a requirement of the inspection standard to report observed safety issues within the main body of the report. Exposed material that is visibly consistent with asbestos is located in the storage room over the entrance and to the gable end cladding over the stage. Recommend engaging a an asbestos technician to investigate and a builder to conduct repairs as required to reduce the risk of serious illness.

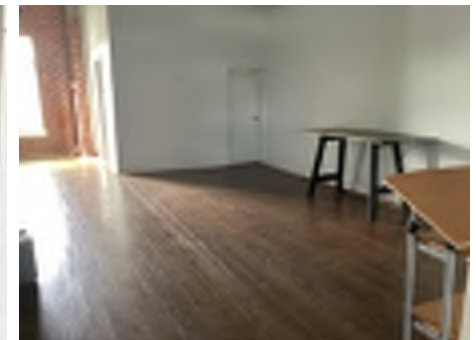
Undulating/uneven floors - recommend engaging a builder to assess appropriate method of rectification to prevent further deterioration, To the rear stage and storage areas.

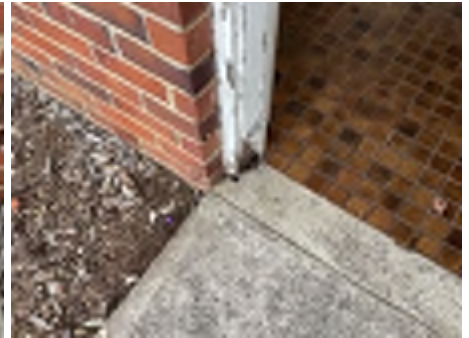
Possible termite damage to the bathroom door jamb Timbers. Recommend engaging a pest technician to investigate to determine if there is concealed damage and if a treatment is required.

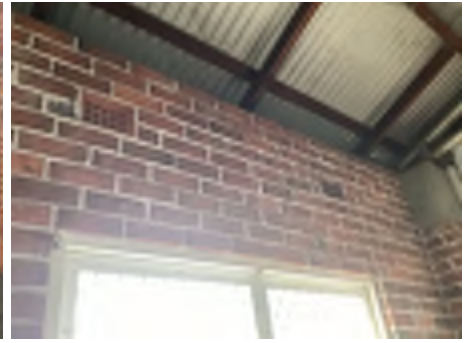
The roof cover appears to have been changed in the past to new roofing iron with modern fasteners. No provision to upgrade supporting timbers and tie downs to the roof to the requirements of the approximate date of the changed roof cover are observed. Recommend engaging an engineer to assess and a builder to install additional timbers, tie downs and strapping or obtaining a signed engineering detail for the roof change as constructed.

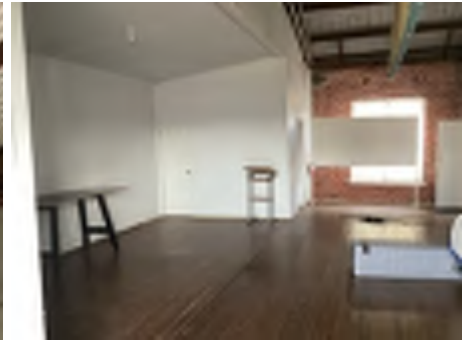
The metal roof truss over the stage in the main hall is visibly displaced where the rear of the stage is subsiding and impacting the roof structure. Recommend engaging an engineer to investigate and a builder to repair to reduce the risk of further movement, deterioration or failure of the structure.

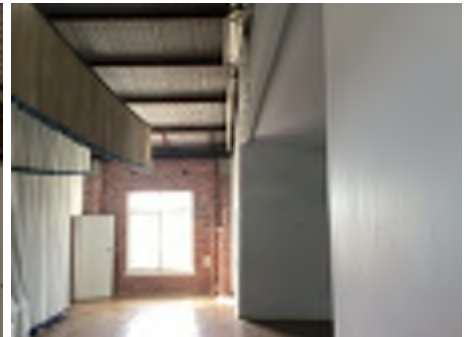
The metal roof truss over the stage in the main hall is visibly displaced where the rear of the stage is subsiding and impacting the roof structure. Recommend engaging an engineer to investigate and a builder to repair to reduce the risk of further movement, deterioration or failure of the structure.

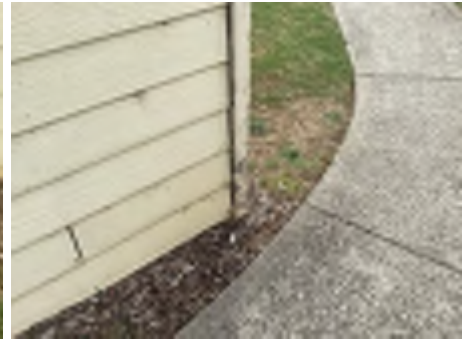
The rear stage clad extension is falling away from the main hall building with cracking to cladding and a large gap opening to the wall at the top to both sides of the extension. Recommend engaging an engineer to investigate and a builder to conduct repairs to reduce the risk of further movement, deterioration or structural failure.

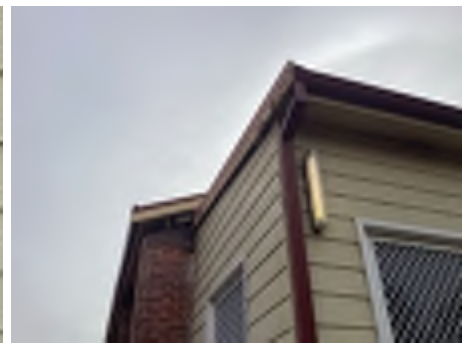
The rear stage clad extension is falling away from the main hall building with cracking to cladding and a large gap opening to the wall at the top to both sides of the extension. Recommend engaging an engineer to investigate and a builder to conduct repairs to reduce the risk of further movement, deterioration or structural failure.

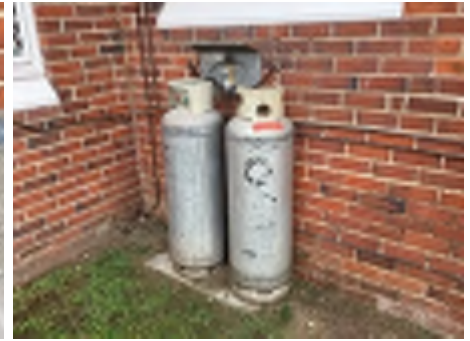
Damaged chain fastener positions to the gas bottles. Recommend engaging a builder to repair to reduce the risk of damage to the bottles and lines and potential injury.
