ELECTED MEMBERS MOTIONS

Ordinary Council Meeting

Tree Inspection and Recommendations Prepared for:

Department of Finance – Building Management & Works River Valley Primary School - Burekup 03/03/2021

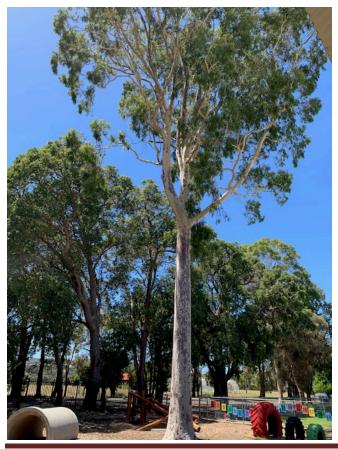
Tree ID: 01. Species: Corymbia maculata (Western Spotted Gum) Location: K/PP Playground

Comments: Tree has sustained 2 recent branch failures, these failures appear to be consistent with excessive loading during an extreme wind event- given the nature of the weather conditions that cause this type of branch failure, the likelihood of people being beneath the crown during this type of weather event is dramatically reduced – therefore the likelihood of impact is also dramatically reduced.

Risk assessment – Tree Part/Target: Deadwood overhanging playground

Likelihood of failure – Possible Likelihood of impact – Low Consequences of failure – Severe

Overall tree risk rating – Low

Recommendations: Carry out deadwood removal, minor load reduction pruning to over-extended laterals, carry out aerial inspection of crown during works – report to BMW if required

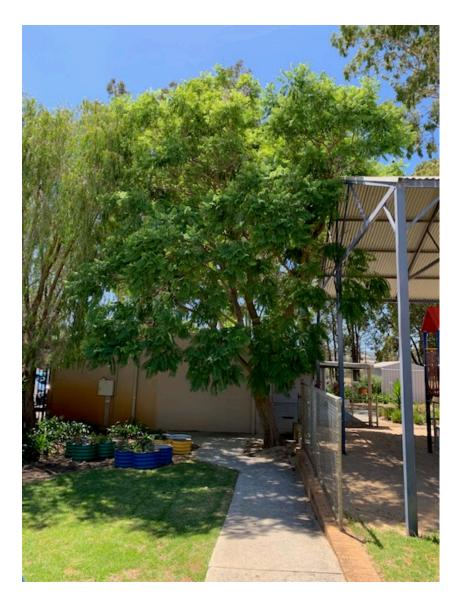
Tree ID: 02. Species: Jacaranda mimosifolia (Jacaranda) Location: K/PP Playground

Tree health: Good Structure: Good Comments: Tree has branches impacting buildings

Overall tree risk rating – Low

Recommendations: Carry out pruning for building clearances

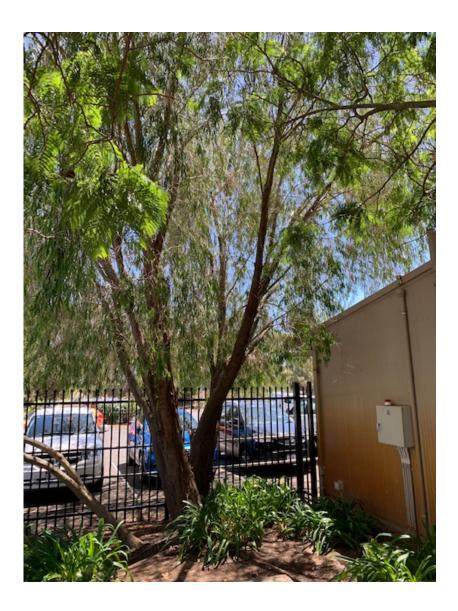
Tree ID: 03. Species: Agonis flexuosa (WA Weeping Peppermint) Location: Northern fence line of K/PP

Tree health: Good Structure: Fair Comments: Tree has branches impacting building and carpark

Overall tree risk rating – Low

Recommendations: Carry out crown lift pruning and building clearance

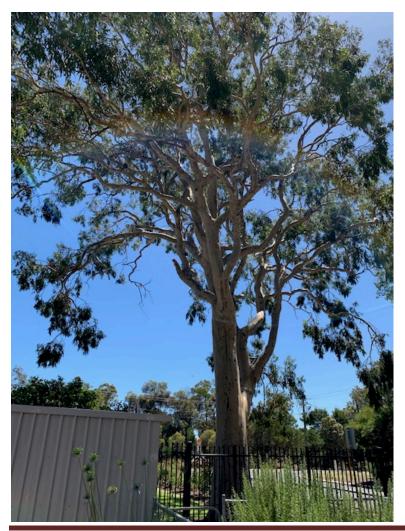
Tree ID: 04. Species: Corymbia maculata (Western Spotted Gum) Location: Eastern boundary overhanging K/PP building

Tree health: Good Structure: Fair Comments: Tree has deadwood throughout crown, over-extended branches and several stubs from branch failures

Risk assessment – Tree Part/Target: Deadwood and over-extended branches overhanging carpark and footpath Likelihood of failure – Probable Likelihood of impact – Low Consequences of impact – Severe

Overall tree risk rating – Low

Recommendations: Carry out deadwood removal, load reduction pruning to over-extended laterals and remedial pruning to damage

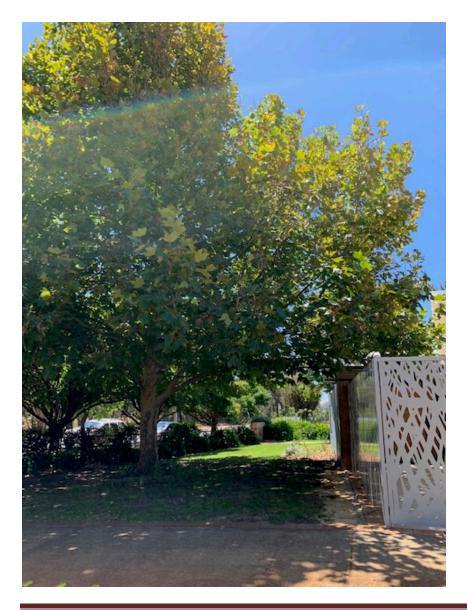
Tree ID: 05.Species: Plantanus acerifolia (London Plane Tree)Location: Front entrance to school – Northern side

Tree health: Good Structure: Good Comments: Tree has branches impacting building

Overall tree risk rating – Low

Recommendations: Carry out pruning for building clearance

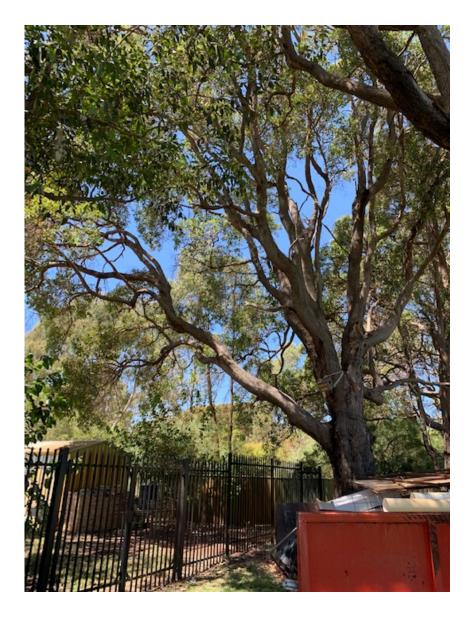
Tree ID: 06. Species: Corymbia calophylla (Marri) Location: S/W corner of school

Tree health: Fair Structure: Fair Comments: Tree has deadwood throughout crown and over-extended lateral branches N/E side of crown

Risk assessment – Tree Part/Target: Deadwood and over-extended lateral branches overhanging play area Likelihood of failure – Probable Likelihood of impact – Low Consequences of impact – Severe

Overall tree risk rating – Low

Recommendations: Carry out deadwood removal and load reduction pruning to over-extended laterals
