Shire of Dardanup

ORDINARY COUNCIL MEETING

Eaton Library & Administration Building

Summary (850)

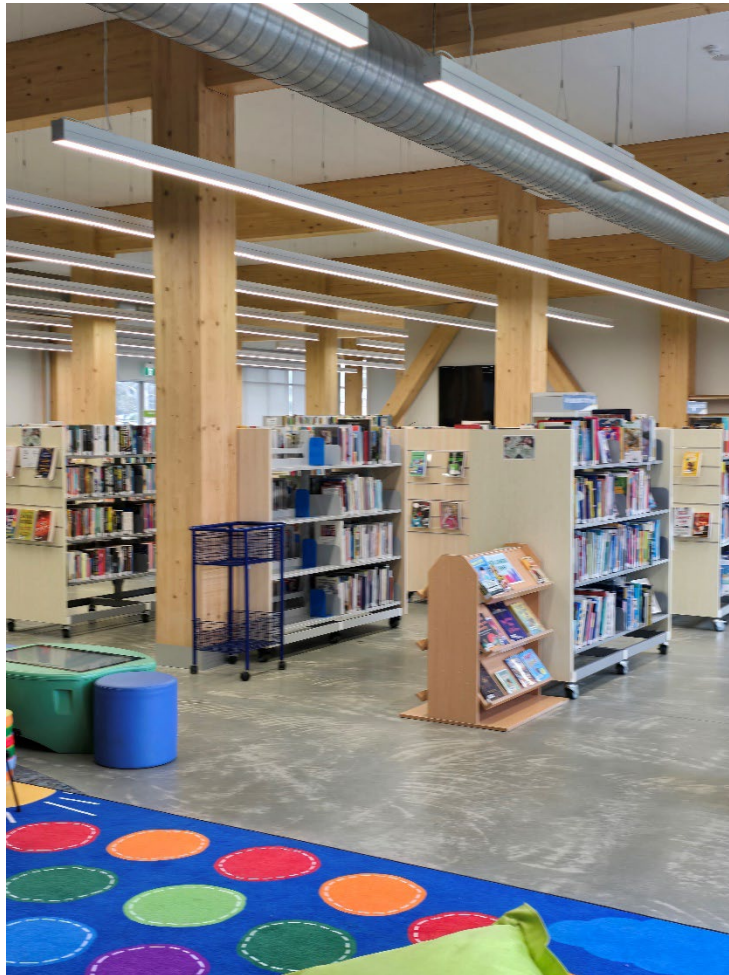
We note that noise received by the bridge player from children is, without complete separation (ie partitioning), likely to be unacceptable (or at least not ideal), however, the transmission of noise across the library could be reduced by :

PHOTO 01 – LIBRARY FROM CHILDREN'S AREA

- The installation of absorption. The areas we suggest that absorption be installed are shown below in Figure 01.
- We also note that the book shelves run in an north south orientation, as shown in Photo 01 below. If the book shelves located adjacent to the children's area were rotated 90 degree (ie running east – west) then these book shelves would act as a partial barrier.

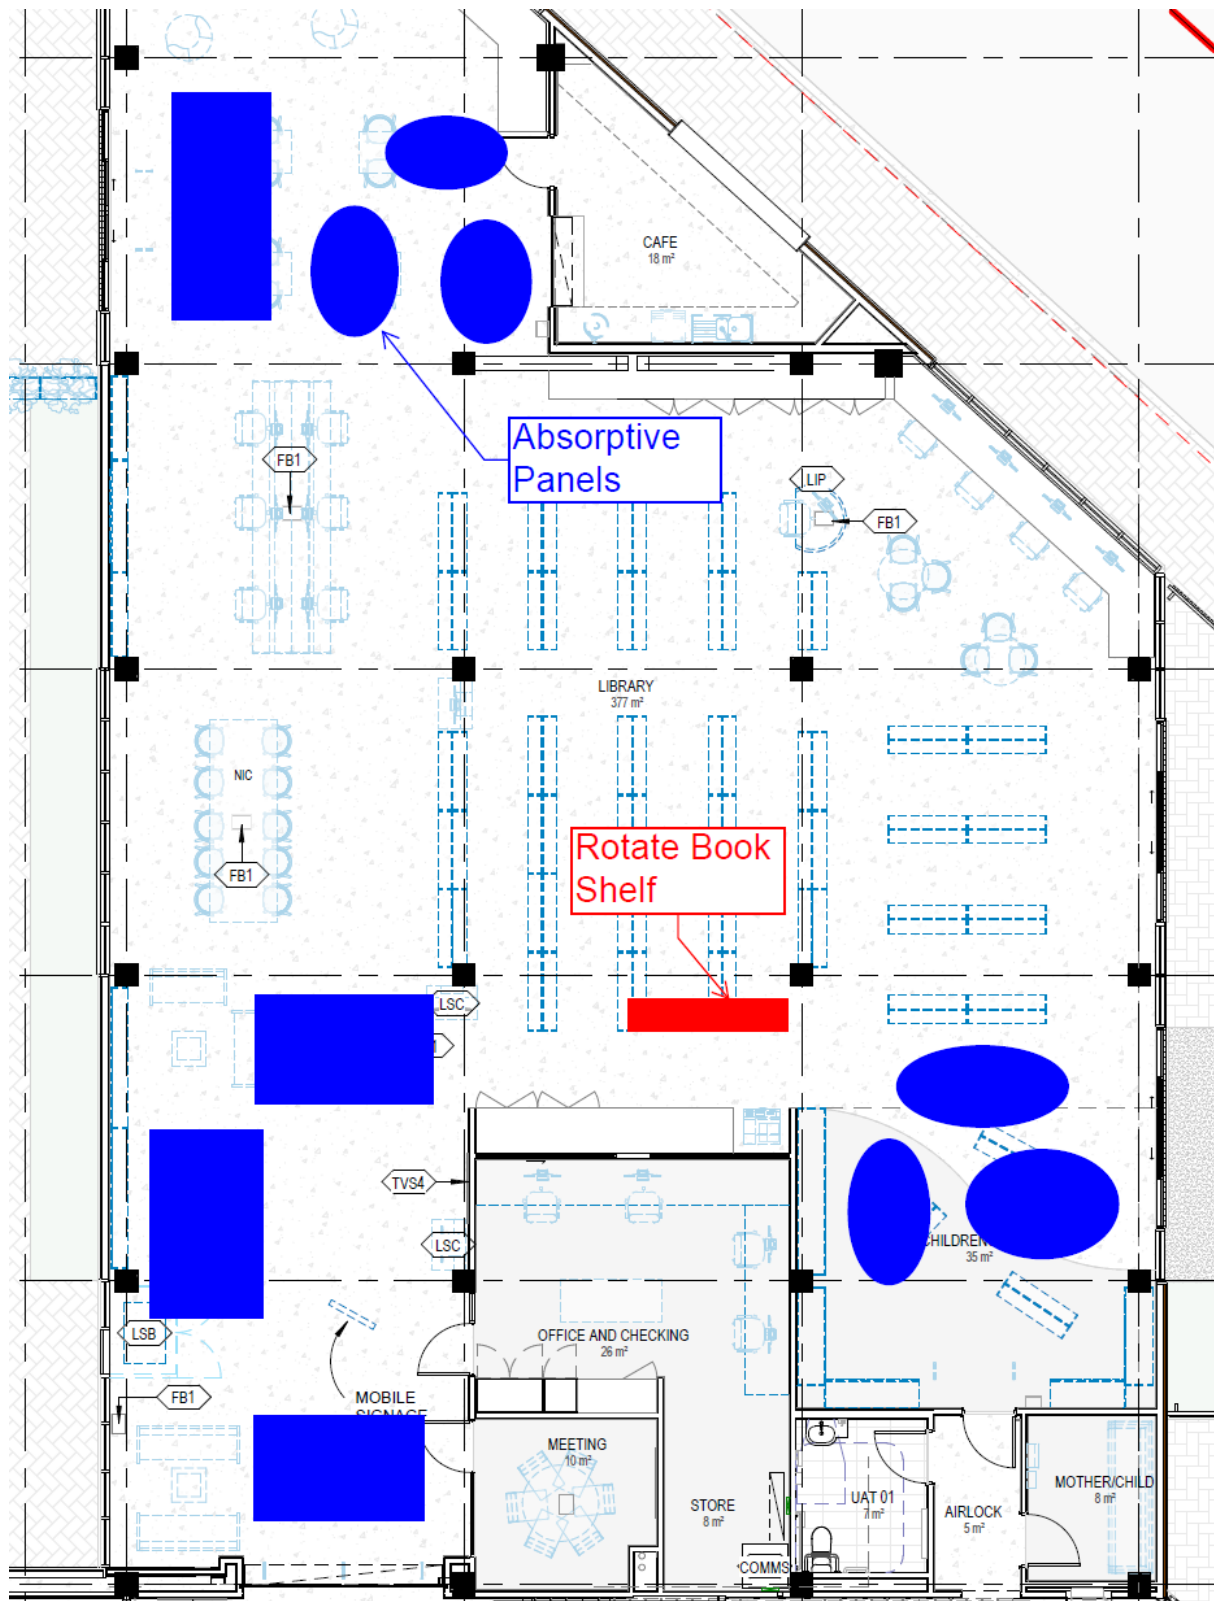
FIGURE 01 – ABSORPTIVE PANEL / ROTATED BOOK SHELF

We note that there are a number of absorptive panels suppliers in the marketplace, such as Autex or Acoufelt. However, the absorptive panel should be a minimum of 24mm thick and have a minimum NRC value of 0.65.

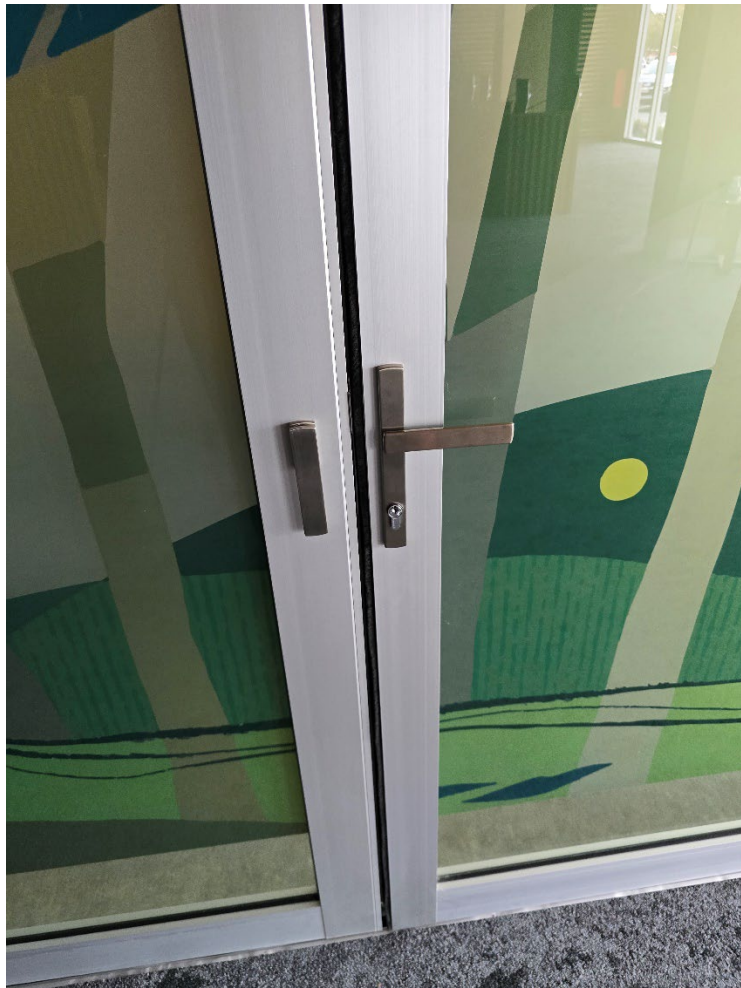
The doors between the dining room and the council chambers are bifold doors, which we understand was to allow for additional public gallery area and functions. From an inspection of these doors compressible seals were noted to be present. However, the centre point where the 2 leaves meet, as shown on Photo 02, has a sizable gap between the doors. This gap could be sealed using an acoustic door seal, such as a Raven RP16 Si or similar.

PHOTO 02 – MEETING STILES TO DOOR FROM COUNCIL CHAMBERS TO THE DINING AREA

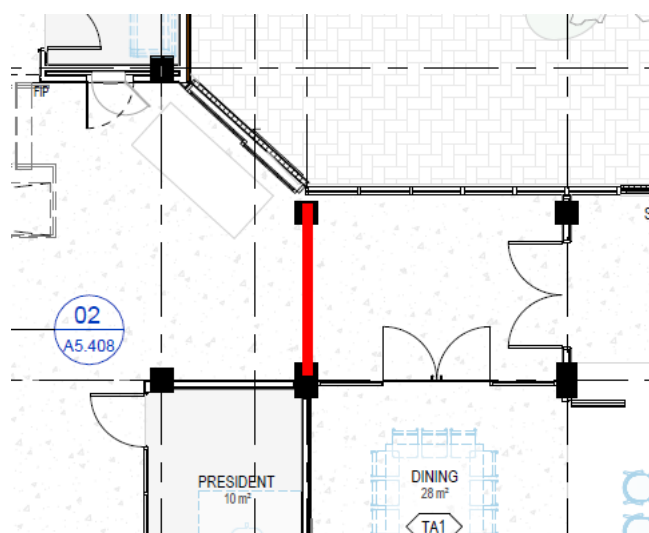
FIGURE 02 – POSSIBLE LOCATION OF ADDITIONAL DOORS

As alternatives to the above, to reduce transmission from the council chambers and the dining area, an additional door could be installed to the corridor, with the likely location being as shown on Figure 02 below, or a noise masking system or introduce background music to the lobby area just outside the area.

Given the usage of the space, we recommend the installation of a noise masking system or background music to the area. This would increase the general noise level within this part of the lobby area, thus reducing the intelligibility of what is being said within the dining space or council chamber.
