# DARDANUP PARK

## LOT 2 HAROLD DOUGLAS DRIVE AND LOT 185 VENN ROAD, DARDANUP WEST SITE-AND-SOIL EVALUATION (SSE)

10012-G-E-R-002-SSE Report

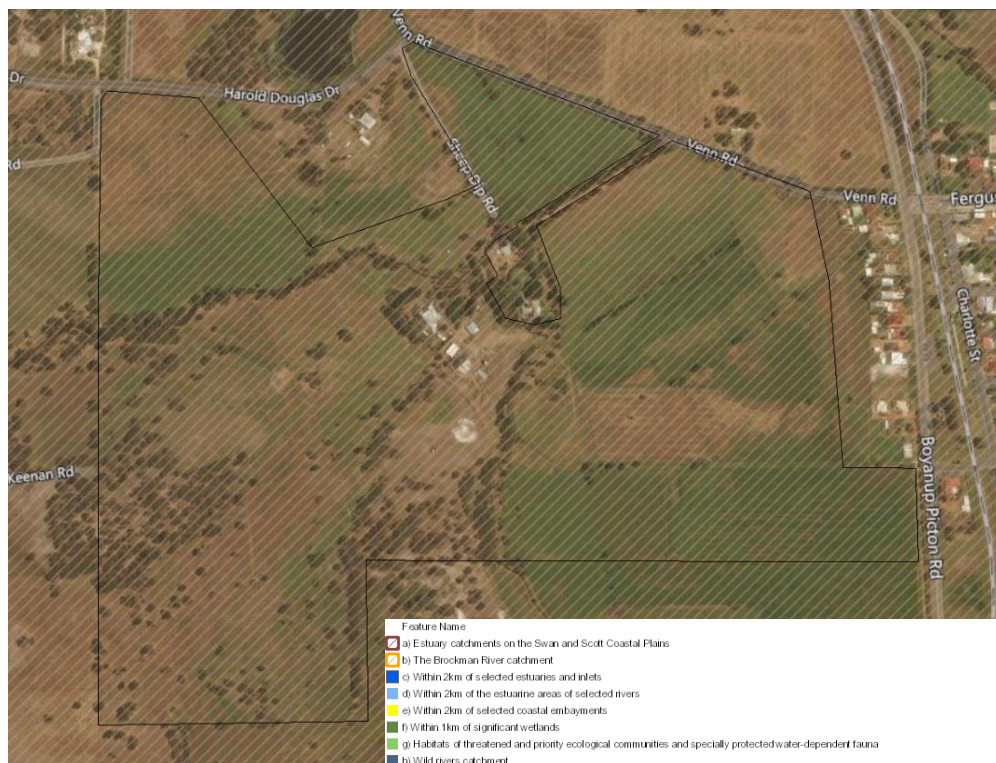
**Figure 1: Site boundaries with sewerage sensitive areas overlaid – site is within a GSP sewerage sensitive zone.**

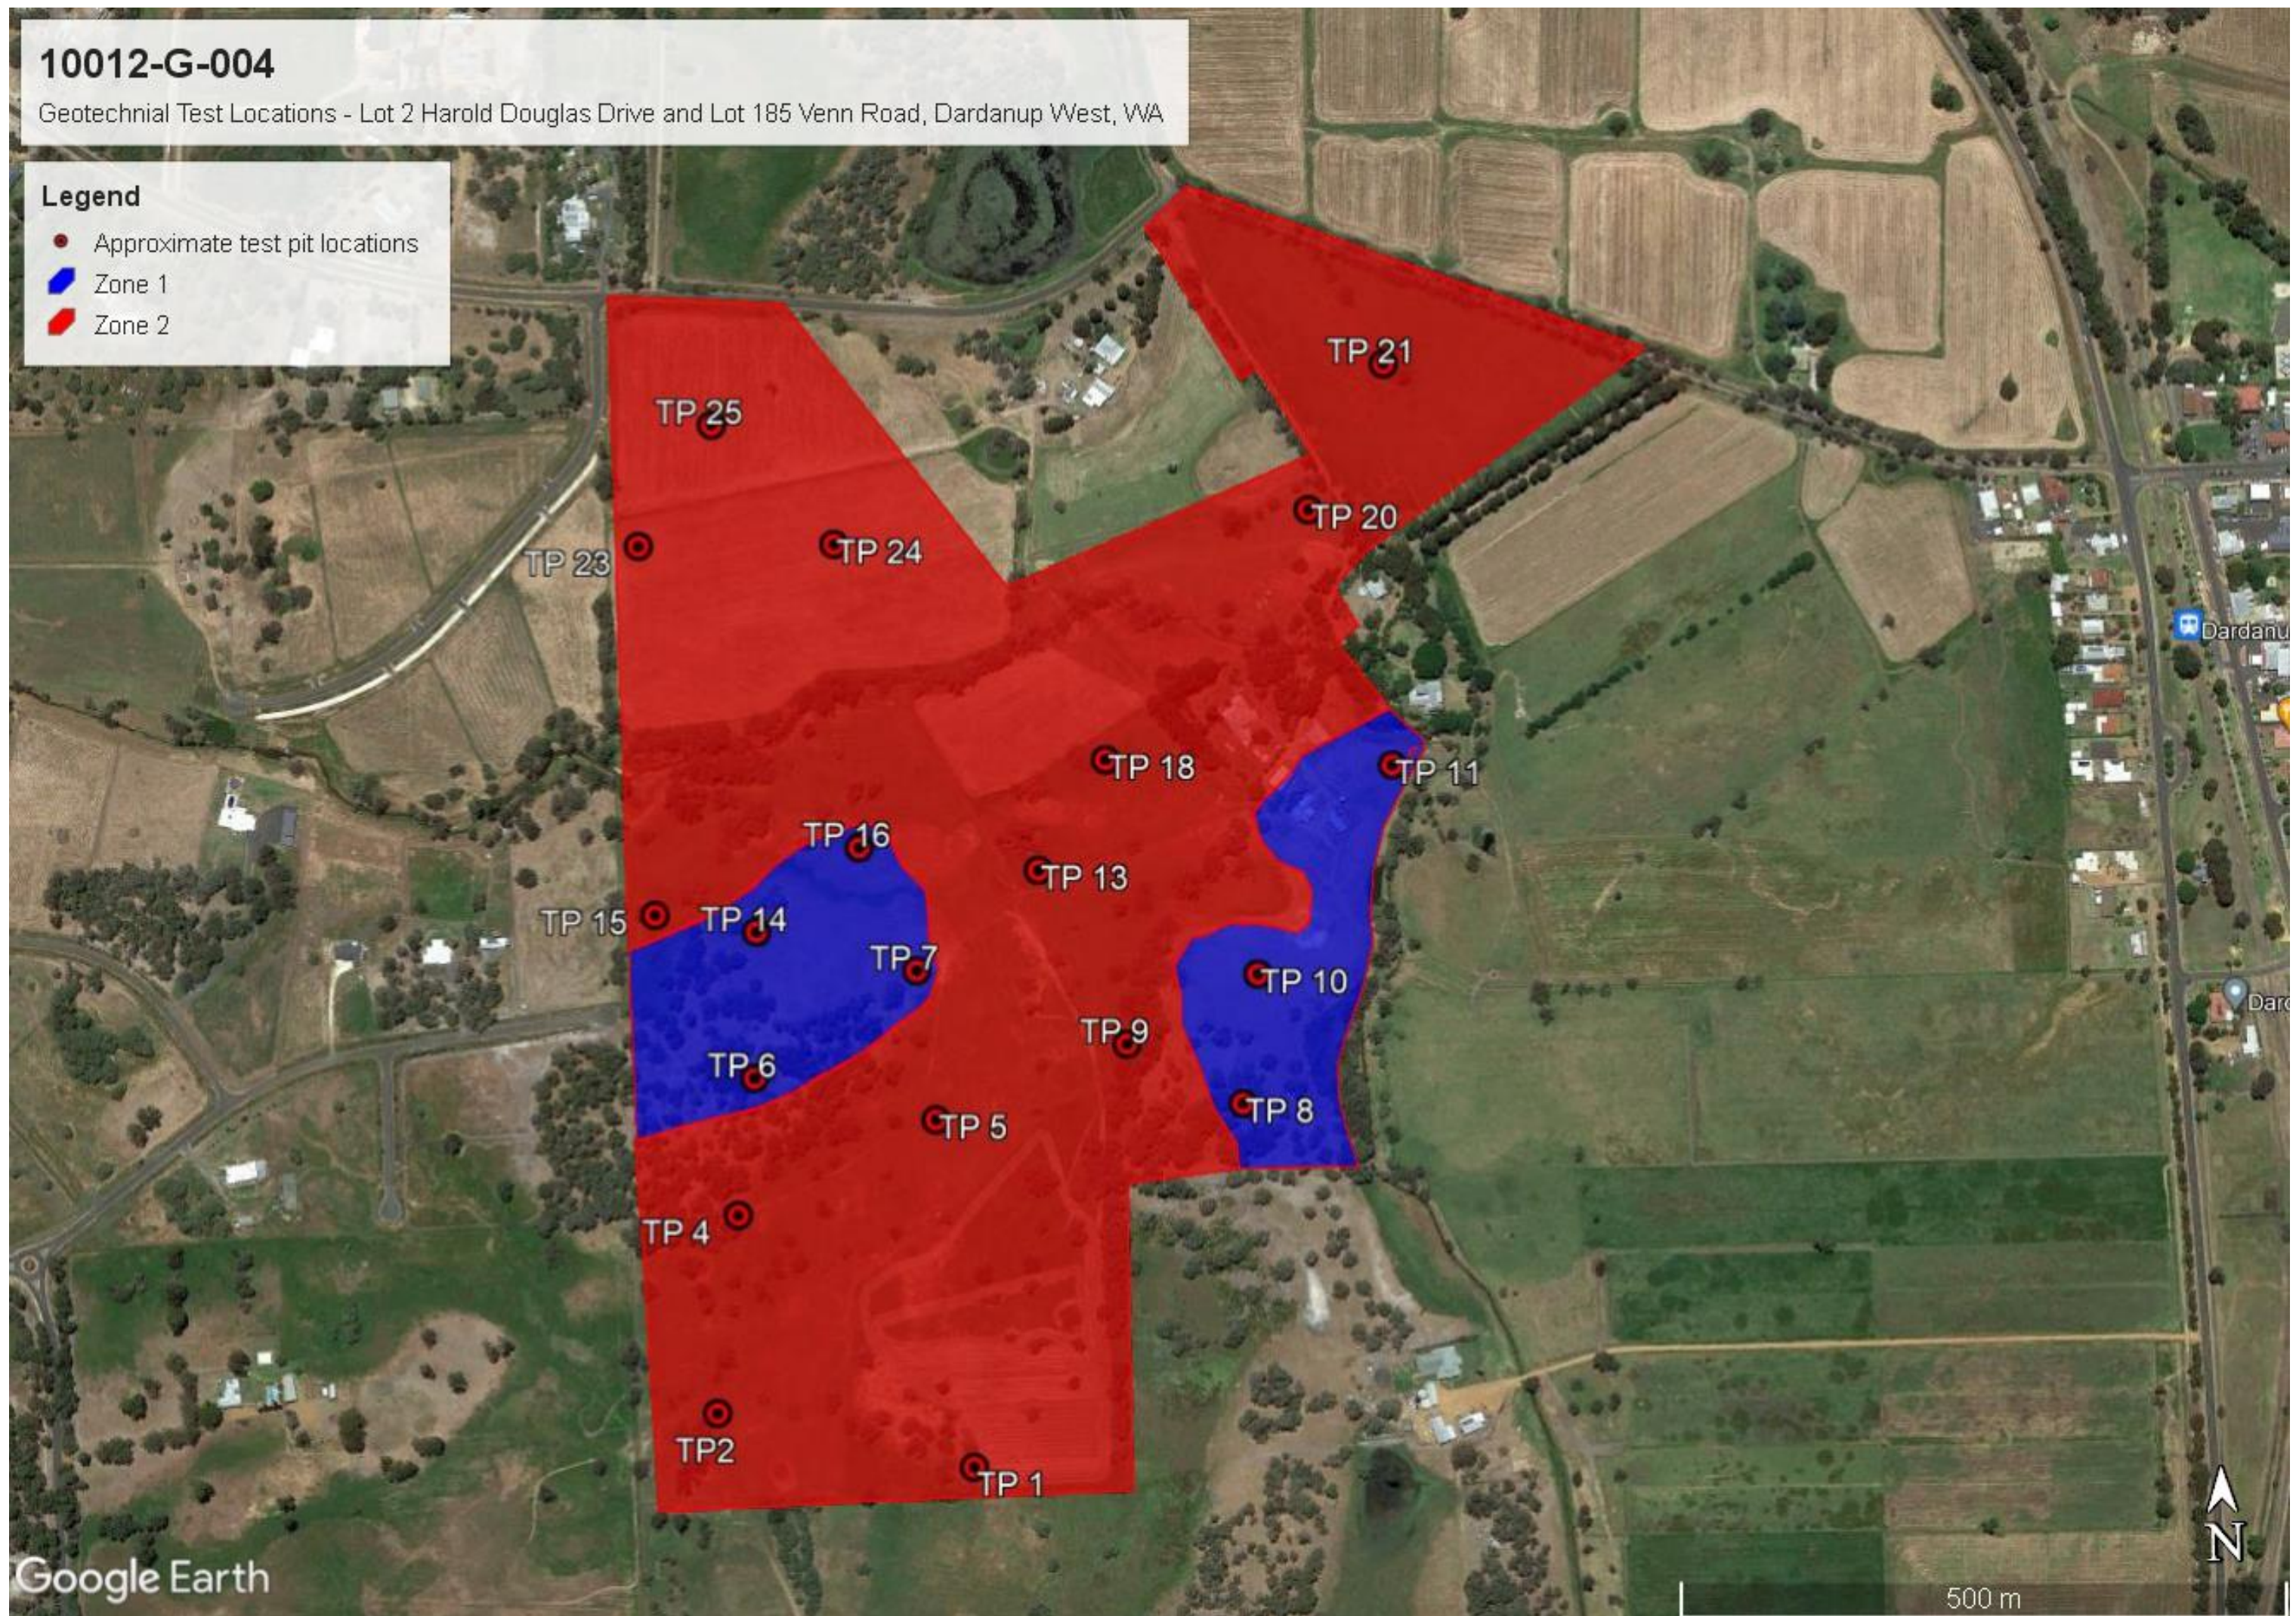
# 10012-G-005

The site can be broken into two areas based on local topography, vegetation, soil characteristics and groundwater, denoted Zones 1 and 2. These zones are shown in Drawing 10012-G-005 and are described below. This report presents recommendations based on the two zones.

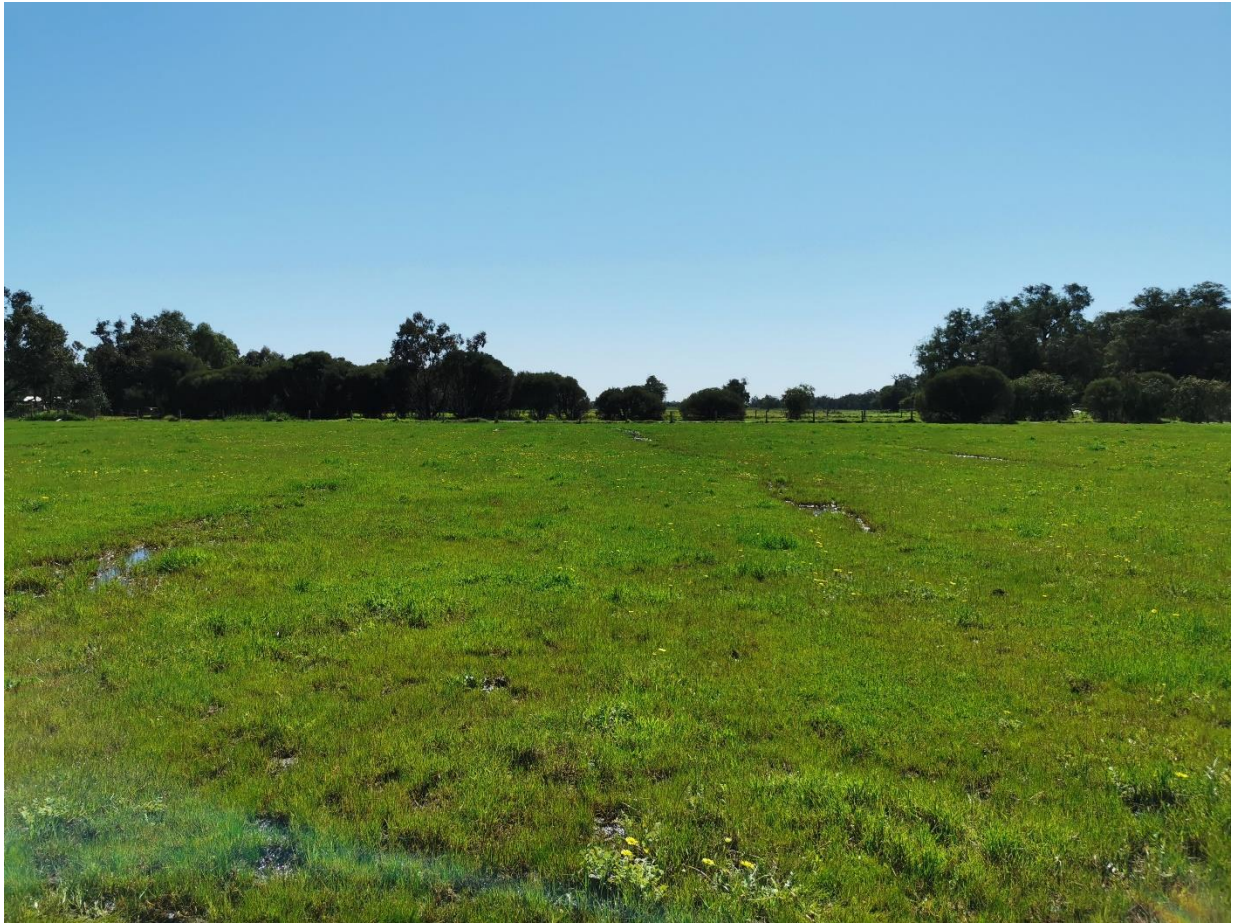
**Figure 2: Looking southeast across the site from TP 25 location. Ponding water at the ground surface.**

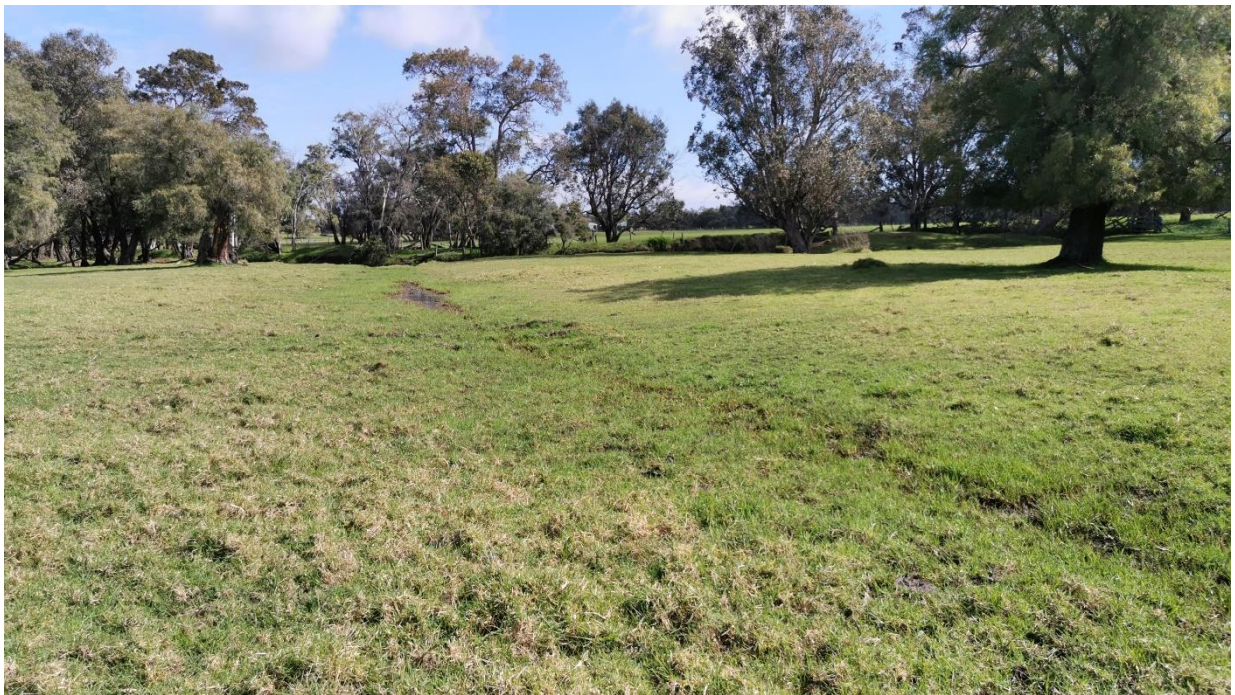
**Figure 3: A drainage channel stretching from southeast to northwest discharging to the existing drain noted north of TP 16 location.**

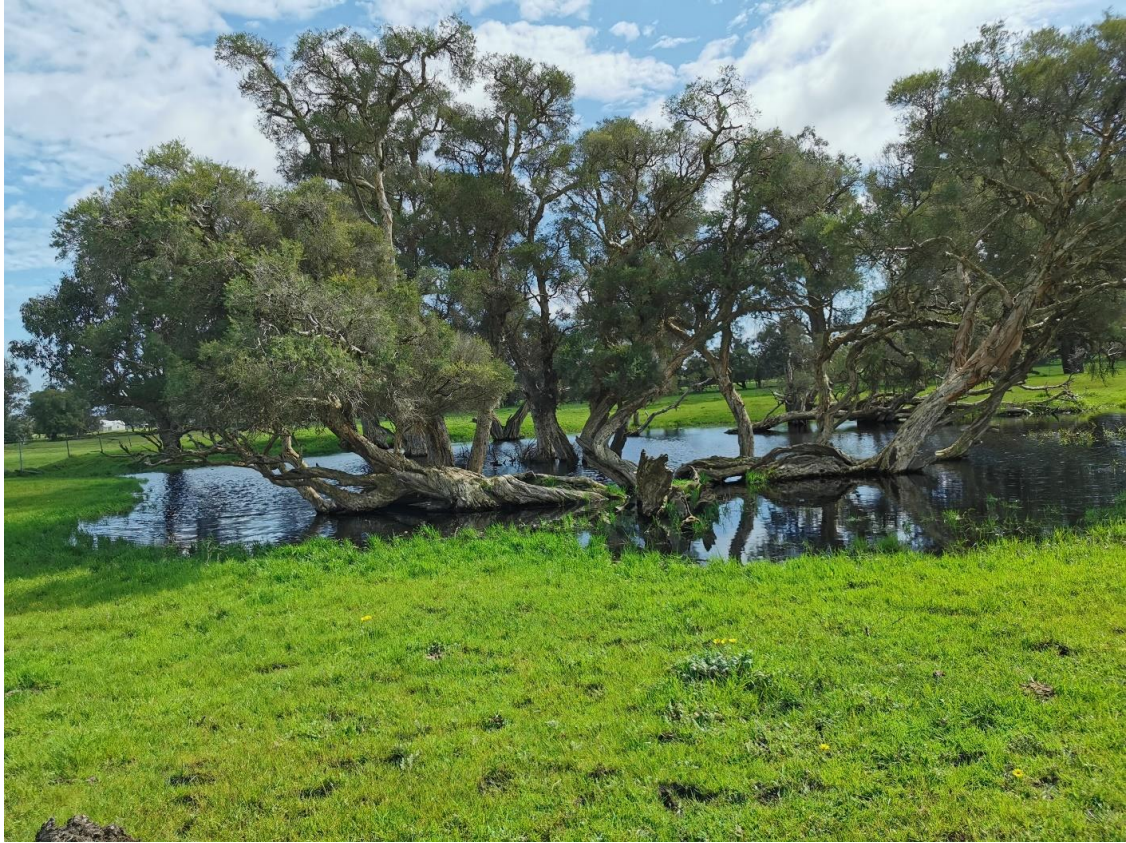
**Figure 4: Water ponding adjacent to TP 13 location.**

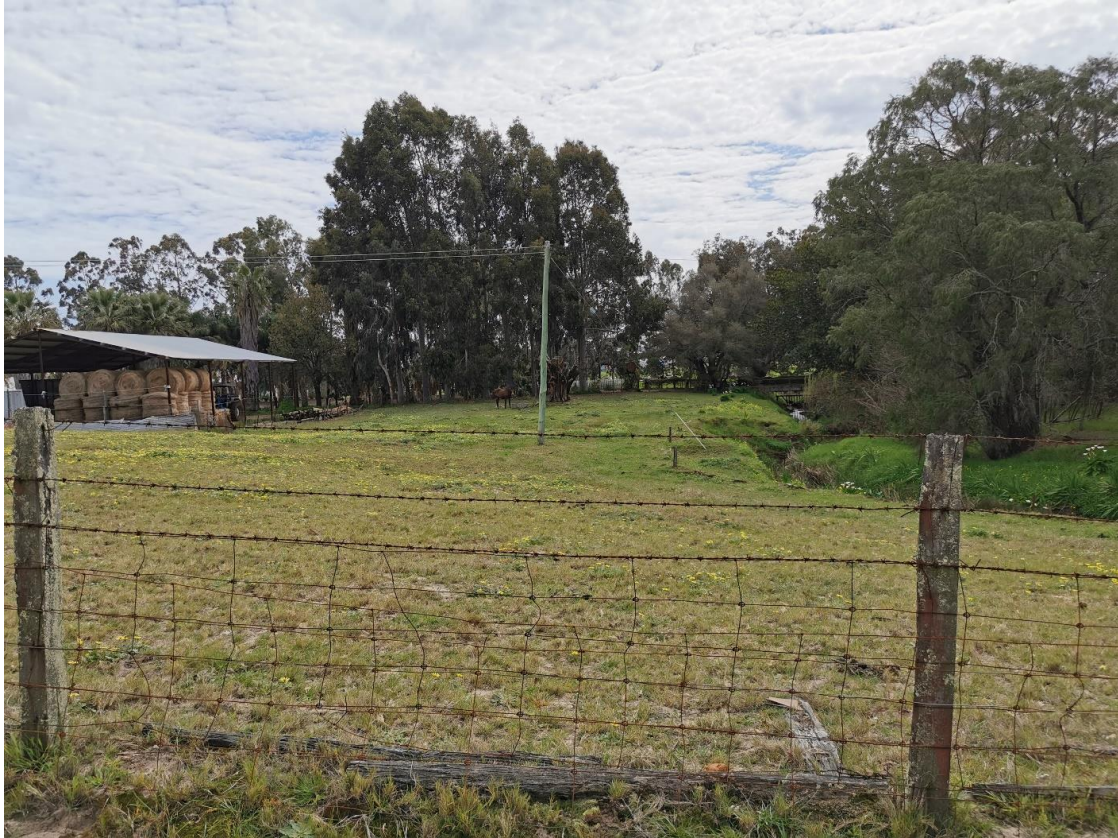
**Figure 6: Looking northwest from TP 11 location. Existing drain on the right and shed structures on the left.**

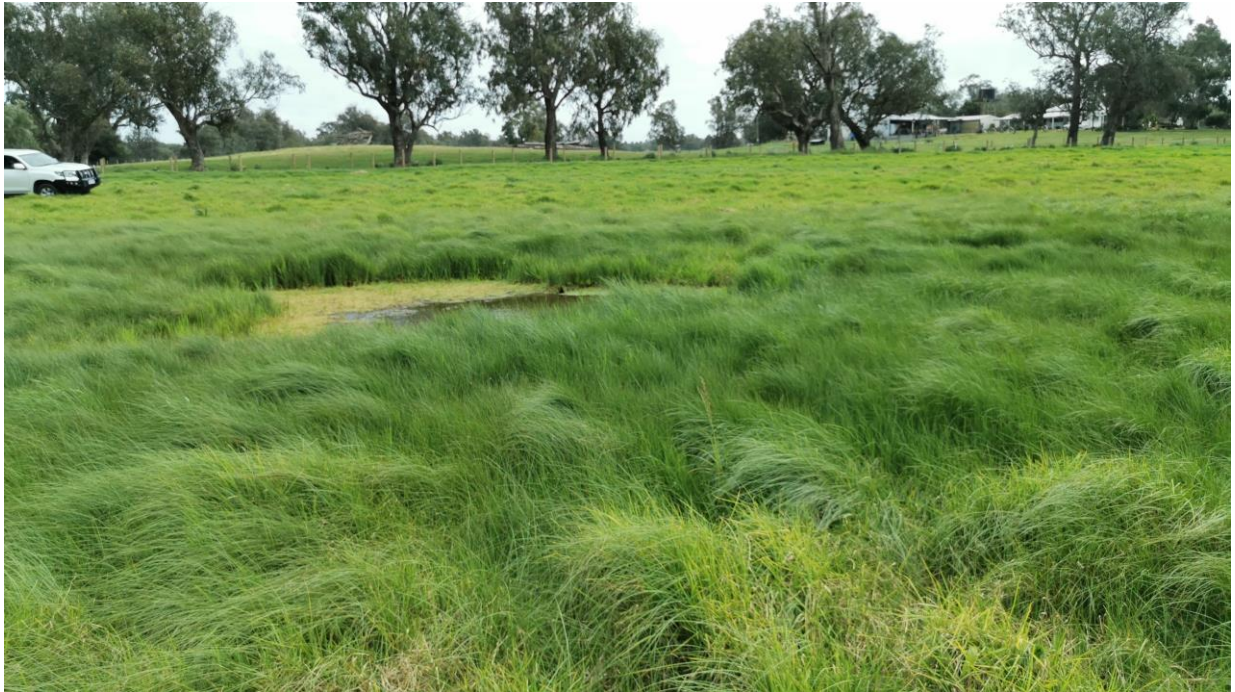
**Figure 8: Waterlogging east of the TP 21.**

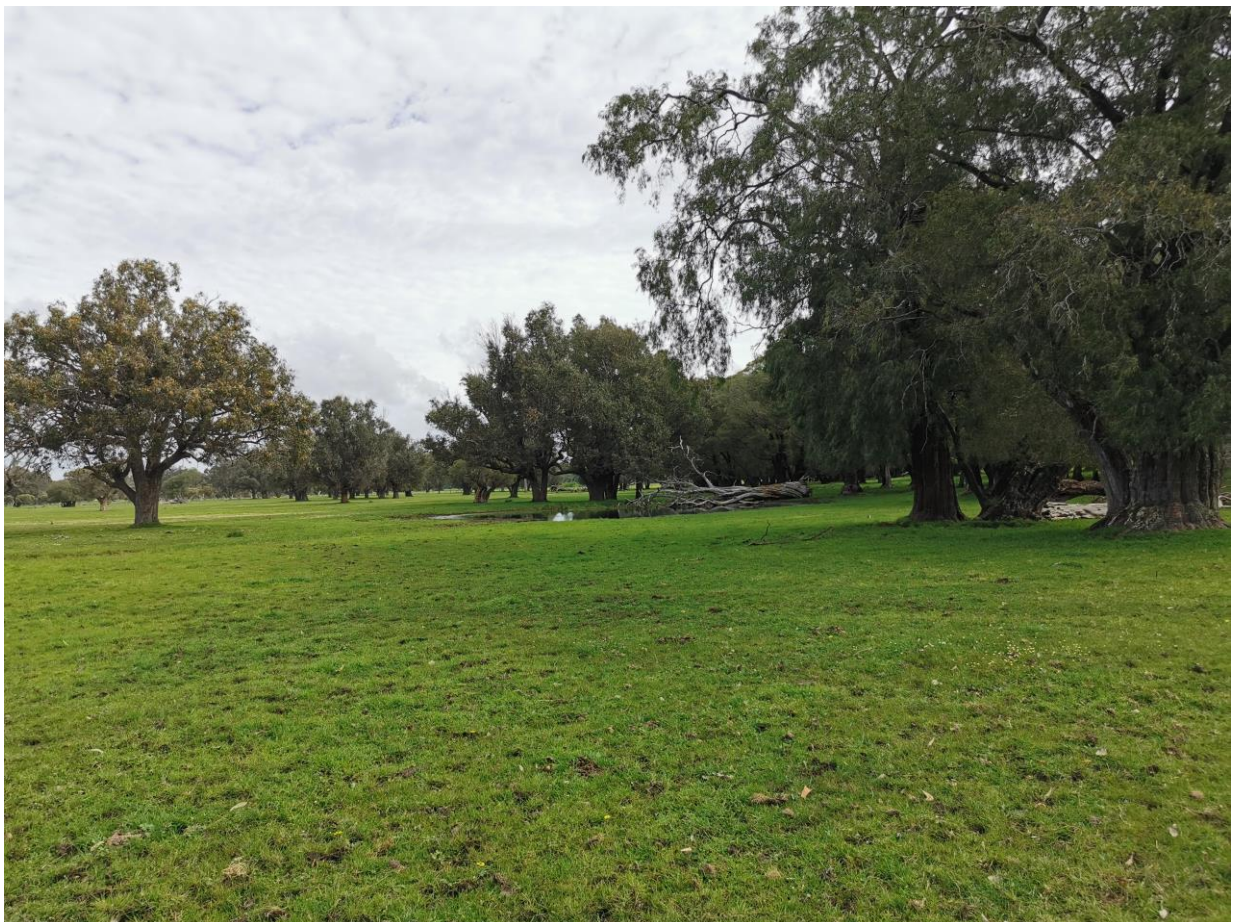
**Figure 9: Looking southwest towards observed inundated area located west of TP 5.**

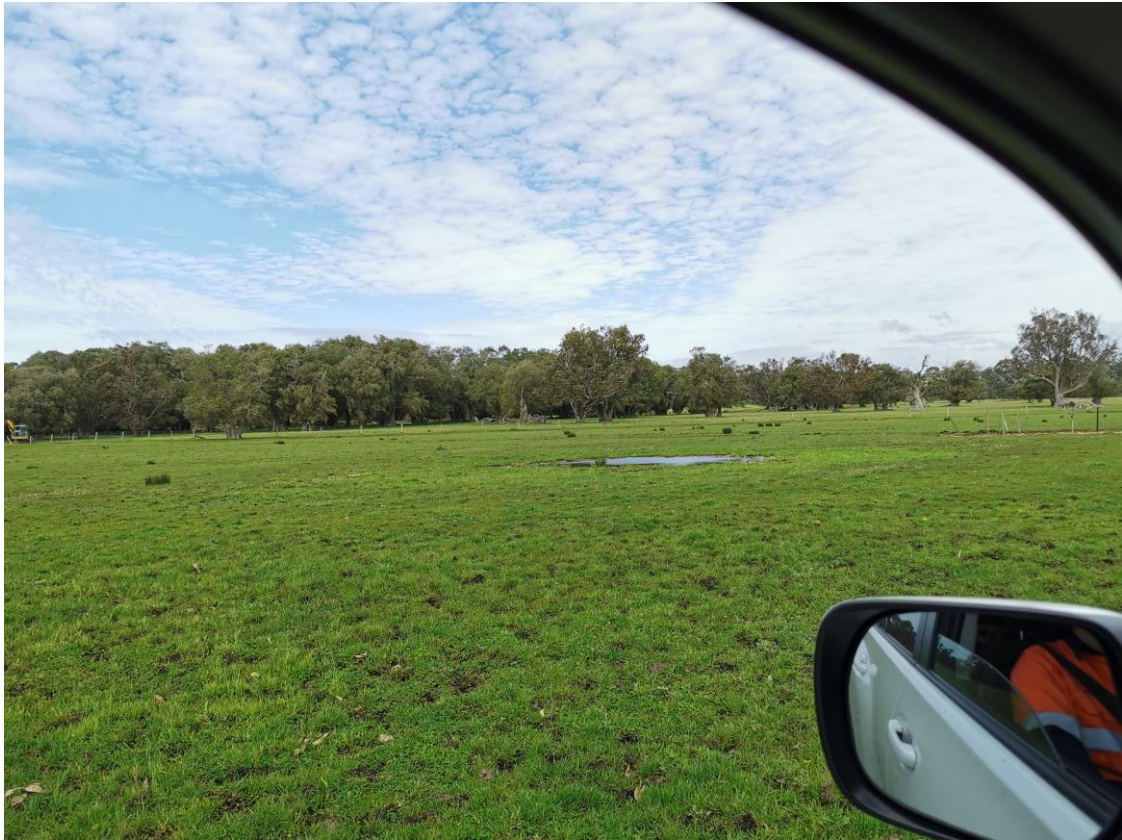
**Figure 10: Looking east towards observed inundated area located east of TP 5.**
