# LOT 2 BANSKIA ROAD, DARDANUP - CLEANAWAY WASTE FACILITY

## VISUAL IMPACT ASSESSMENT REVIEW

**SHIRE OF DARDANUP**

AUGUST 2022

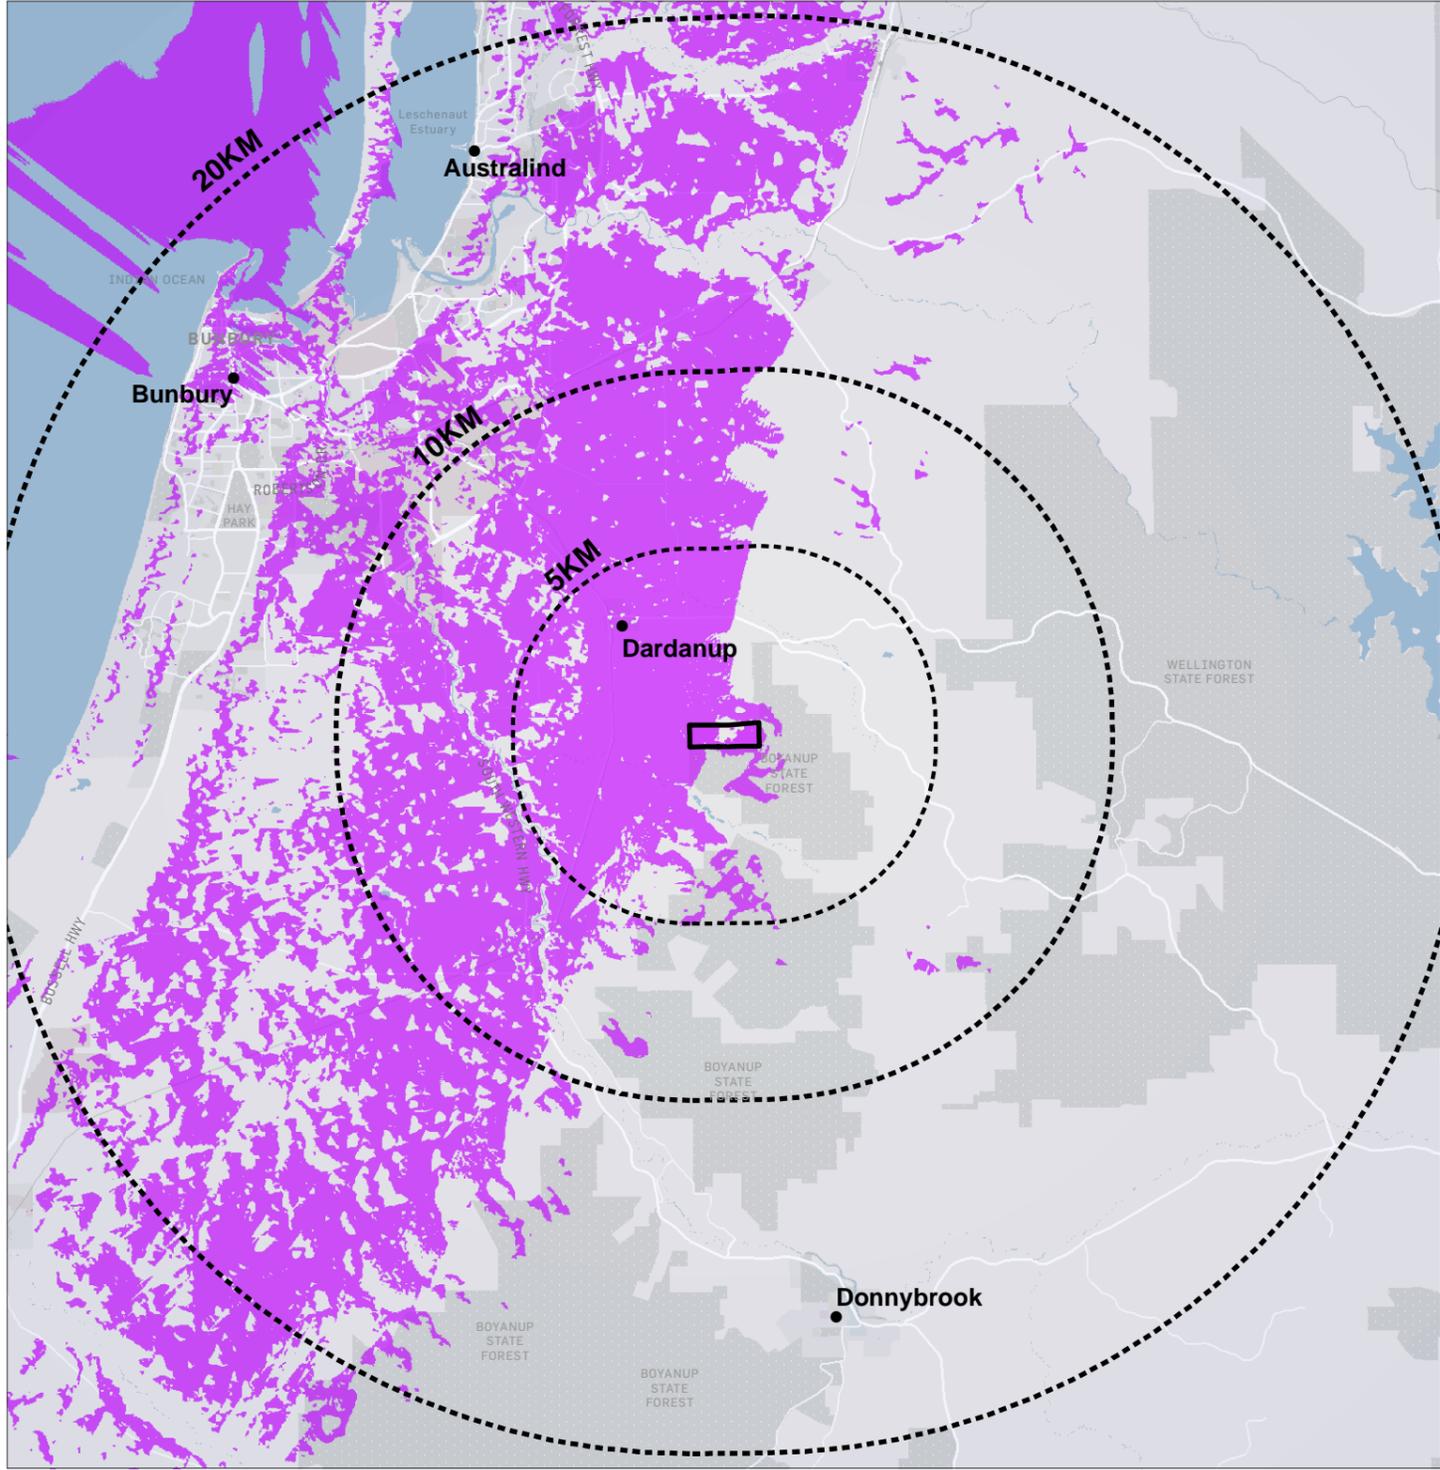
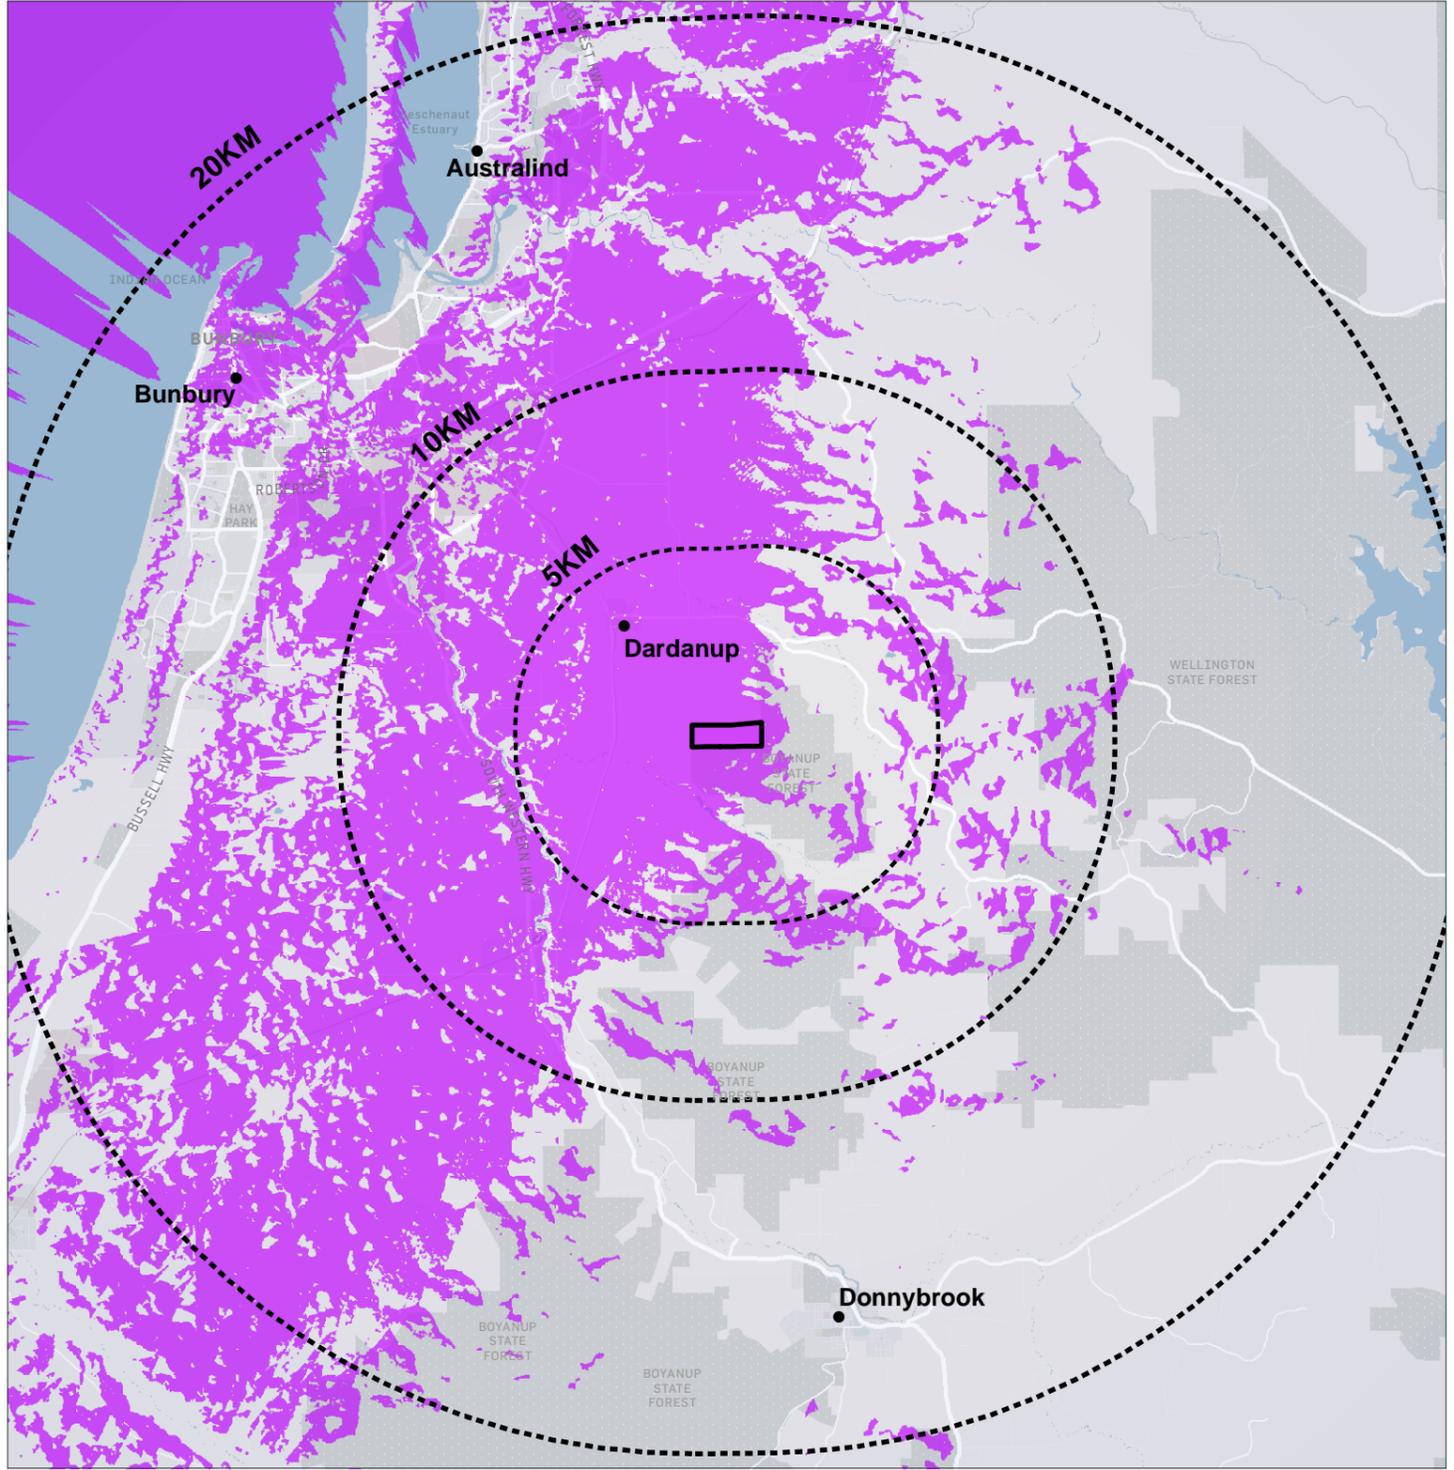
**EXISTING - 114 m AHD**

**FUTURE - 151 m AHD**

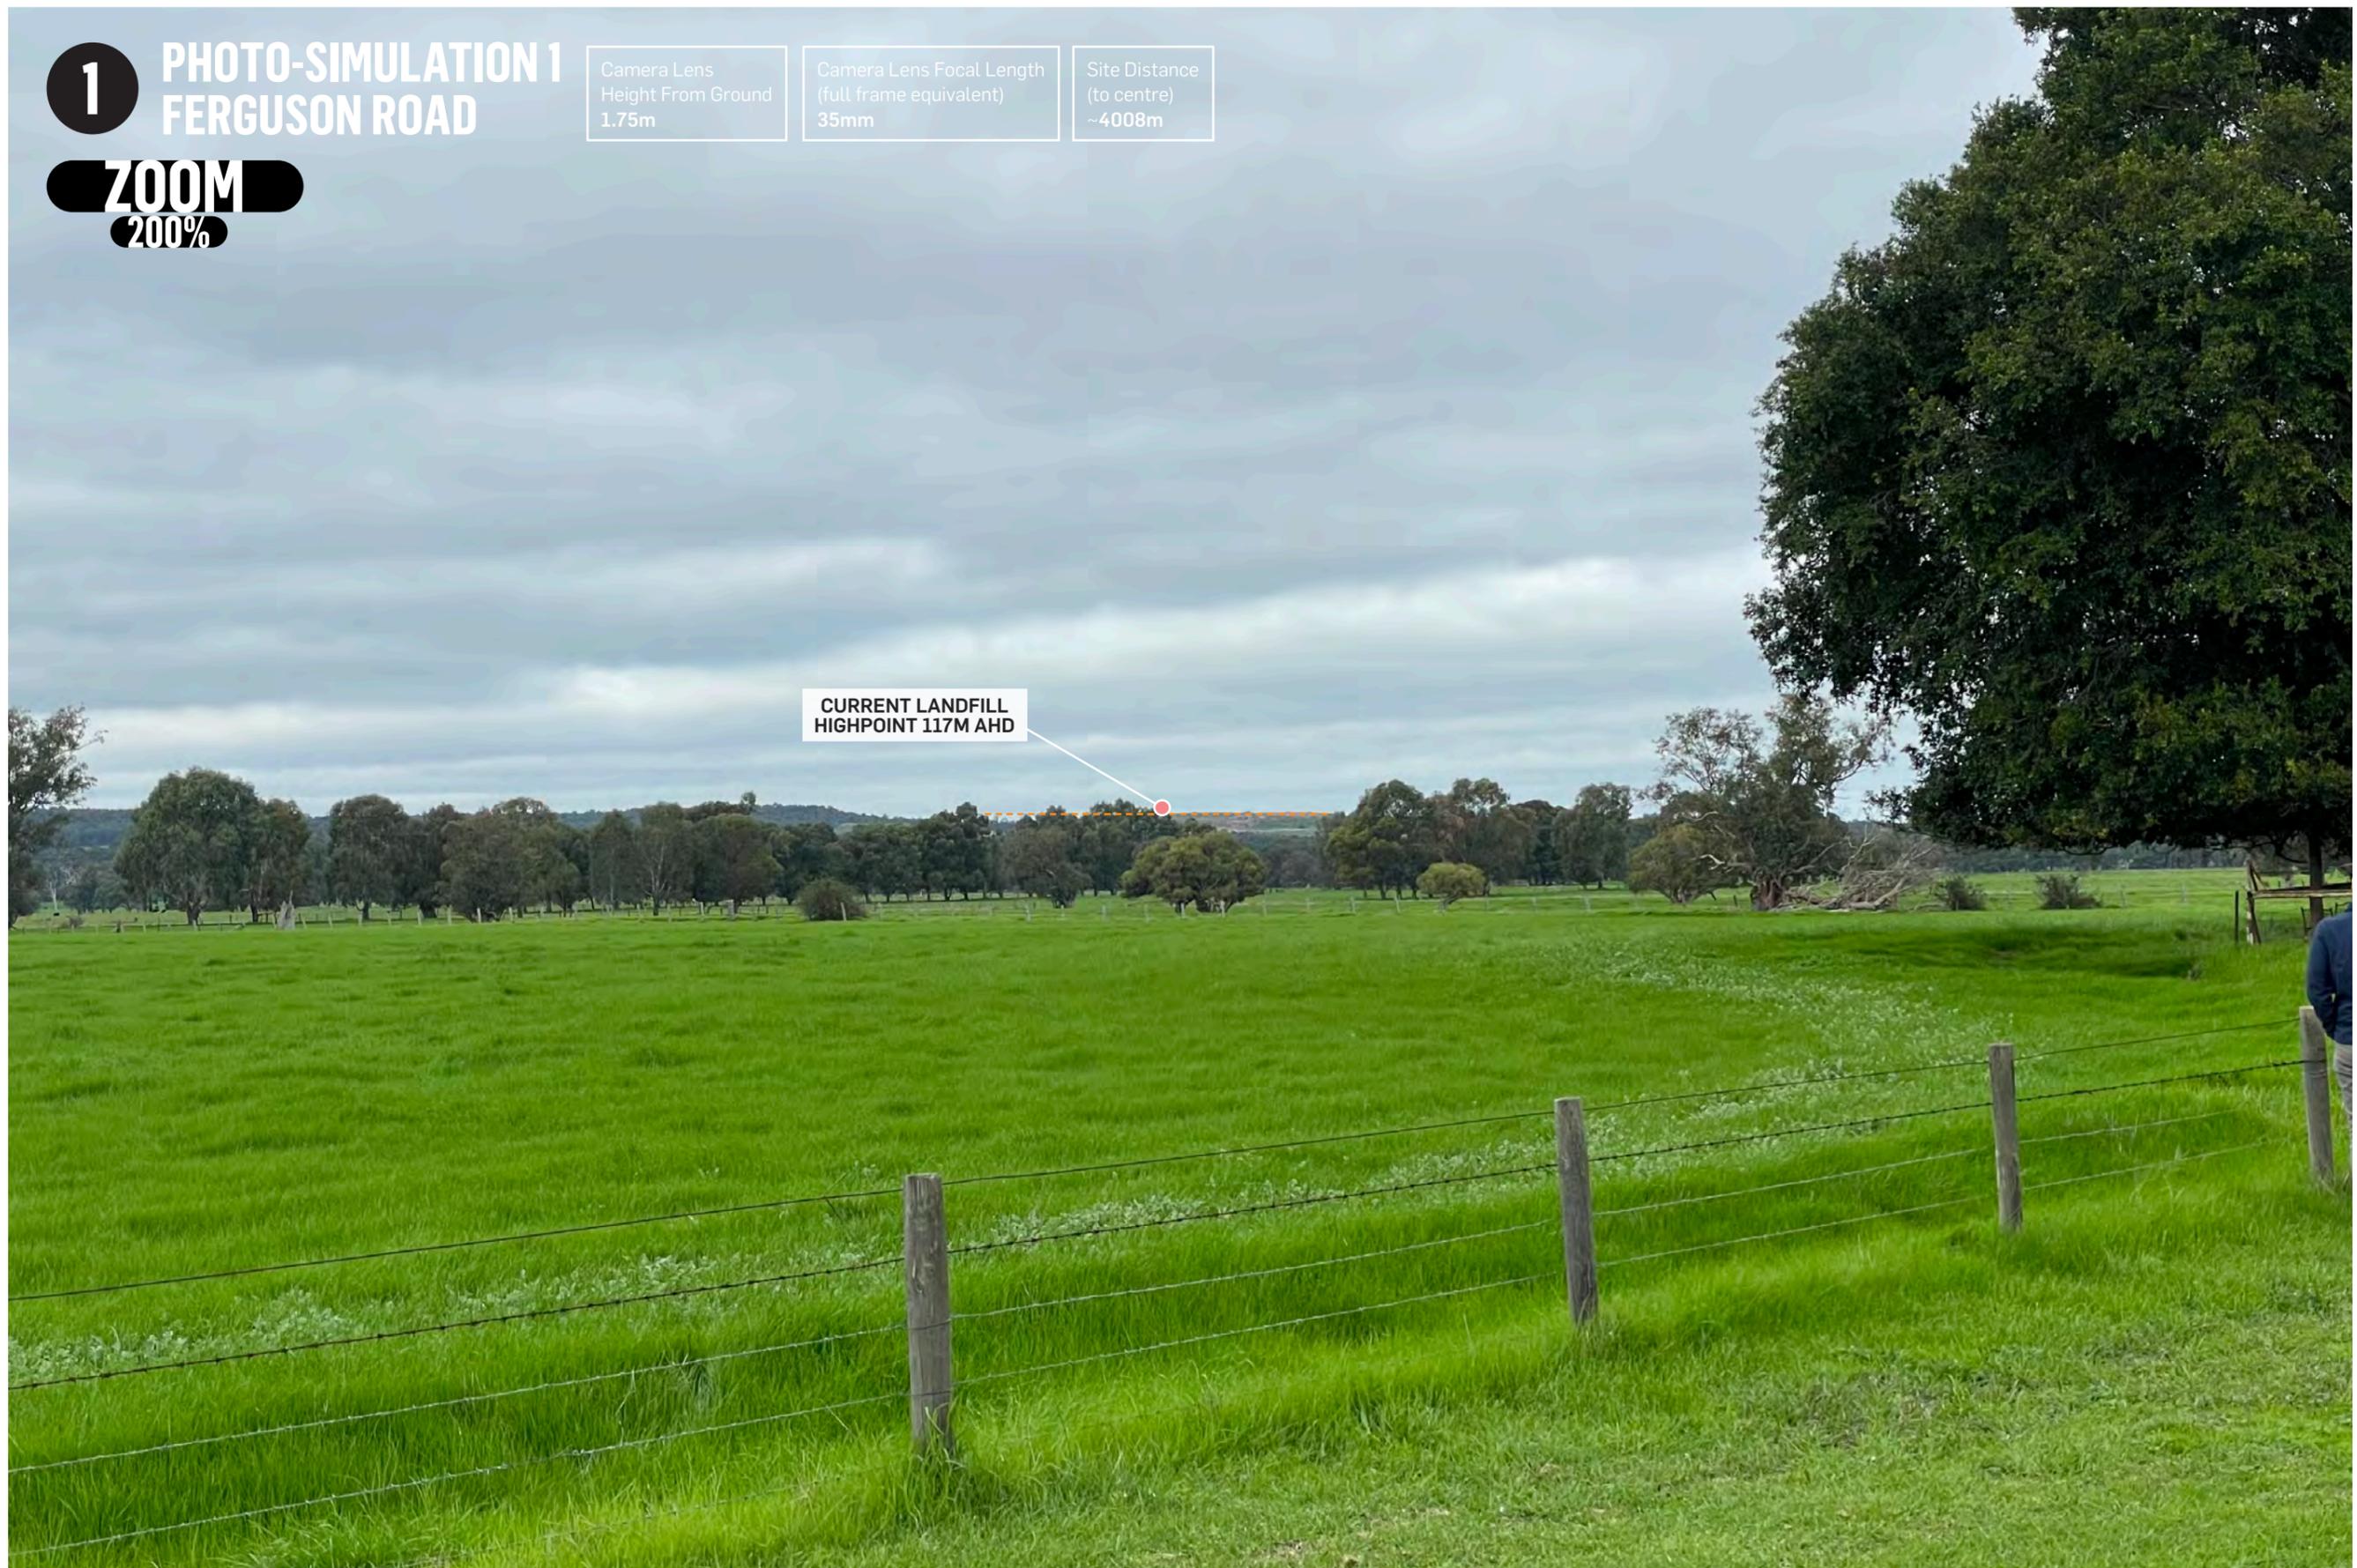
# 1 PHOTO-SIMULATION 1 FERGUSON ROAD

Camera Lens  
Height From Ground  
1.75m

Camera Lens Focal Length  
(full frame equivalent)  
35mm

Site Distance  
(to centre)  
~4008m

CURRENT LANDFILL  
HIGHPOINT 117M AHD

- **A broad open view can be witness from many of the surrounding properties, roads - refer Photo Simulations 1, 2, 4, 5, 6, 7, 8, 9, 10, 13, and 15.**

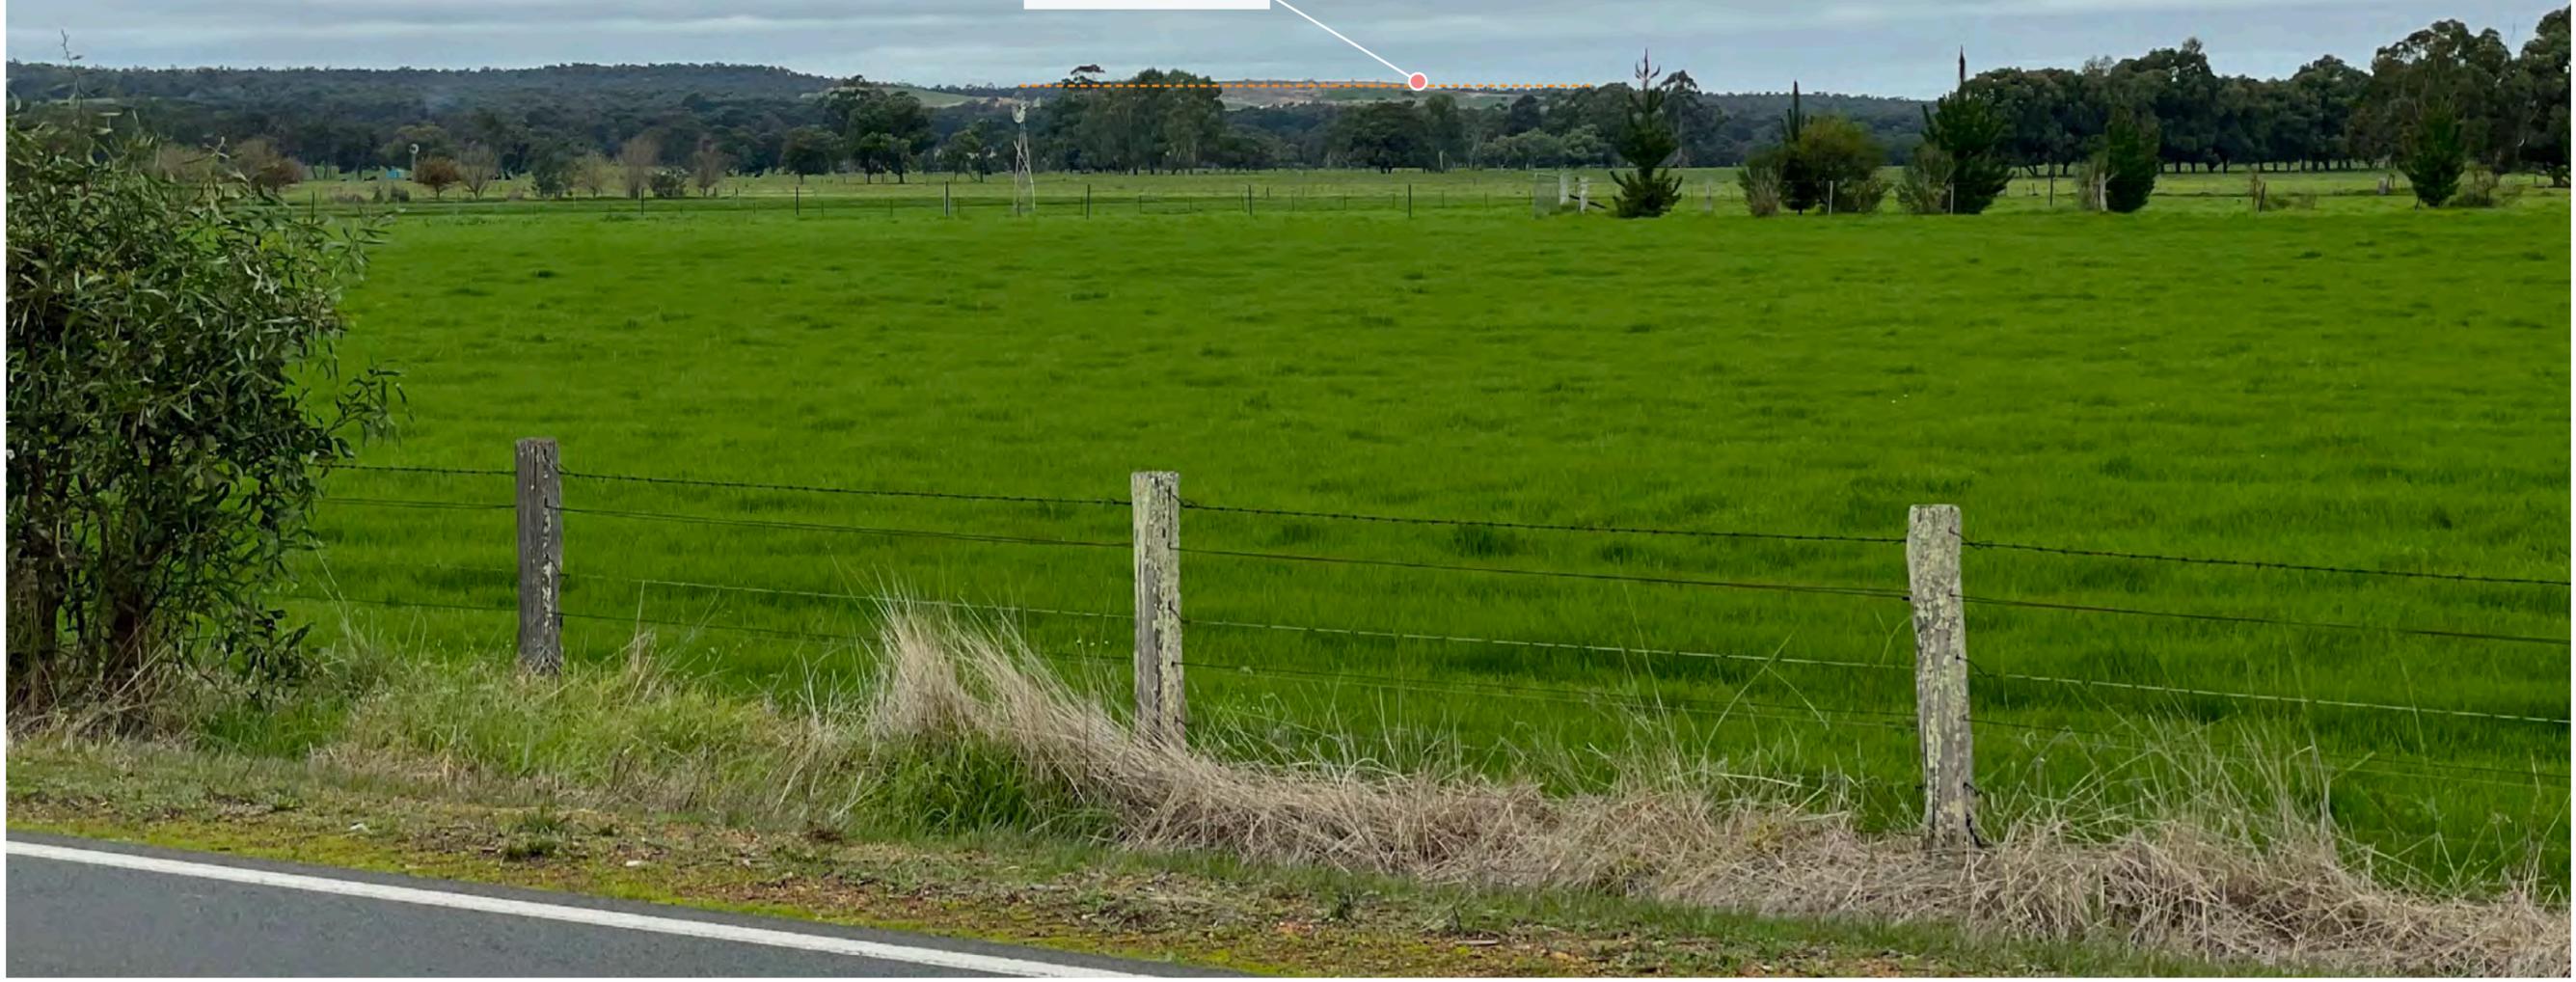
# 2 PHOTO-SIMULATION 2 FERGUSON ROAD

Camera Lens  
Height From Ground  
1.75m

Camera Lens Focal Length  
(full frame equivalent)  
35mm

Site Distance  
(to centre)  
~3950m

CURRENT LANDFILL  
HIGHPOINT 117M AHD

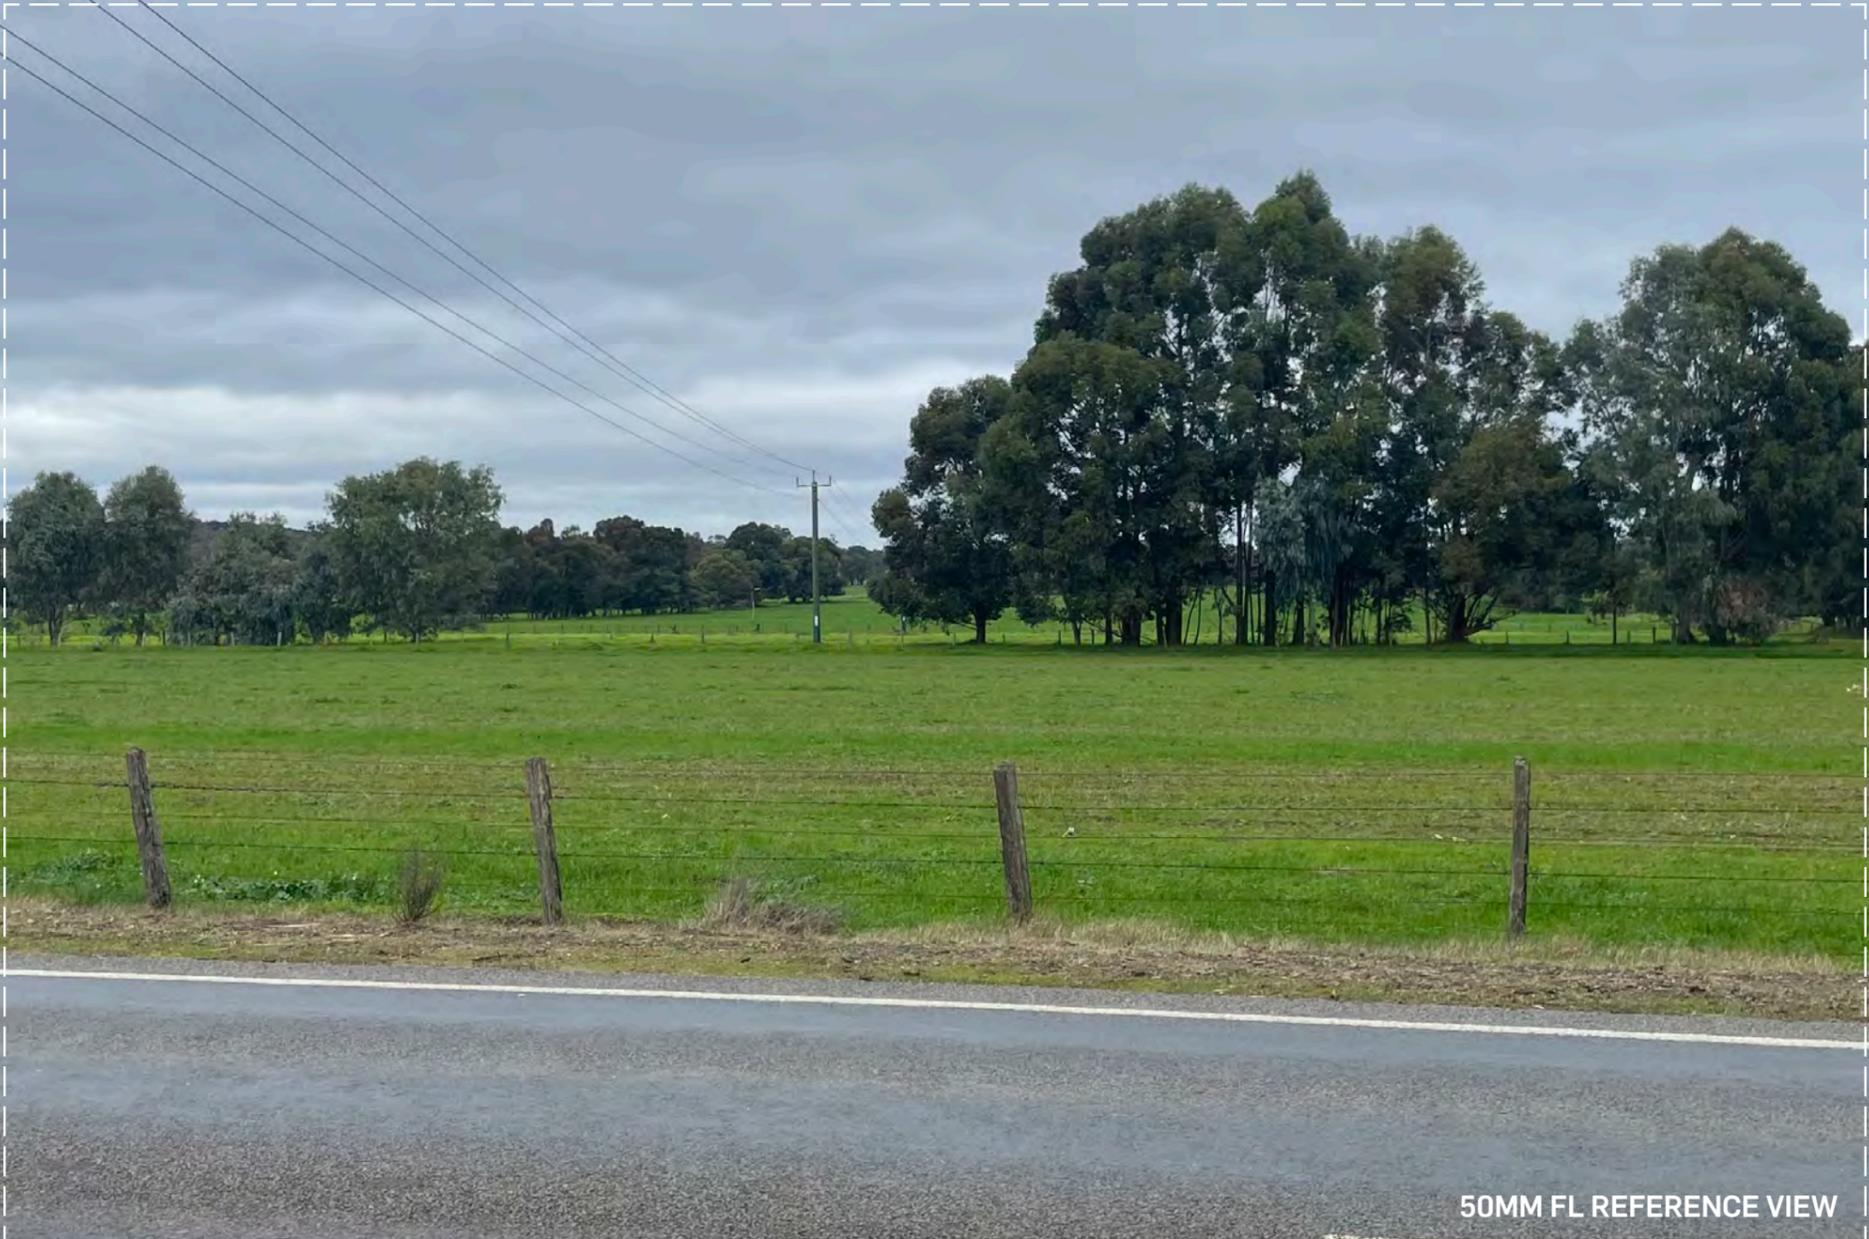
Camera Lens Focal Length  
(full frame equivalent)  
35mm

Site Distance  
(to centre)  
~3339m

50MM FL REFERENCE VIEW

ORIGINAL PHOTO EXTENT - 35MM FL

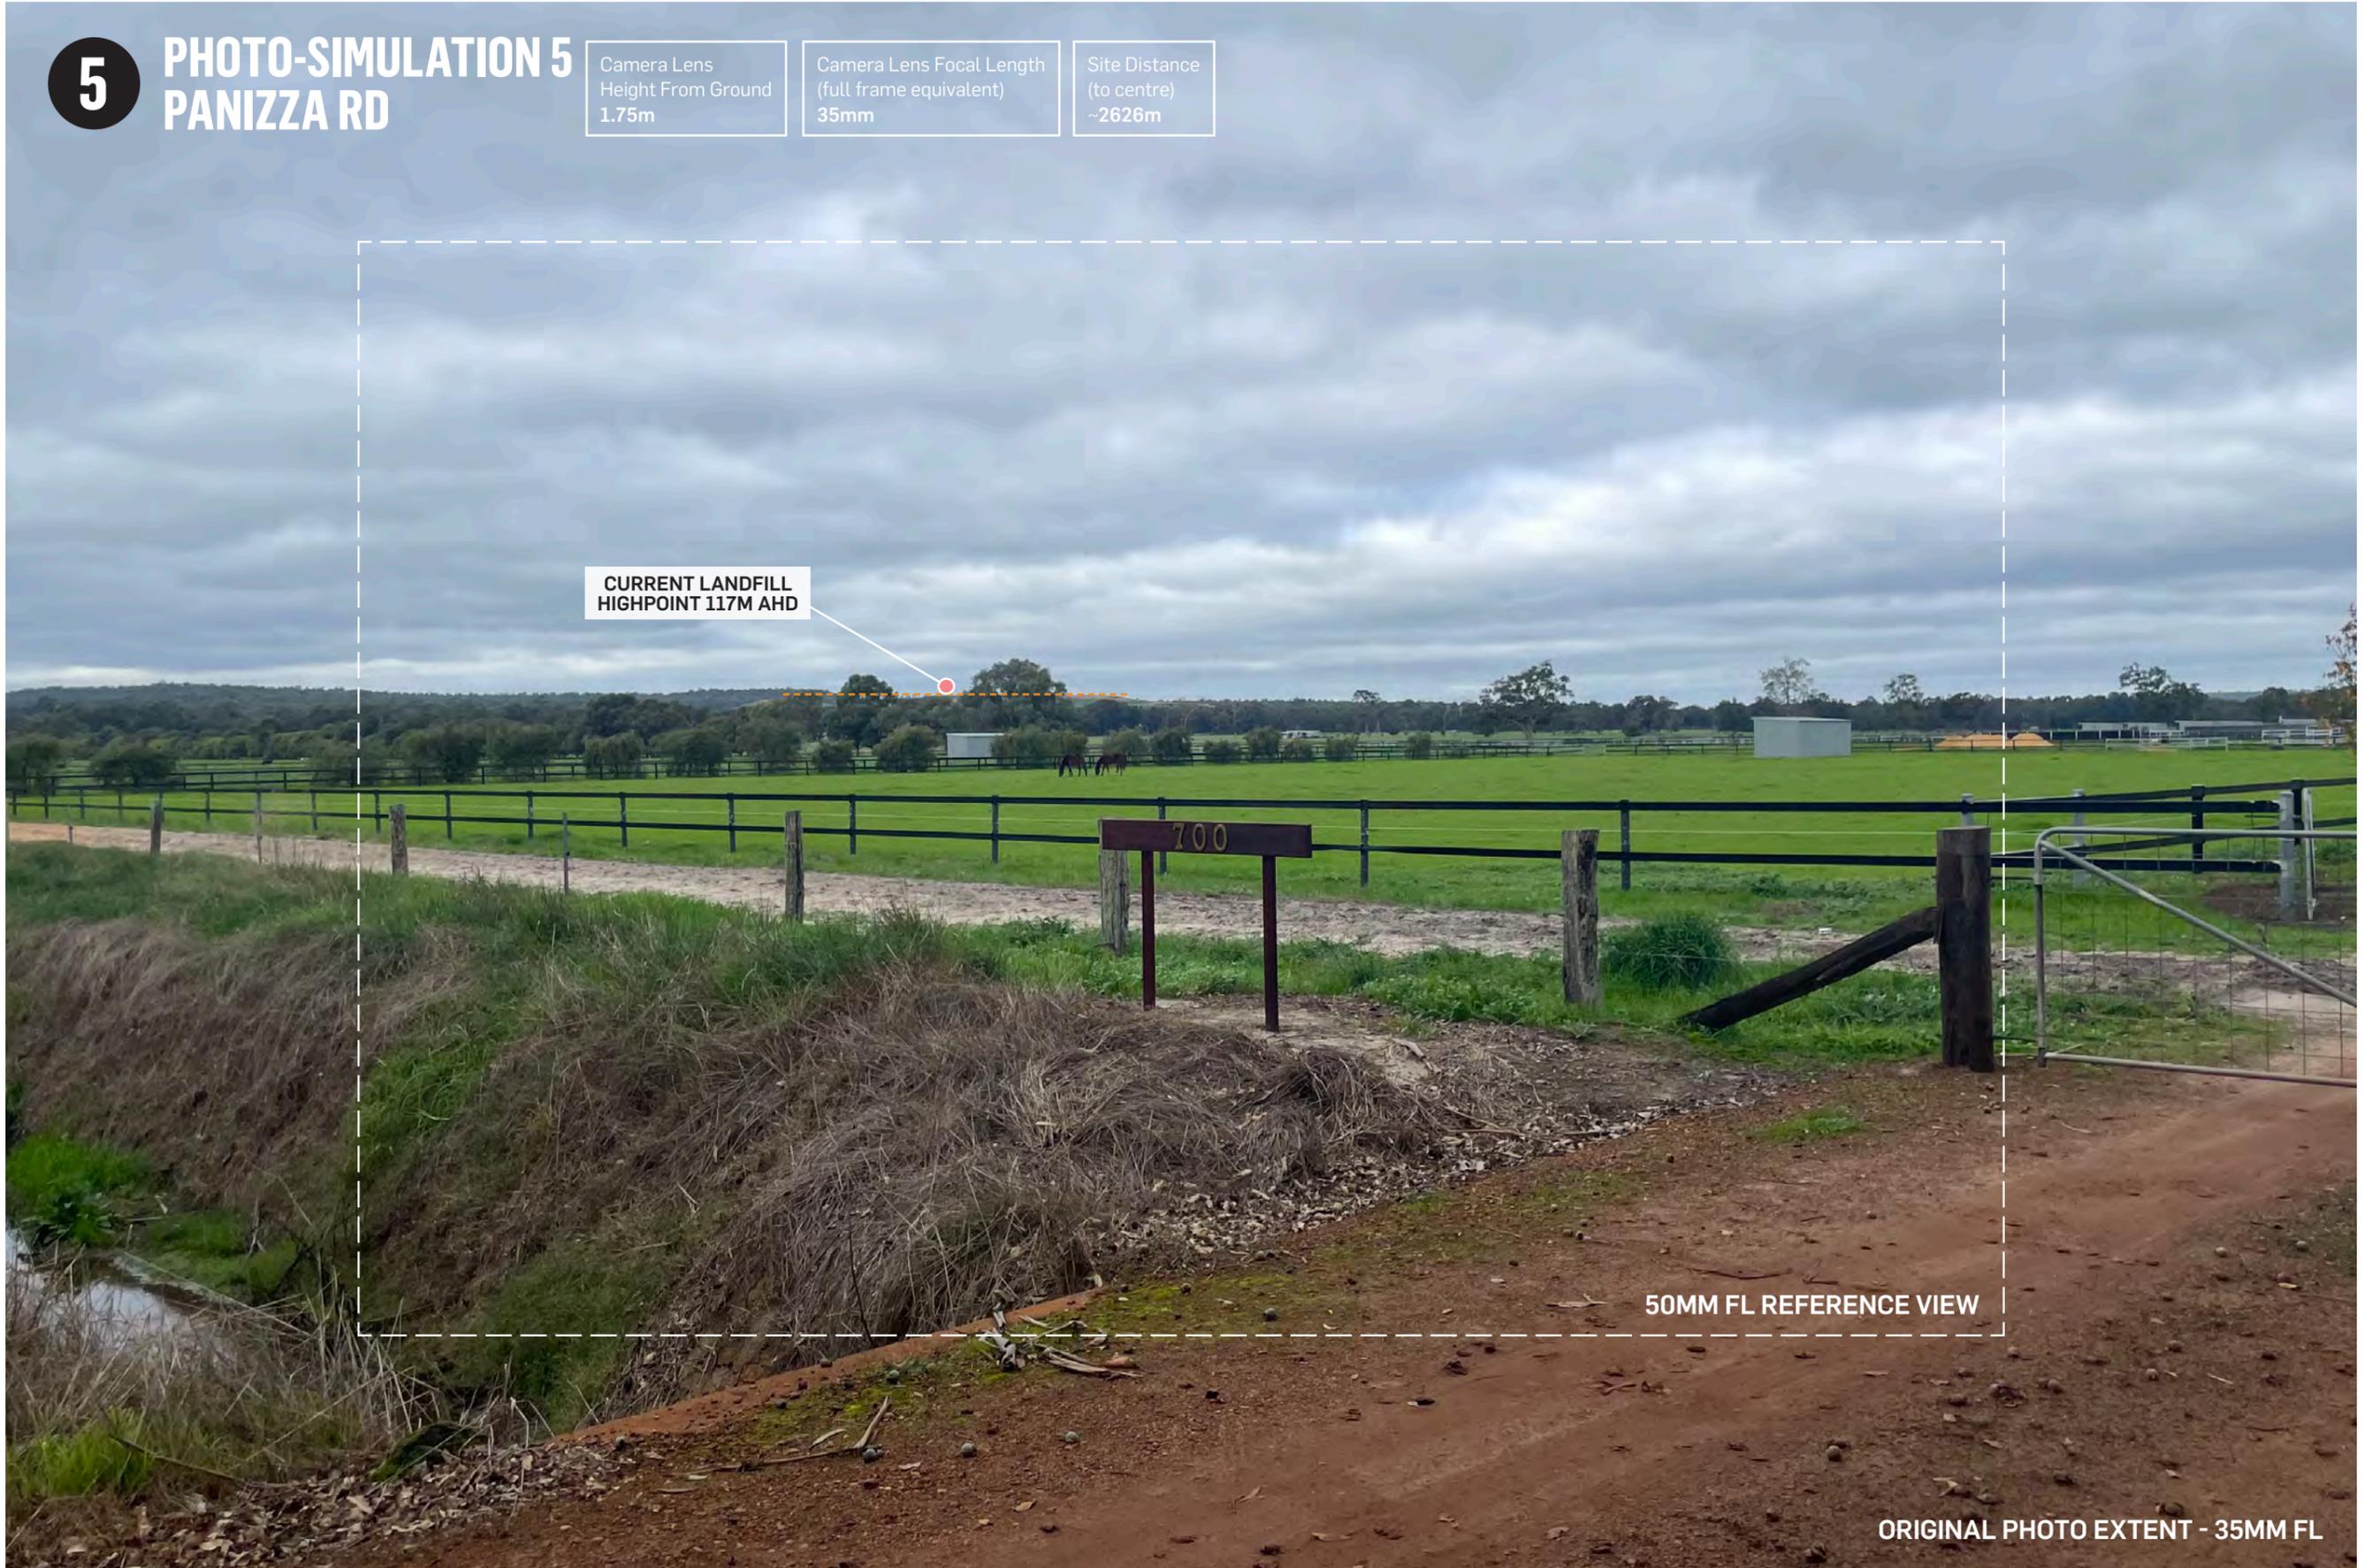
# PHOTO-SIMULATION 5 PANIZZA RD

Camera Lens  
Height From Ground  
1.75m

Camera Lens Focal Length  
(full frame equivalent)  
35mm

Site Distance  
(to centre)  
~2626m

CURRENT LANDFILL  
HIGHPOINT 117M AHD

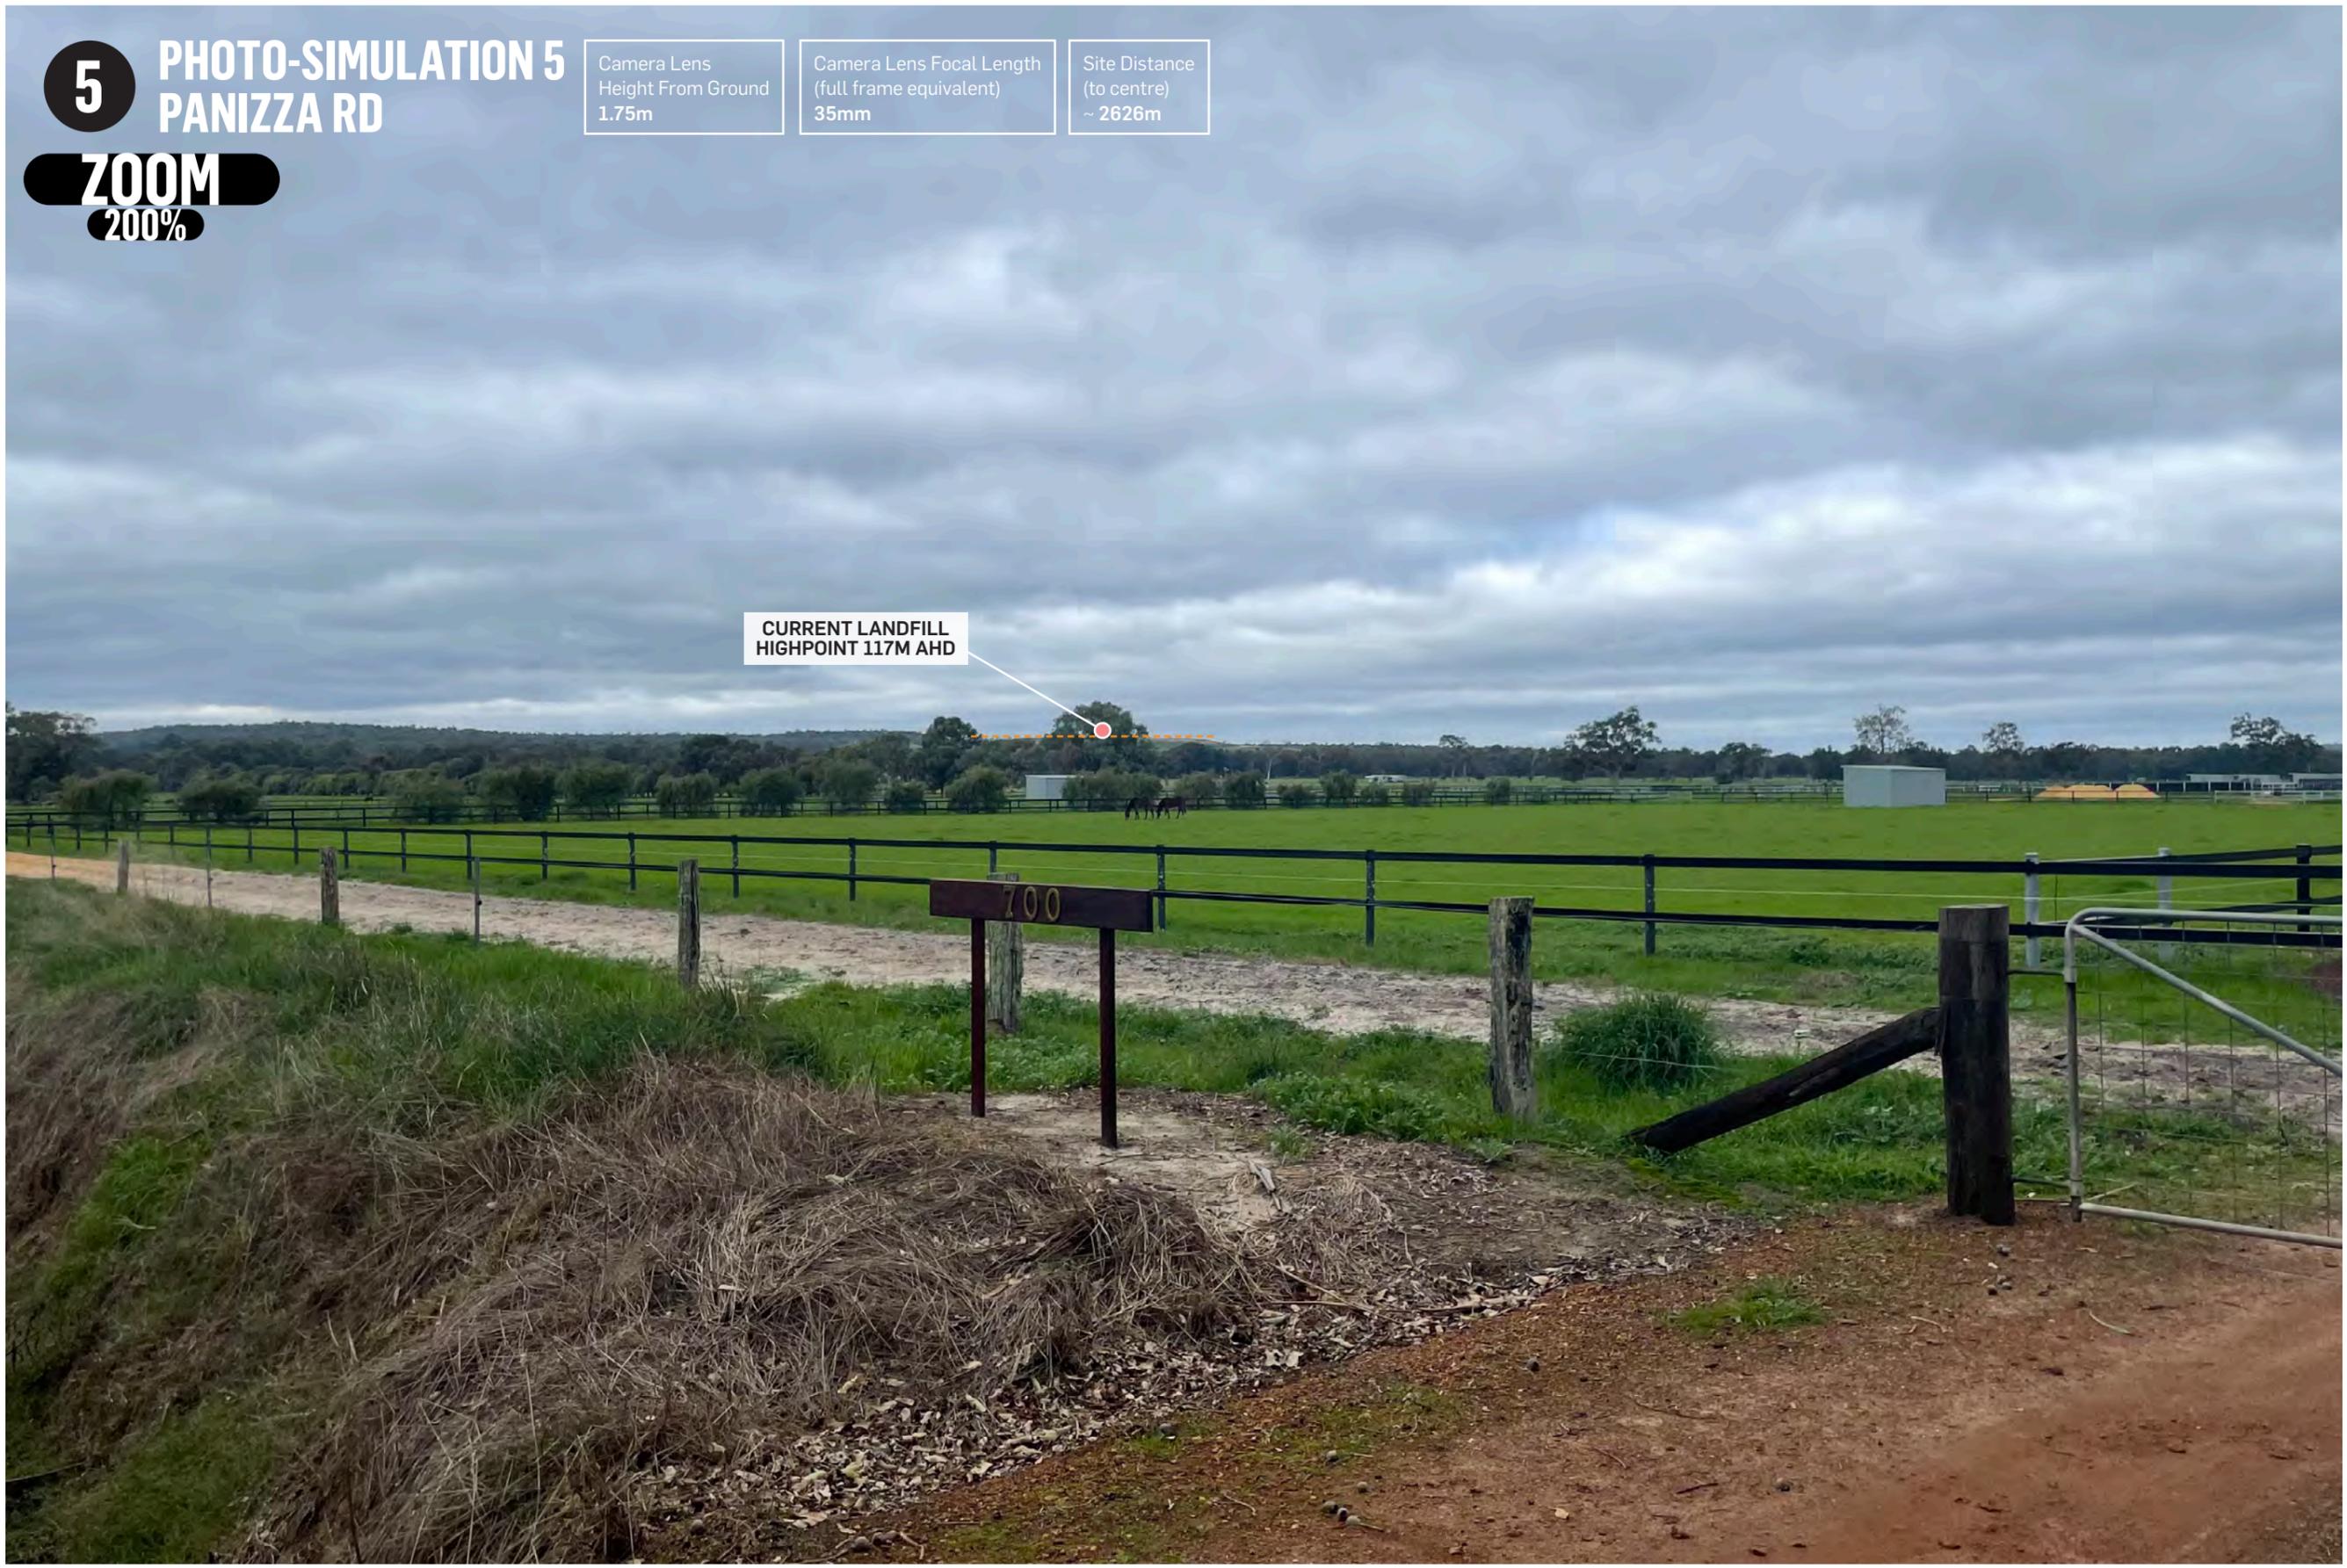
# PHOTO-SIMULATION 5 PANIZZA RD

Camera Lens  
Height From Ground  
1.75m

Camera Lens Focal Length  
(full frame equivalent)  
35mm

Site Distance  
(to centre)  
~ 2626m

CURRENT LANDFILL  
HIGHPOINT 117M AHD
