# LOT 2 BANSKIA ROAD, DARDANUP - CLEANAWAY WASTE FACILITY

## VISUAL IMPACT ASSESSMENT REVIEW

**SHIRE OF DARDANUP**

AUGUST 2022

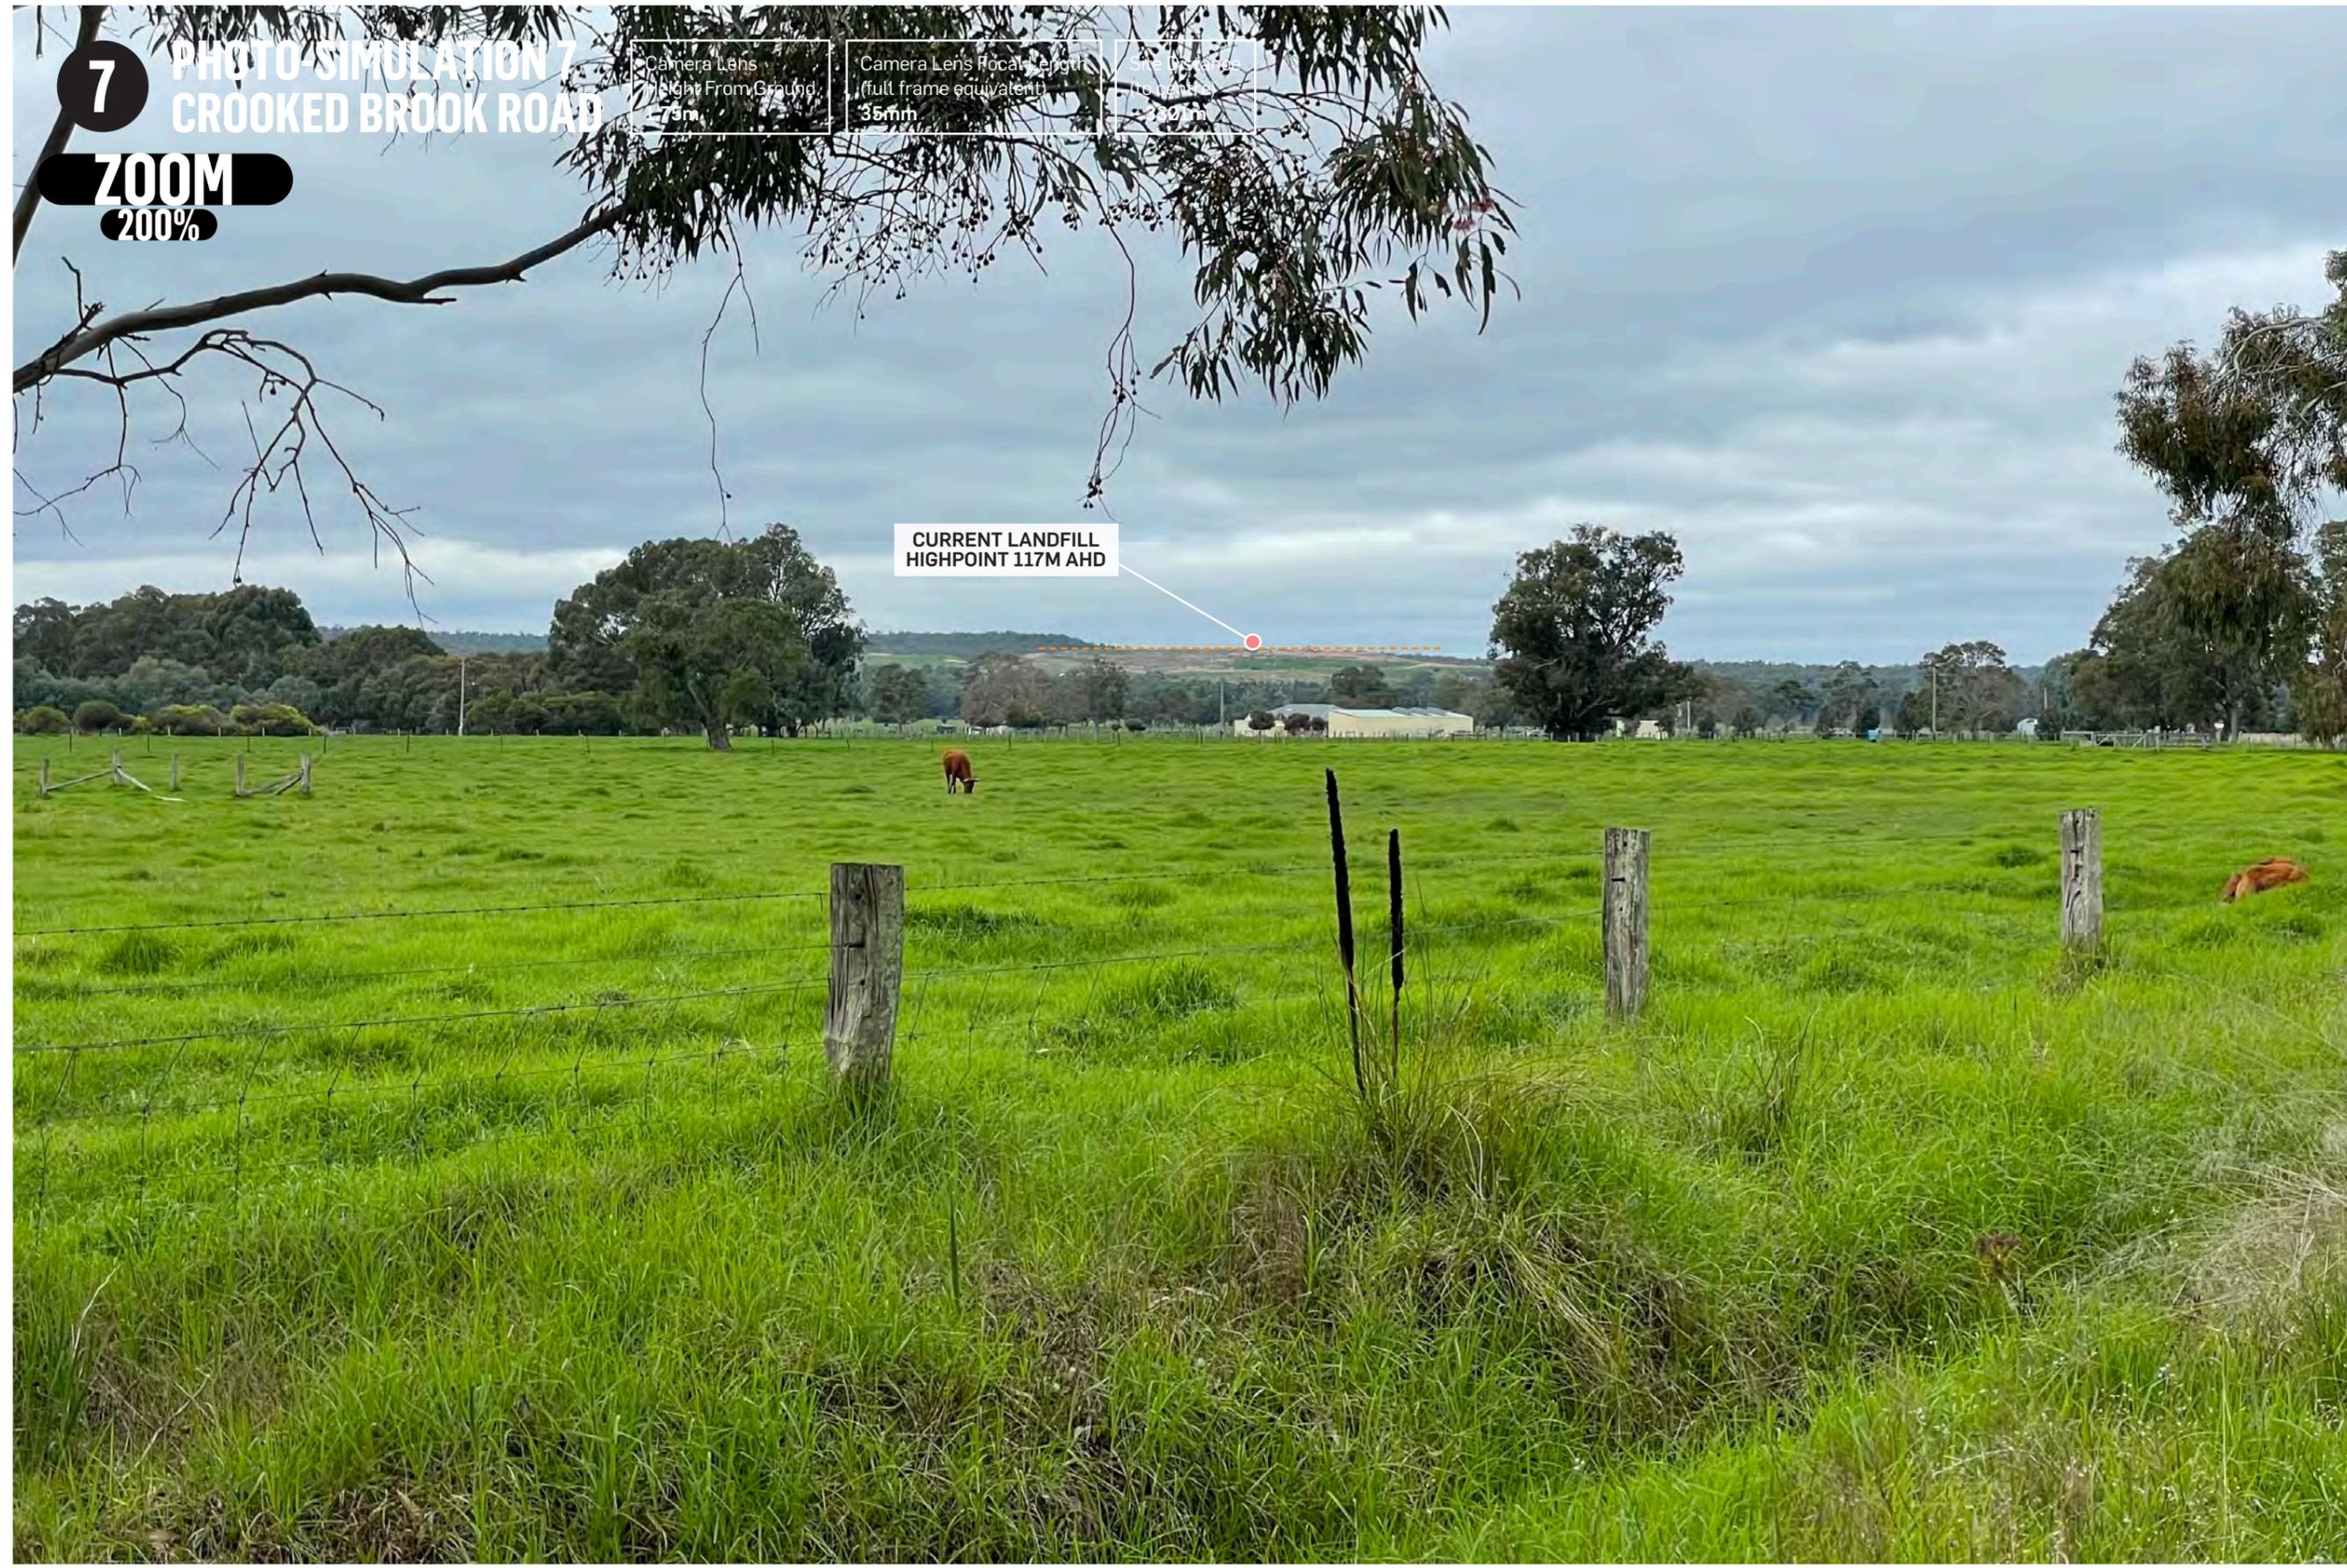
# PHOTO SIMULATION 7 CROOKED BROOK ROAD

Camera Lens  
Height From Ground  
7.5m

Camera Lens Focal Length  
(full frame equivalent)  
35mm

Camera Lens  
Height From Ground  
1.2m

CURRENT LANDFILL  
HIGHPOINT 117M AHD

- **A broad open view can be witness from many of the surrounding properties, roads - refer Photo Simulations 1, 2, 4, 5, 6, 7, 8, 9, 10, 13, and 15.**

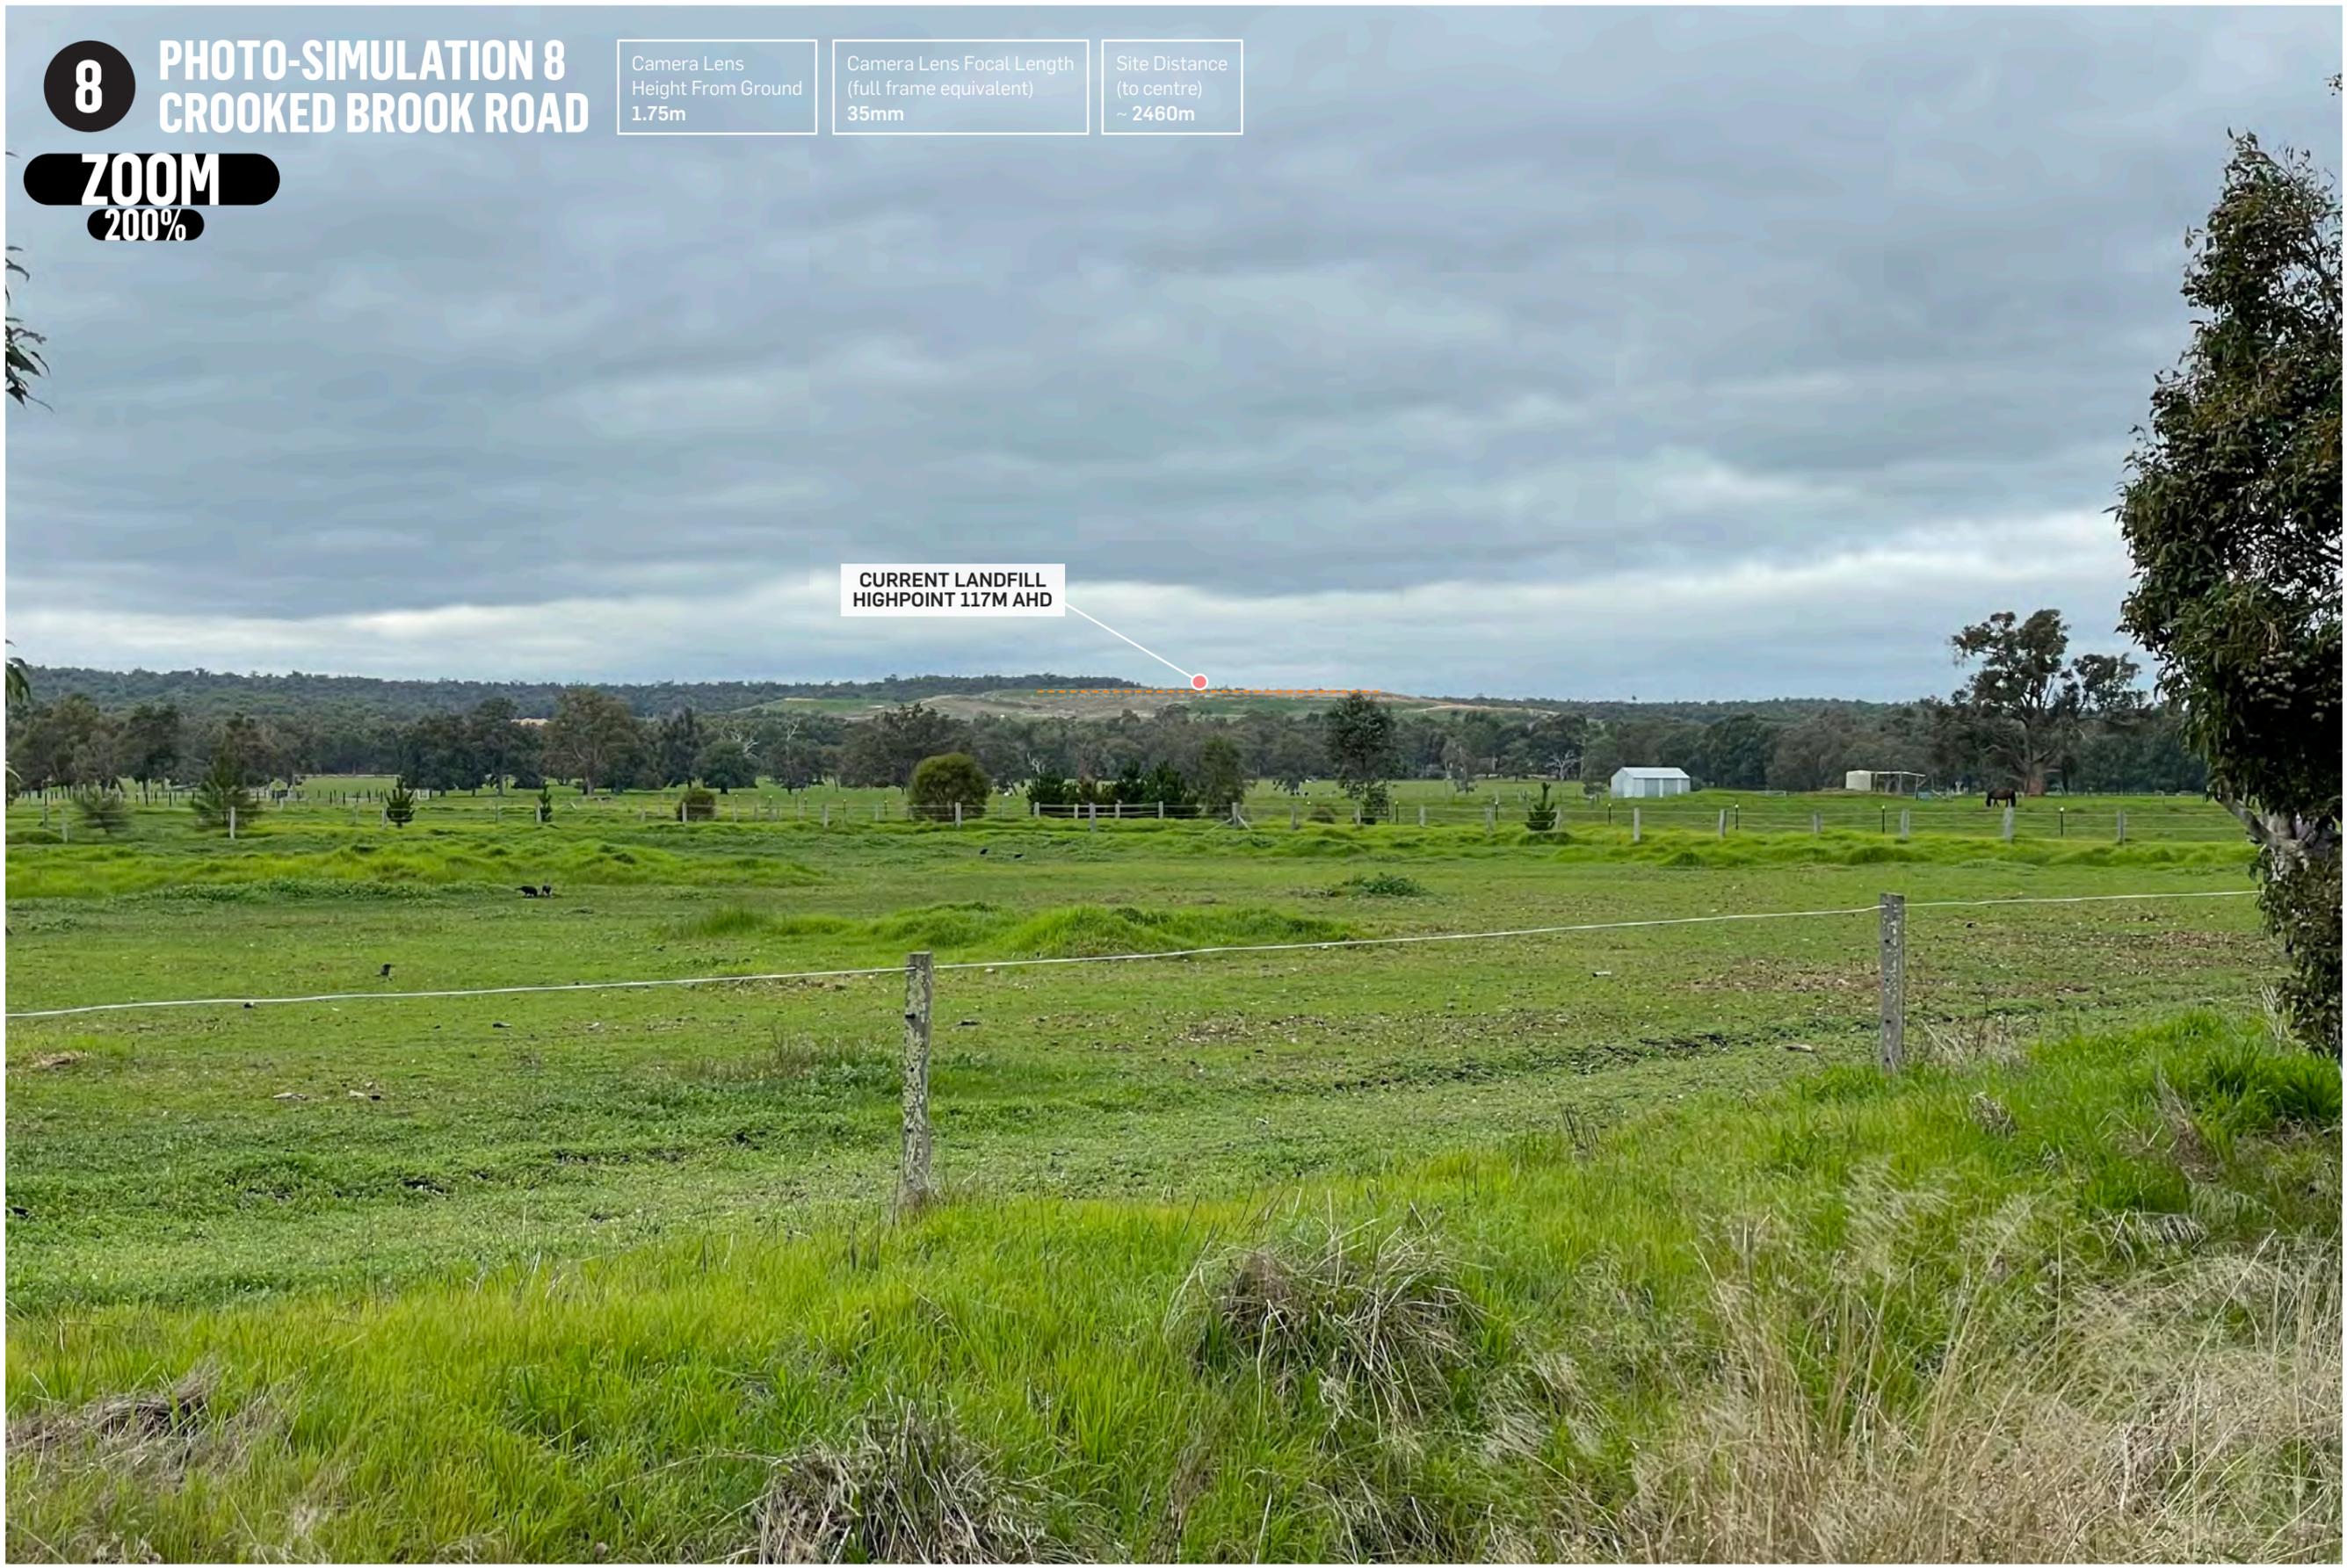
# 8 PHOTO-SIMULATION 8 CROOKED BROOK ROAD

Camera Lens  
Height From Ground  
1.75m

Camera Lens Focal Length  
(full frame equivalent)  
35mm

Site Distance  
(to centre)  
~ 2460m

CURRENT LANDFILL  
HIGHPOINT 117M AHD

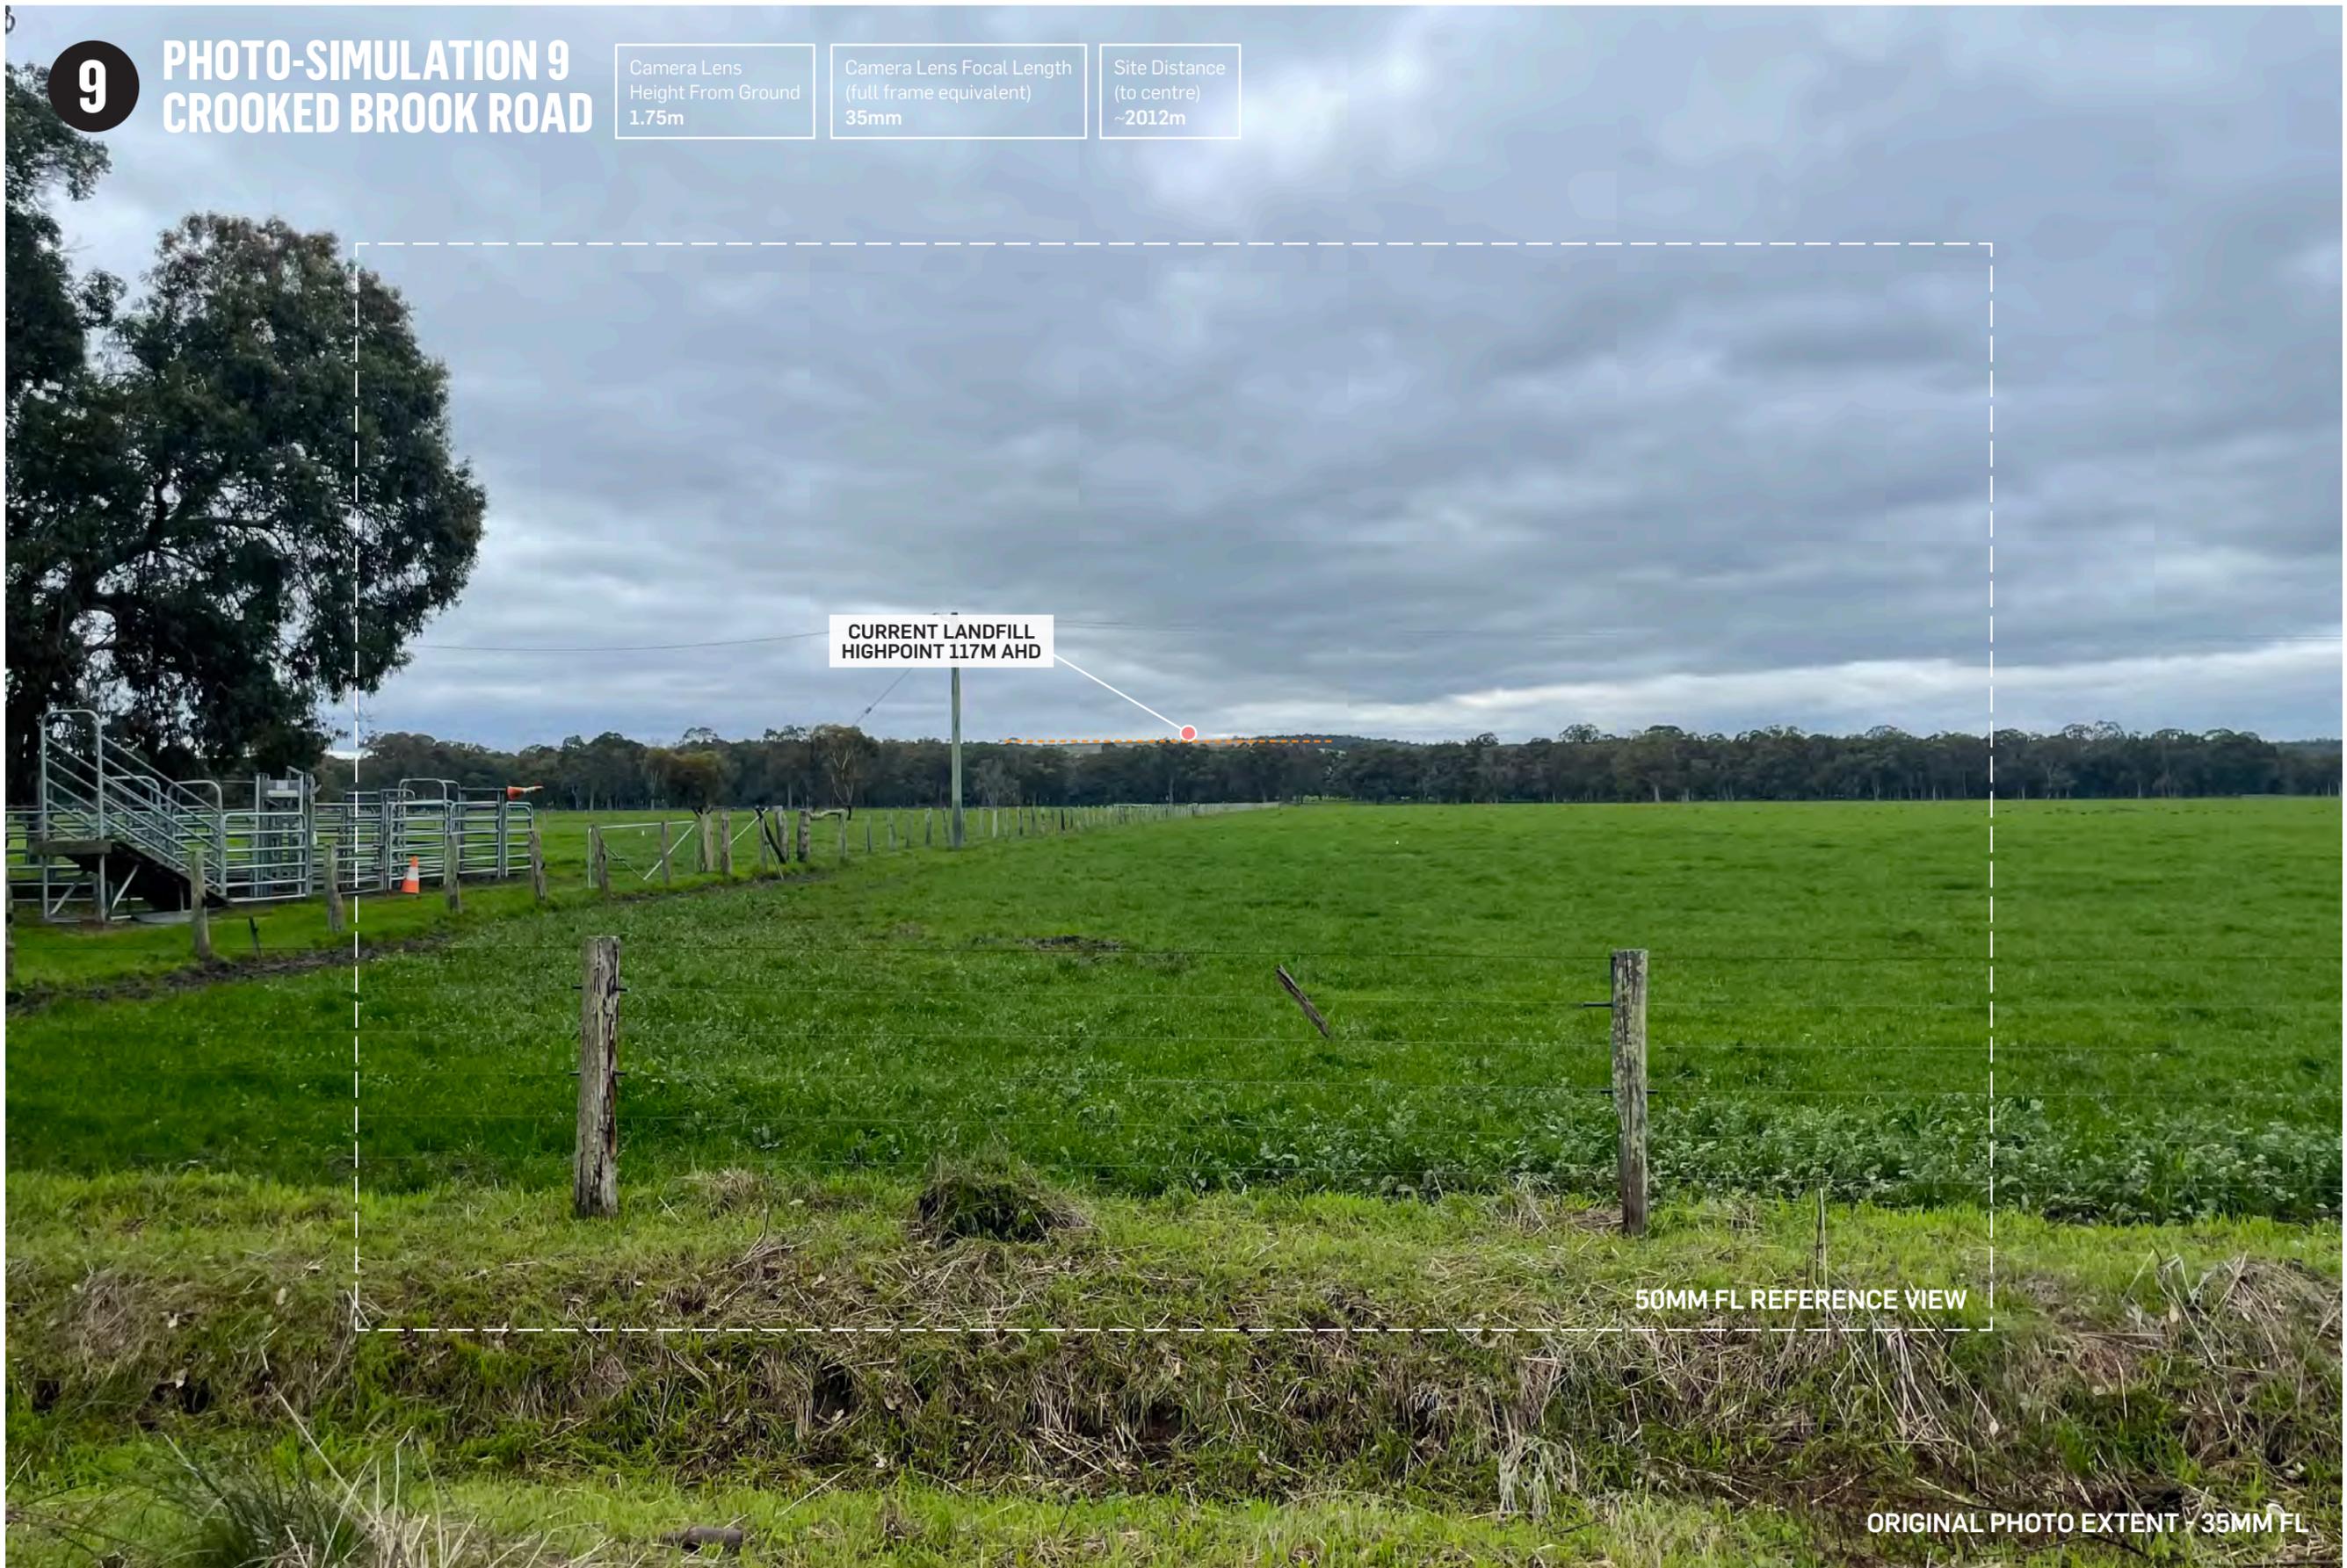
# PHOTO-SIMULATION 9 CROOKED BROOK ROAD

Camera Lens  
Height From Ground  
1.75m

Camera Lens Focal Length  
(full frame equivalent)  
35mm

Site Distance  
(to centre)  
~2012m

CURRENT LANDFILL  
HIGHPOINT 117M AHD

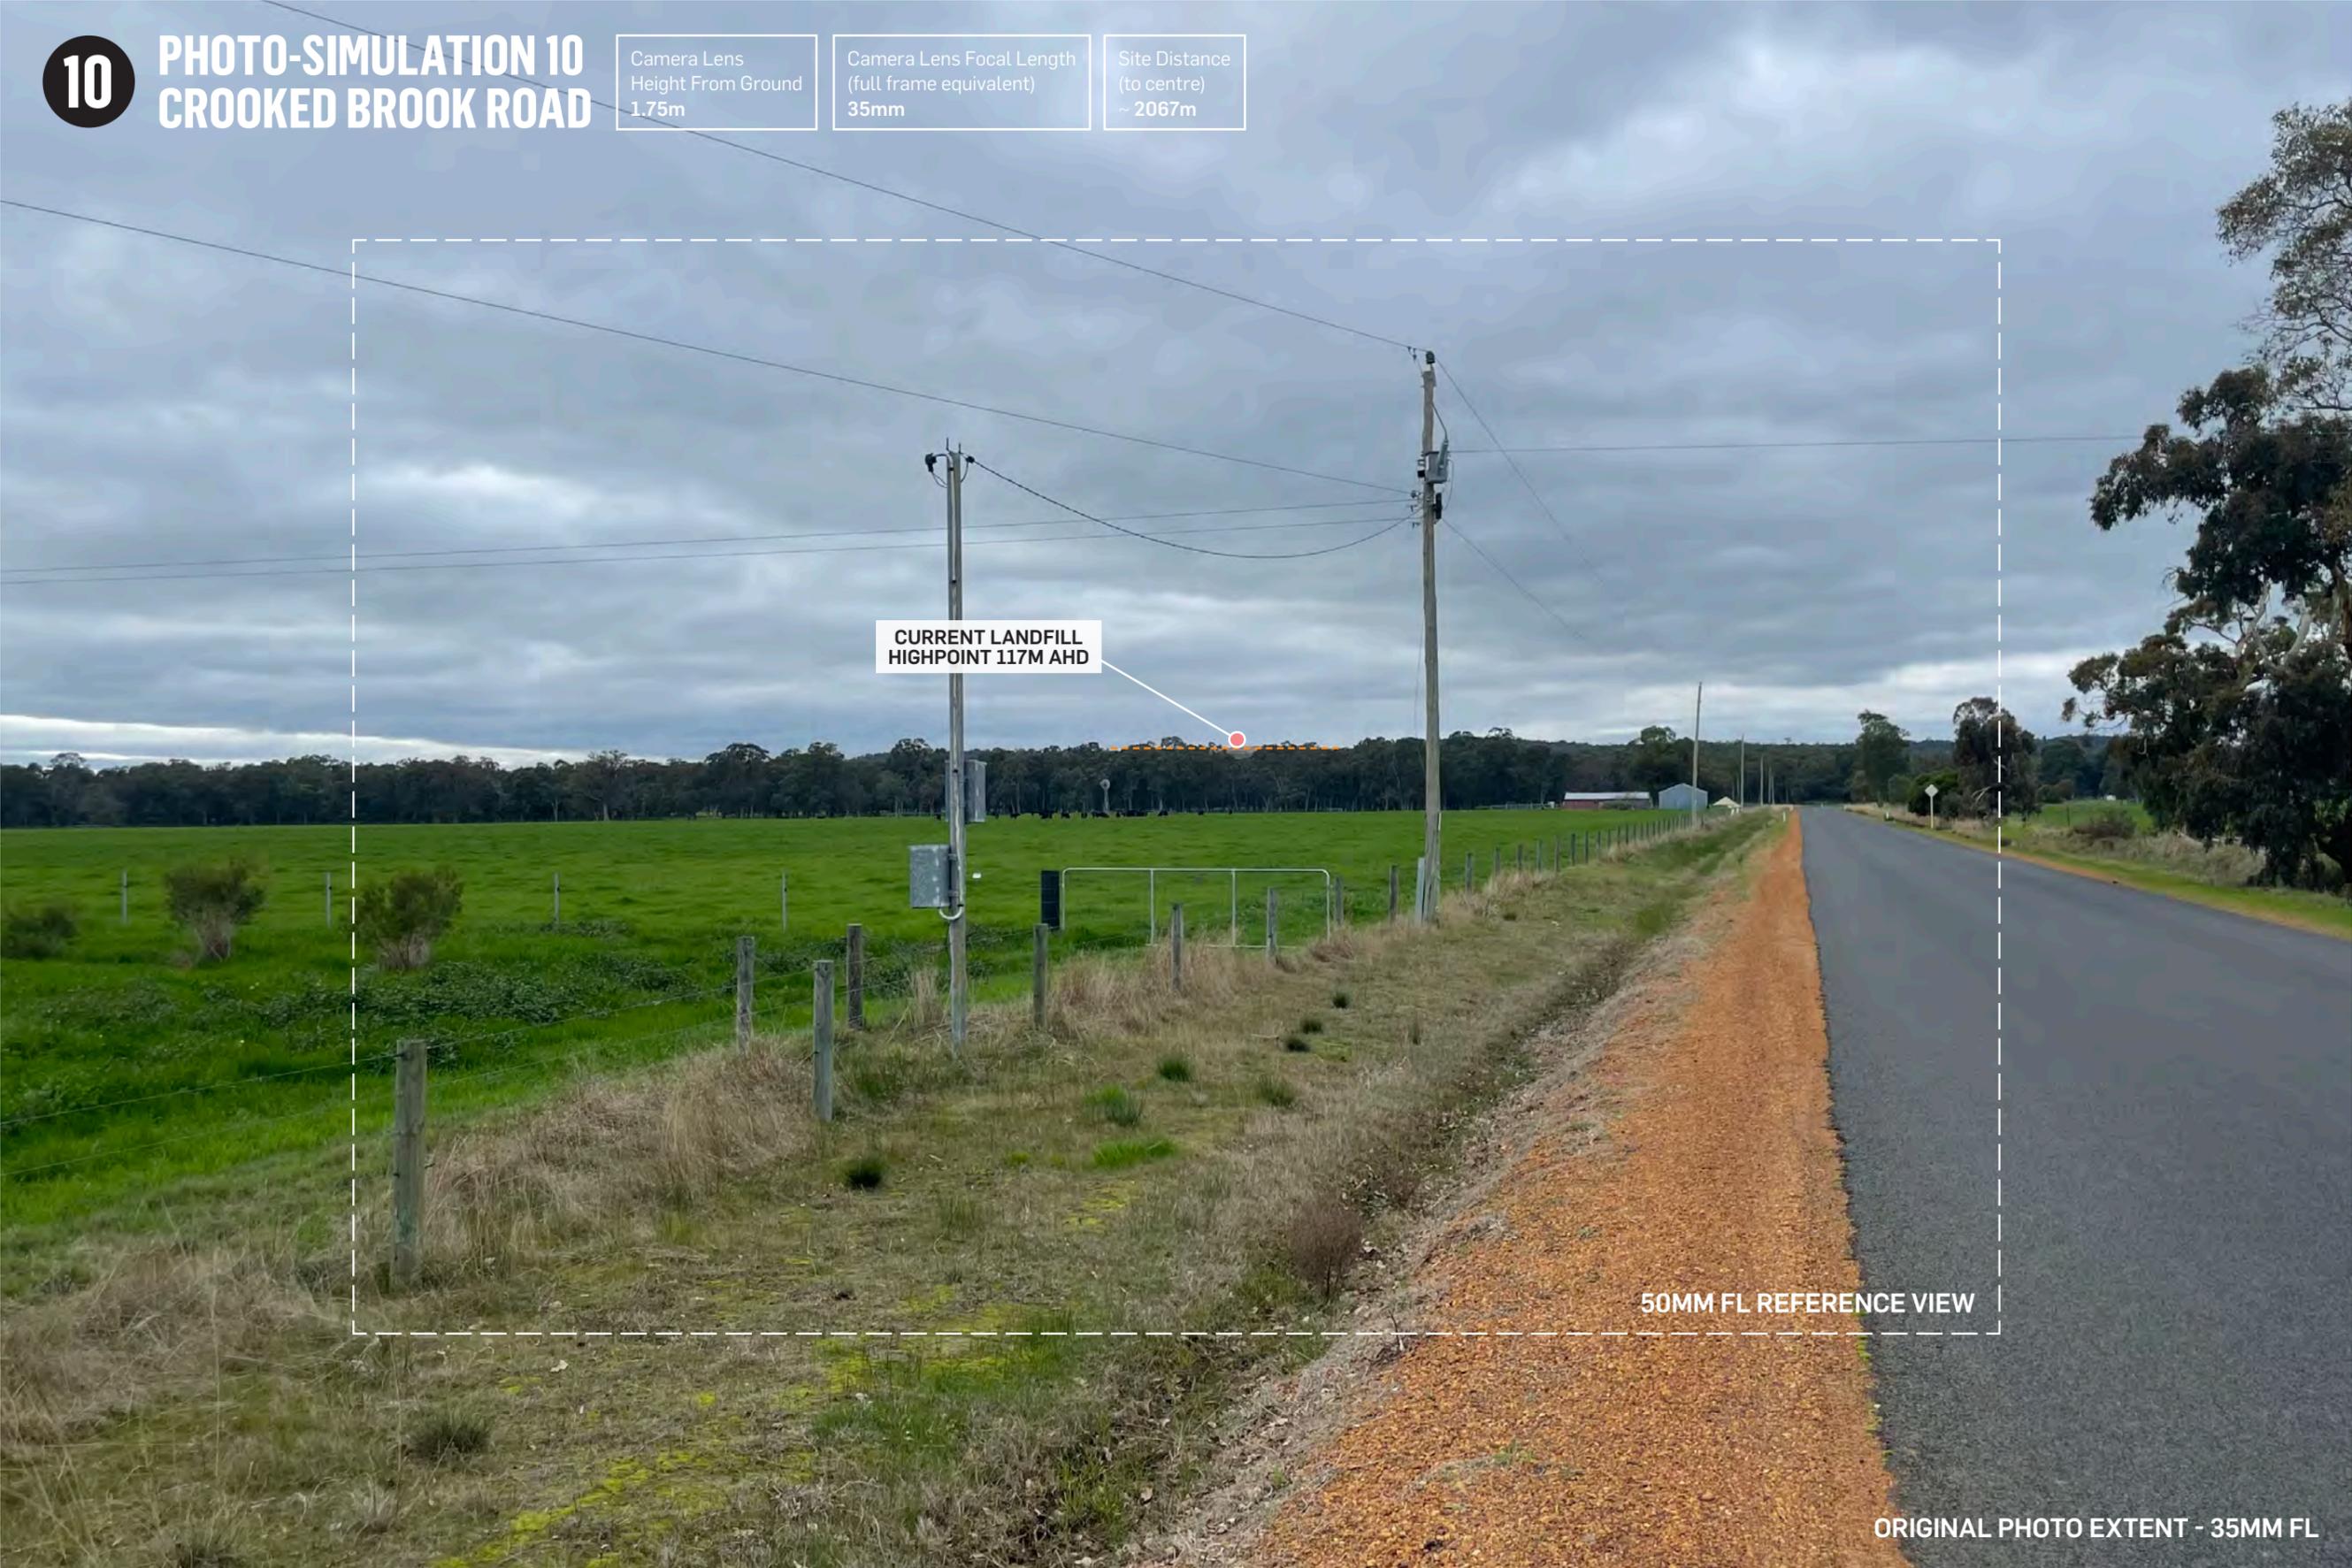
# PHOTO-SIMULATION 10 CROOKED BROOK ROAD

Camera Lens  
Height From Ground  
1.75m

Camera Lens Focal Length  
(full frame equivalent)  
35mm

Site Distance  
(to centre)  
~ 2067m

CURRENT LANDFILL  
HIGHPOINT 117M AHD

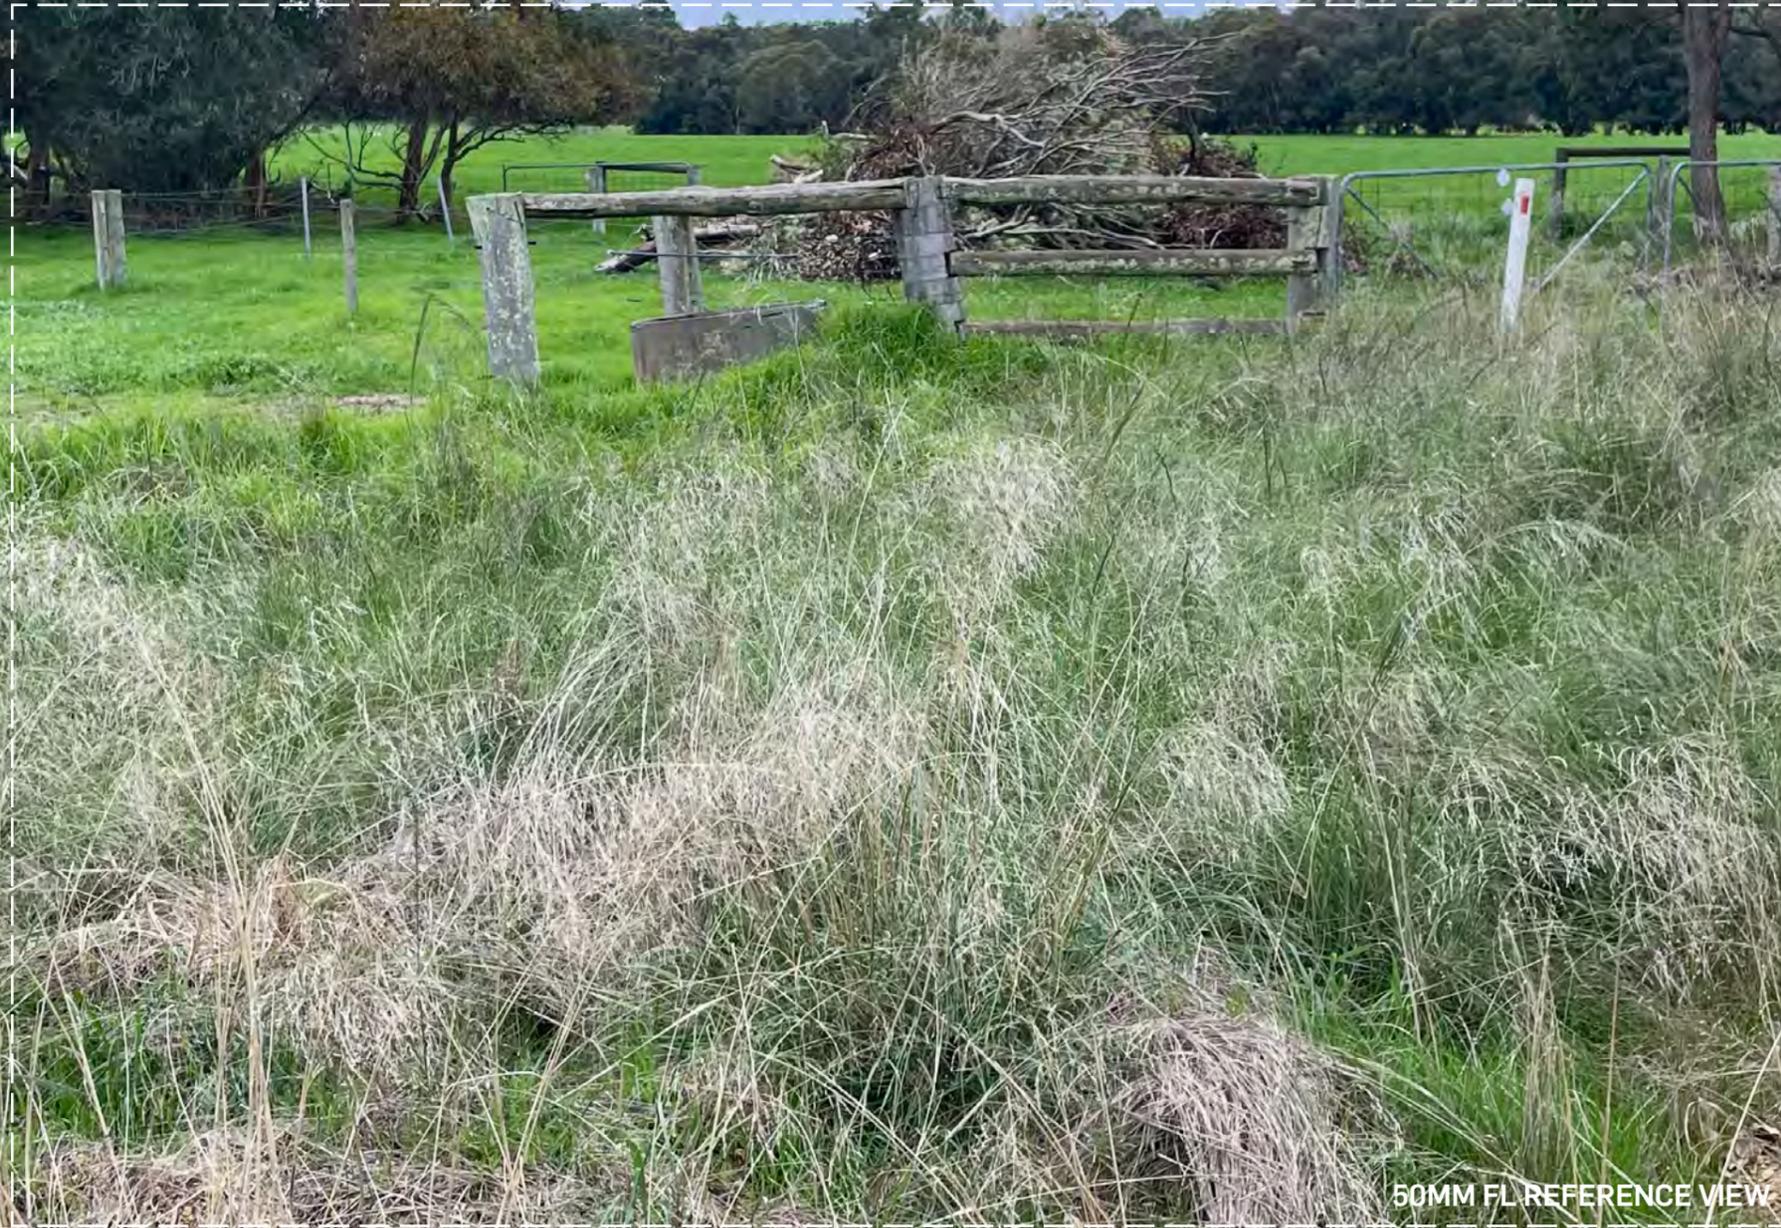
Camera Lens Focal Length  
(full frame equivalent)  
35mm

Site Distance  
(to centre)  
~2081m

50MM FL REFERENCE VIEW

ORIGINAL PHOTO EXTENT - 35MM FL

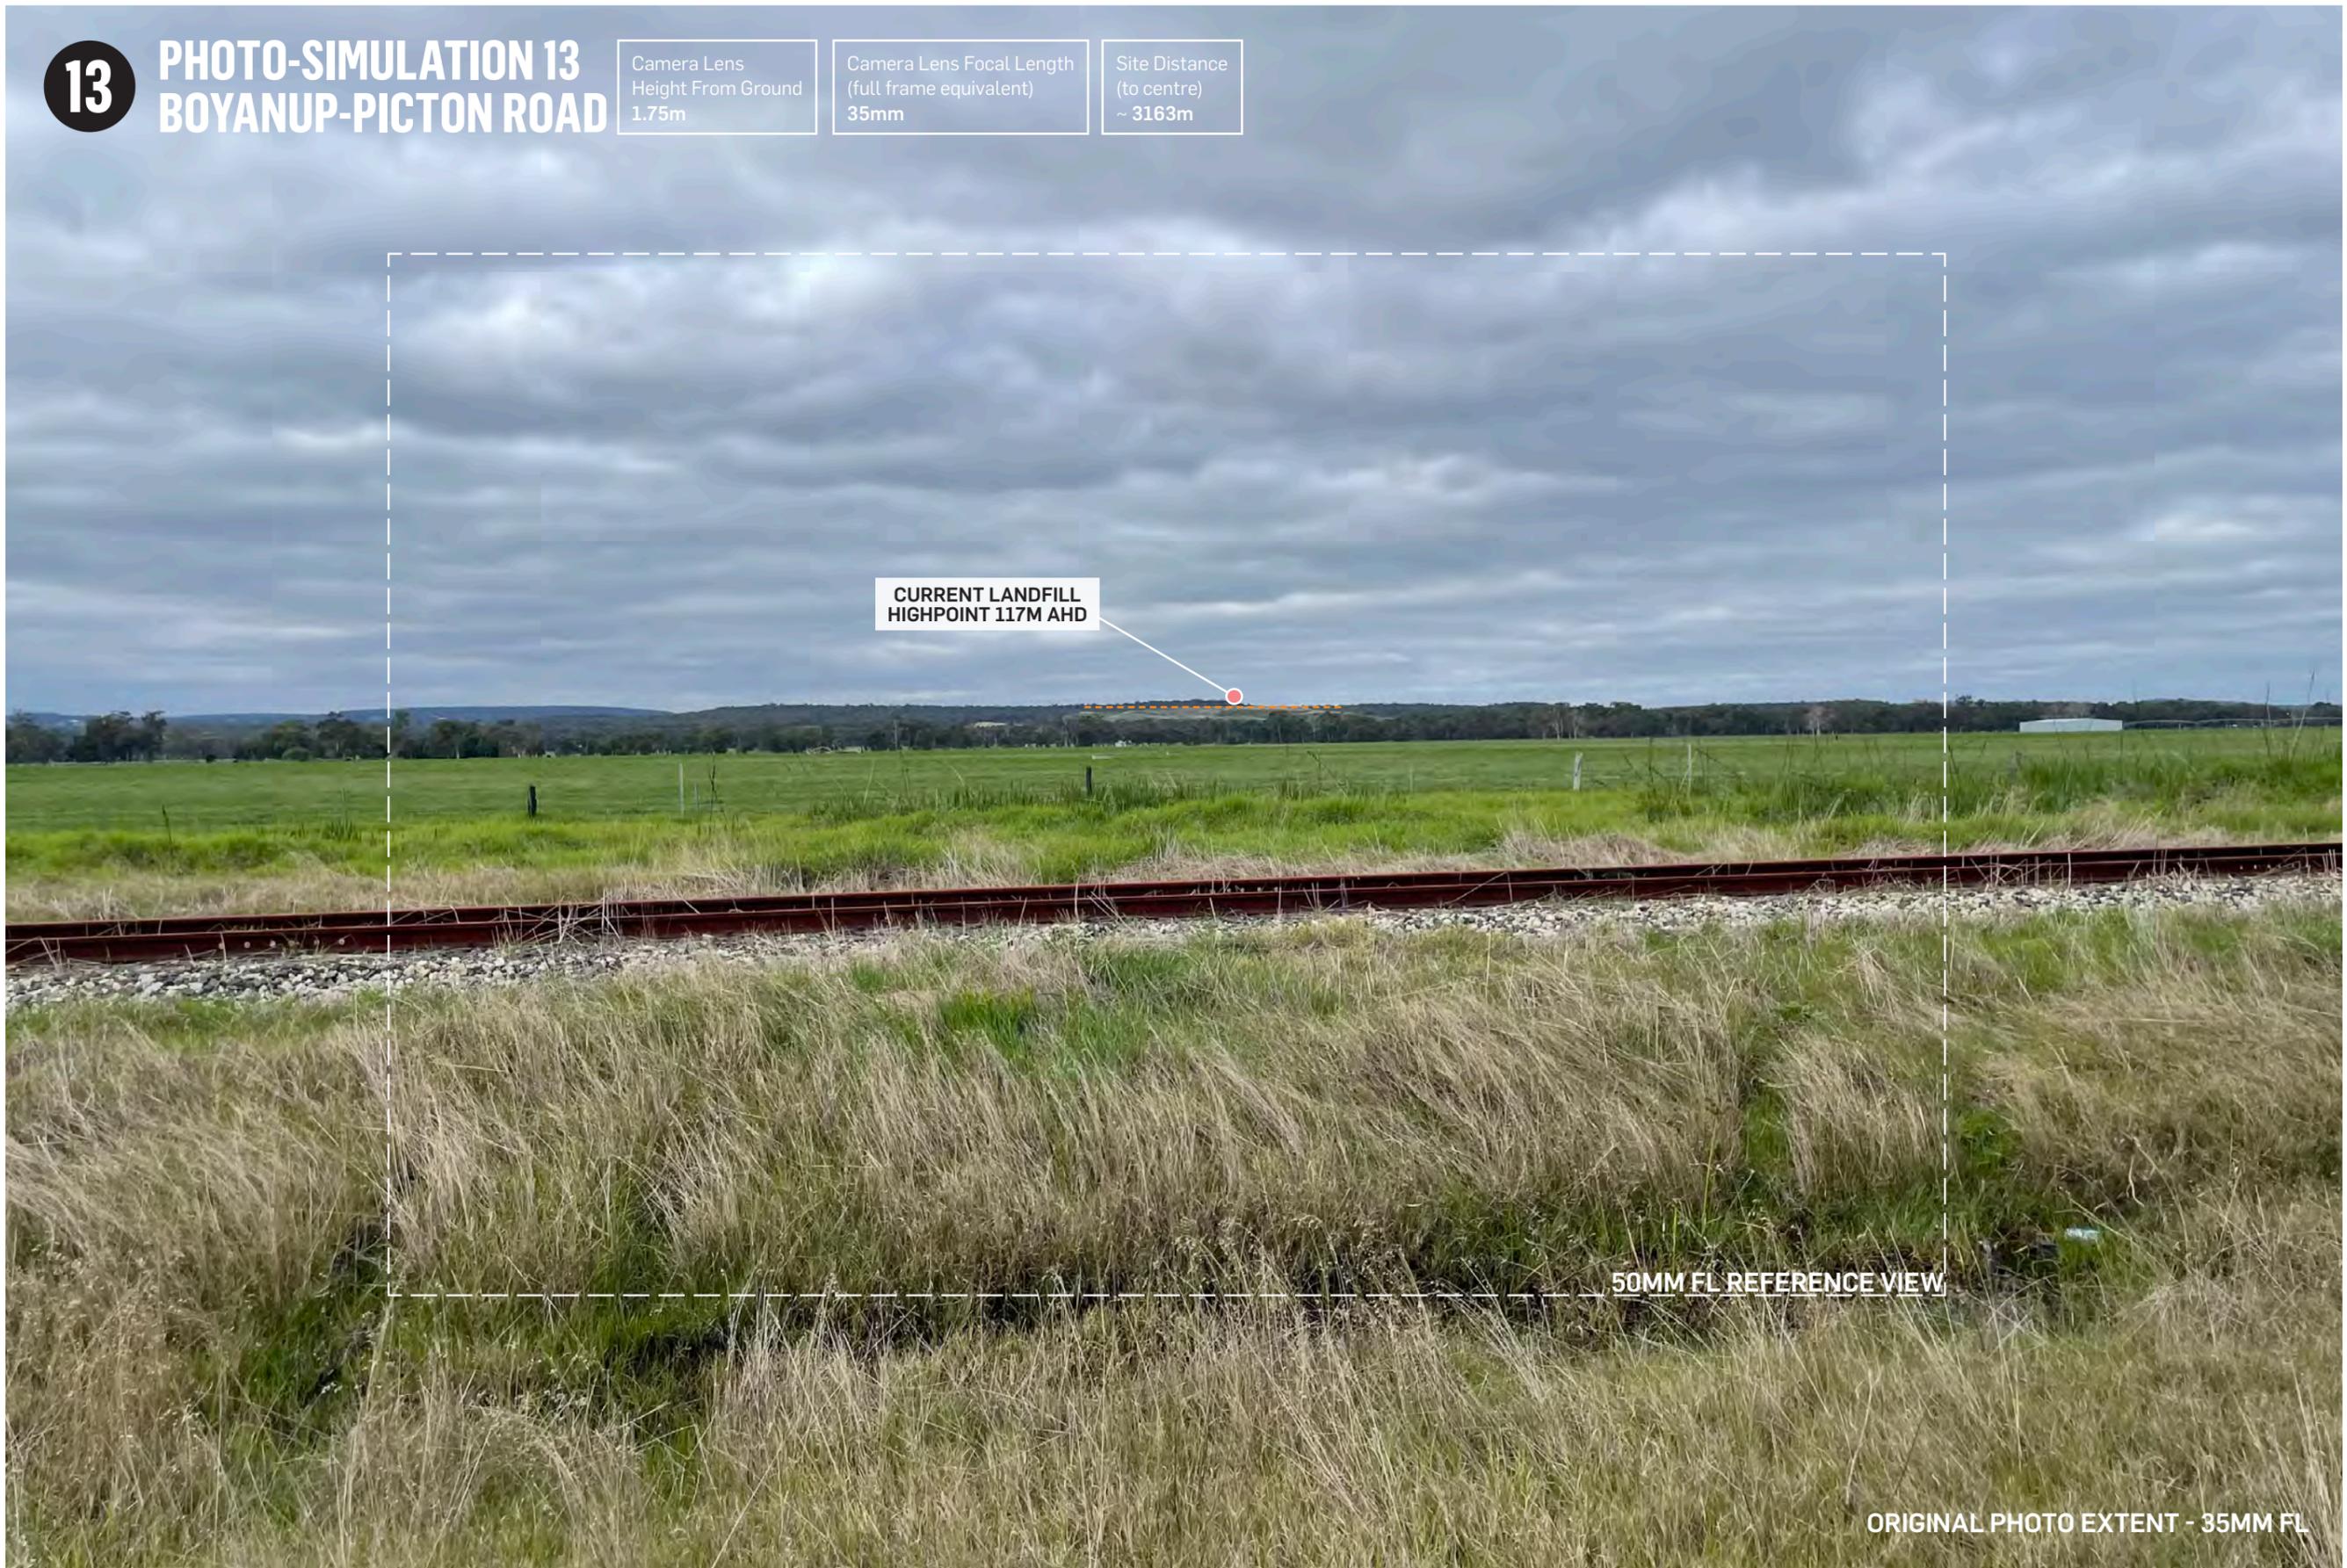
# PHOTO-SIMULATION 13 BOYANUP-PICTON ROAD

Camera Lens  
Height From Ground  
1.75m

Camera Lens Focal Length  
(full frame equivalent)  
35mm

Site Distance  
(to centre)  
~ 3163m

CURRENT LANDFILL  
HIGHPOINT 117M AHD
