# LOT 2 BANSKIA ROAD, DARDANUP - CLEANAWAY WASTE FACILITY

## VISUAL IMPACT ASSESSMENT REVIEW

**SHIRE OF DARDANUP**

AUGUST 2022

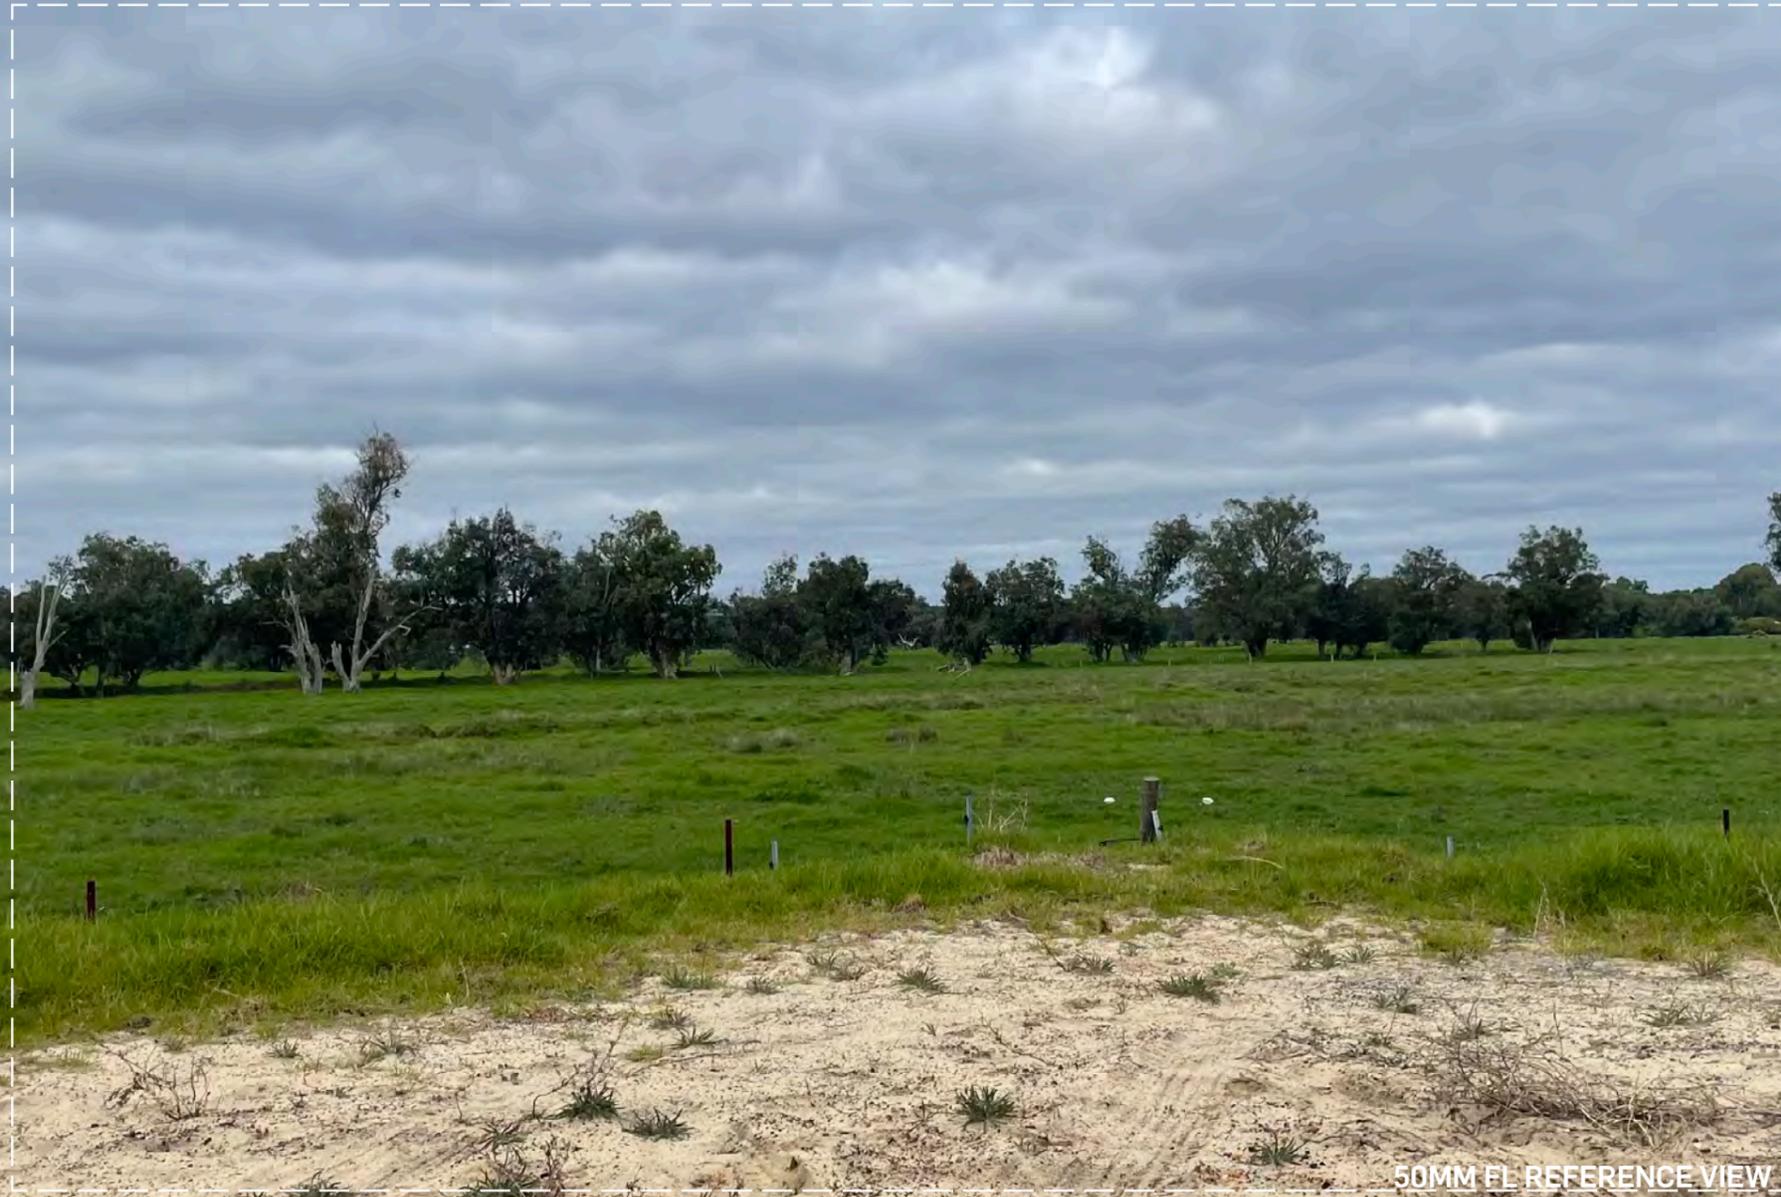
Camera Lens Focal Length  
(full frame equivalent)  
35mm

Site Distance  
(to centre)  
~4219m

50MM FL REFERENCE VIEW

ORIGINAL PHOTO EXTENT - 35MM FL

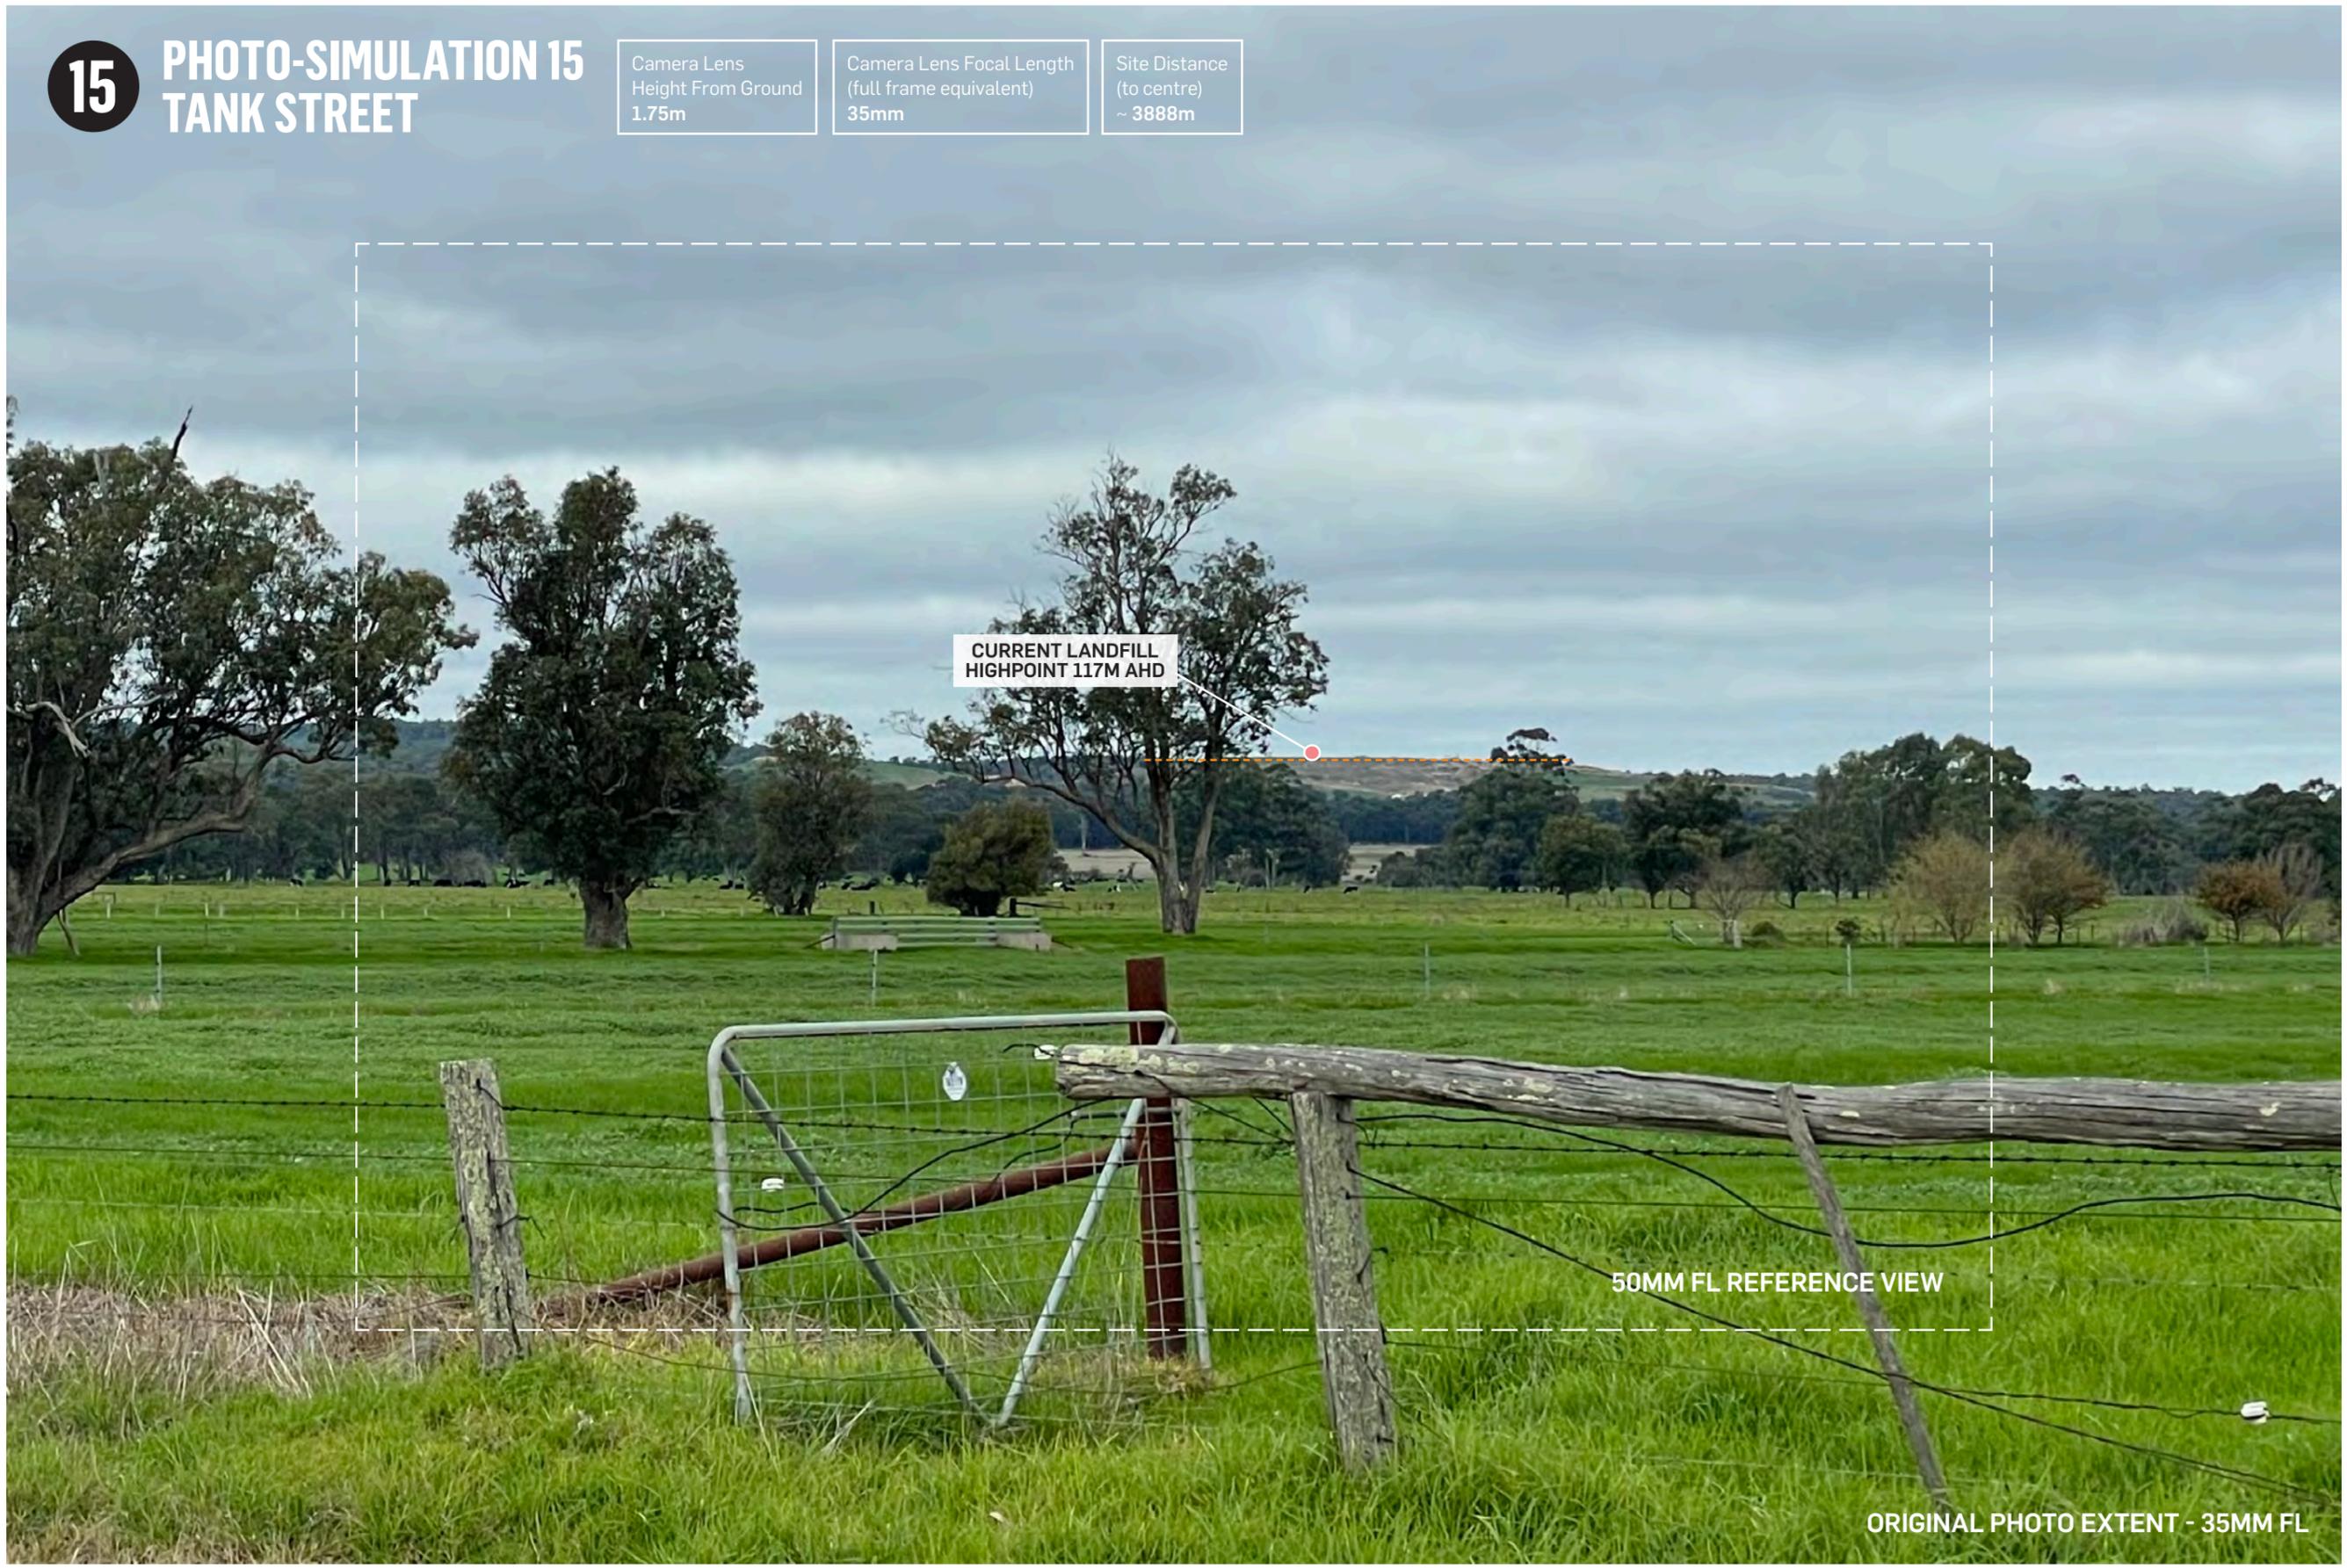
# PHOTO-SIMULATION 15 TANK STREET

Camera Lens  
Height From Ground  
1.75m

Camera Lens Focal Length  
(full frame equivalent)  
35mm

Site Distance  
(to centre)  
~ 3888m

CURRENT LANDFILL  
HIGHPOINT 117M AHD

- **A broad open view can be witness from many of the surrounding properties, roads - refer Photo Simulations 1, 2, 4, 5, 6, 7, 8, 9, 10, 13, and 15.**

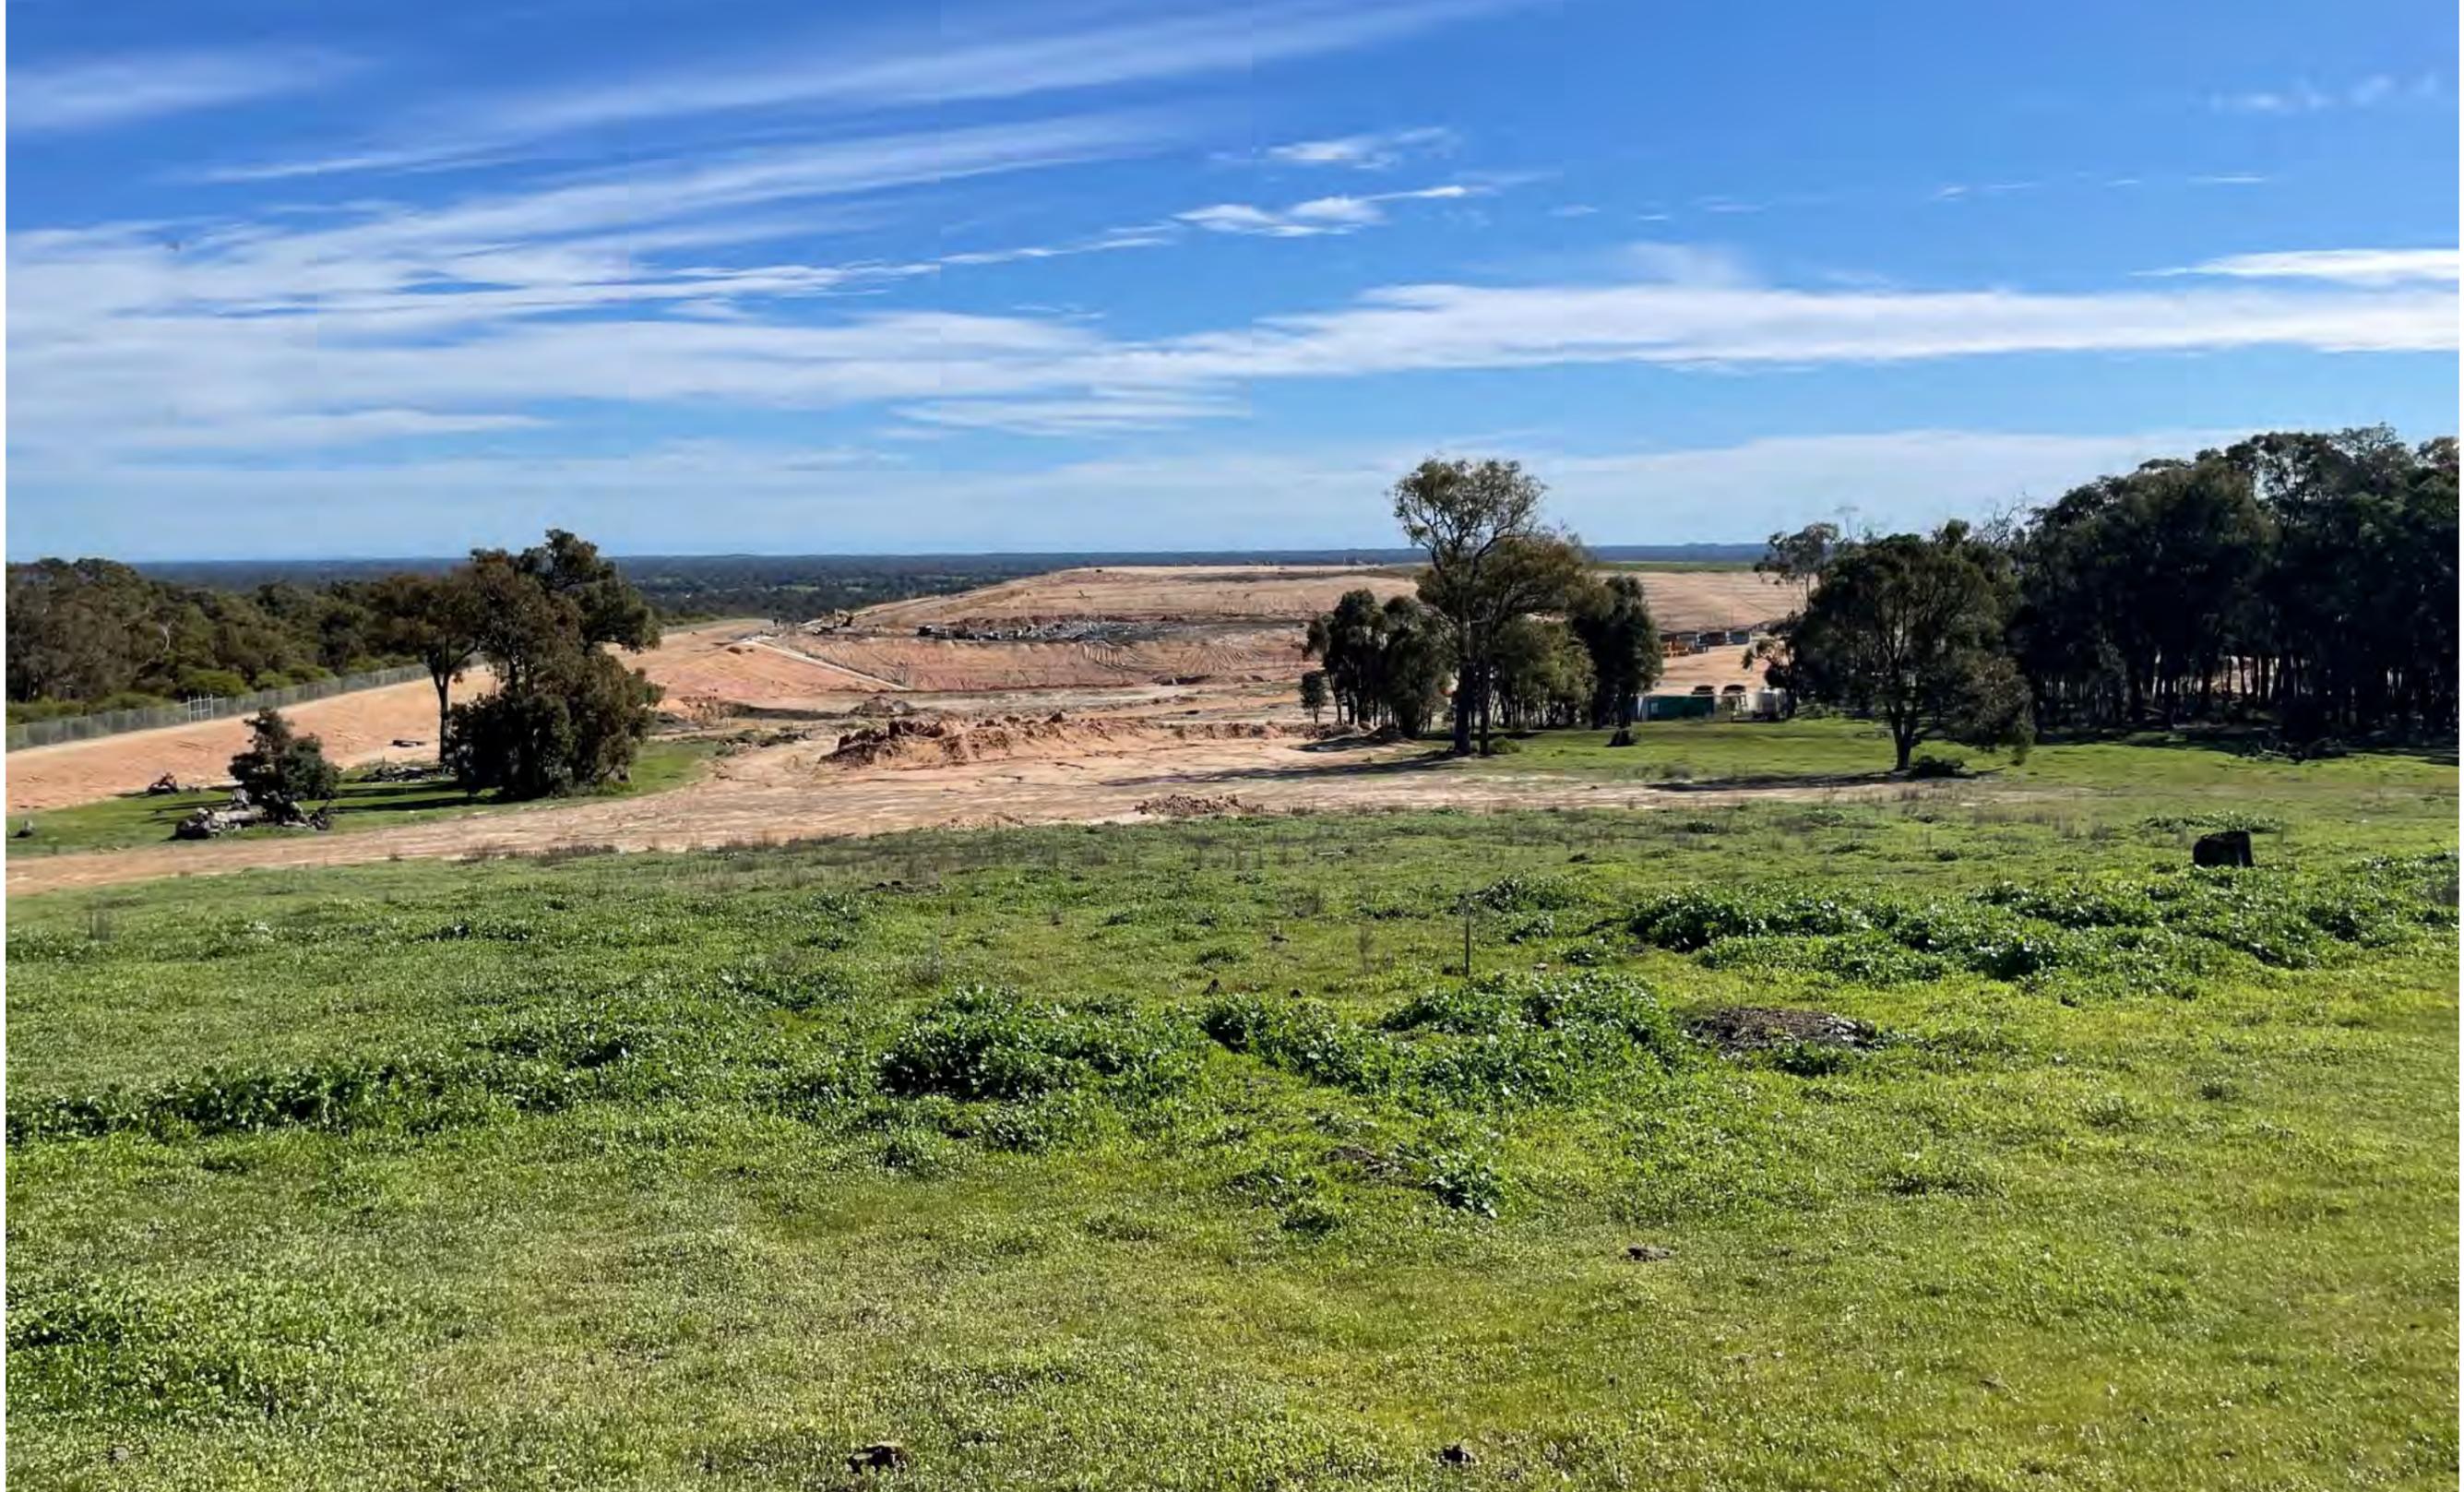
Camera Lens  
Height From Ground  
1.75m

Camera Lens Focal Length  
(full frame equivalent)  
35mm

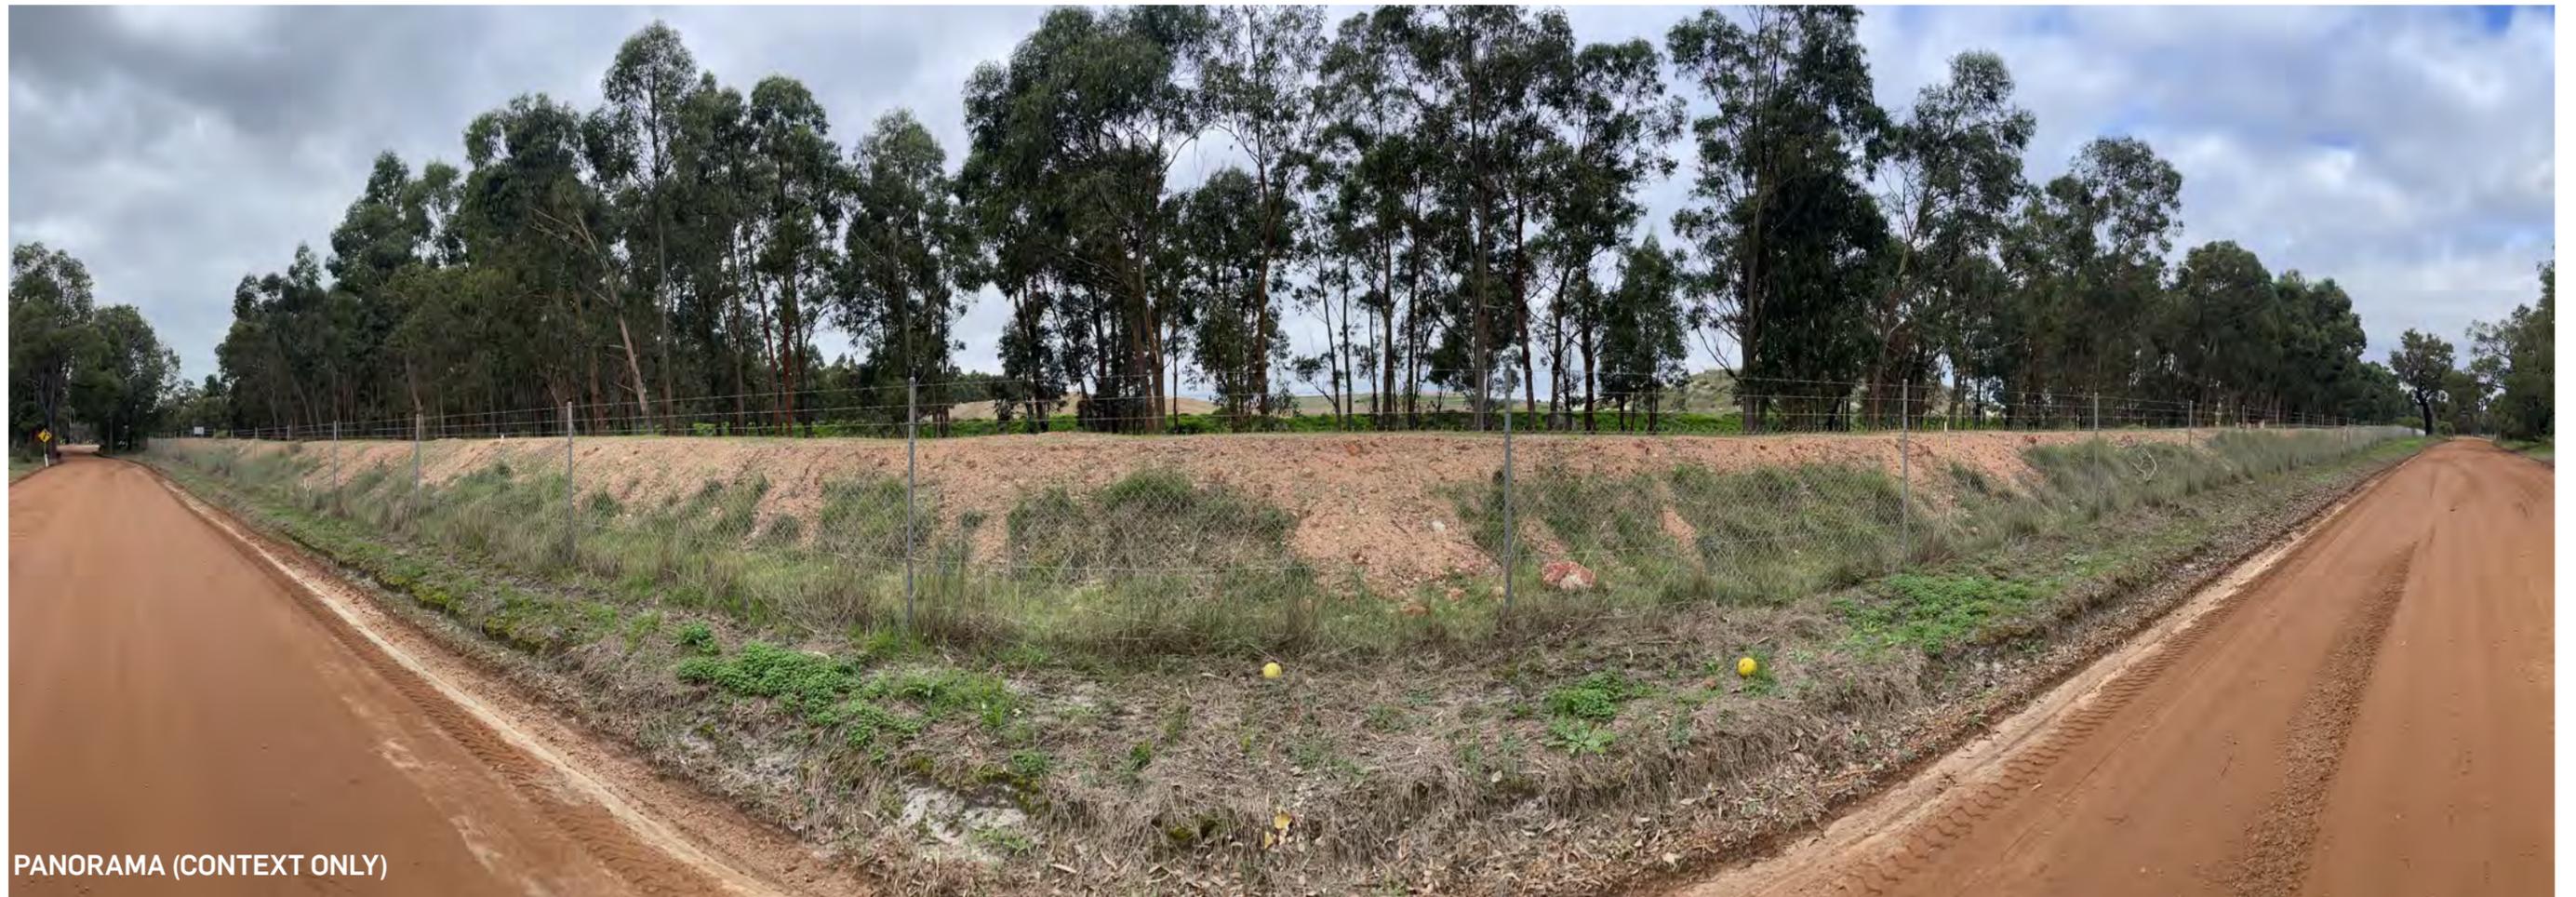
## 2 PHOTO VIEW 2 - PANORAMA

Camera Lens  
Height From Ground  
1.75m

Camera Lens Focal Length  
(full frame equivalent)  
35mm

PANORAMA (CONTEXT ONLY)

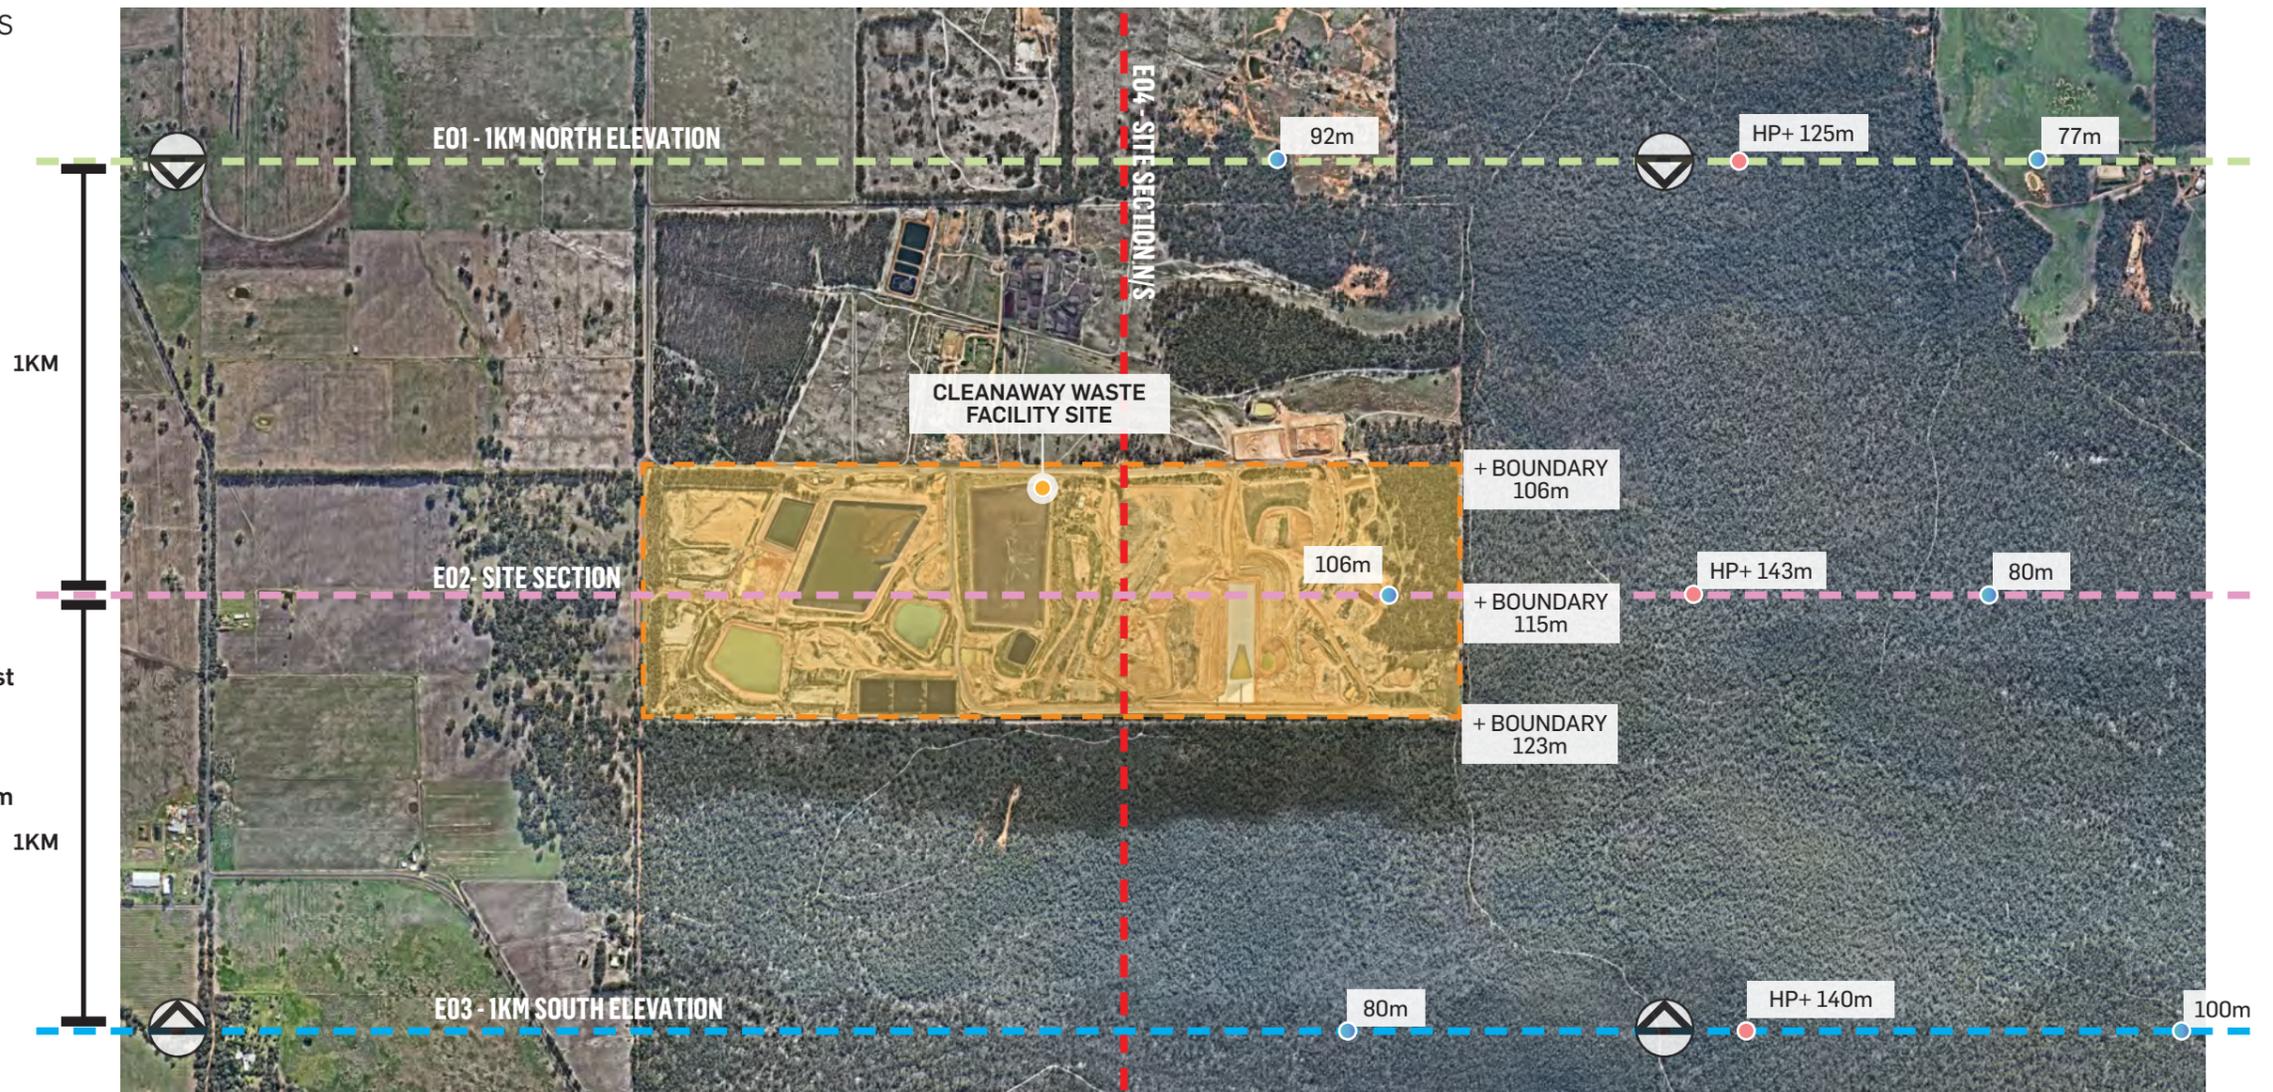
Figure 3 PLAN OF ELEVATION LINES

An Elevation profile analysis was conducted using Google Earth data to assess the average gradient of 4.65% across the site. With the highest surrounding point running through the centre of the site identified as 143m. The height where current works meet the existing grade is 103m and the height at the boundary is approximately 115m.

The process of analysing the elevation change was first running a 5km East West line through the site and exactly 1km north and 1km south of the site to identify surrounding high-points.

Once the high points of each elevation line were identified it was then offset 1km East and West to find a grading change over 1km.

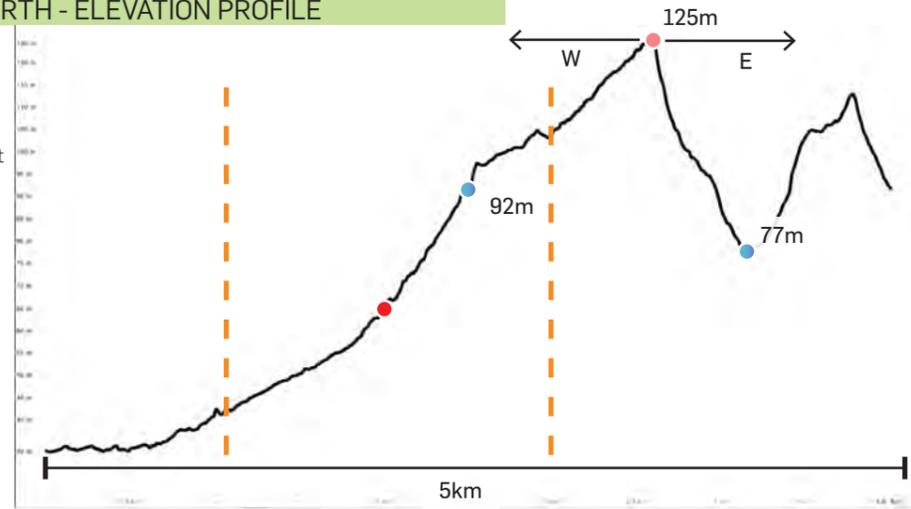
**Figure 4 E01 - 1KM NORTH - ELEVATION PROFILE**

E - 1KM EAST	NUMBER
RISE	48m
RUN	1000m
GRADE	4.8%
ANGLE	2.748 °

W - 1KM WEST	NUMBER
RISE	33m
RUN	1000m
GRADE	3.3%
ANGLE	1.89°

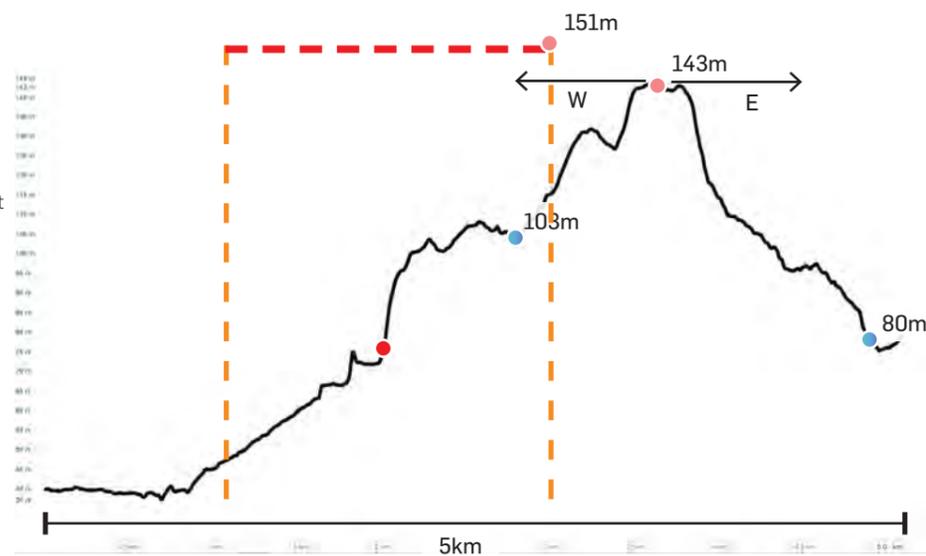
**Figure 5 E0 2 - SITE SECTION - ELEVATION PROFILE**

E - 1KMEAST	NUMBER
RISE	63m
RUN	1000m
GRADE	6.3%
ANGLE	3.605 °

W - 1KM WEST	NUMBER
RISE	40m
RUN	1000m
GRADE	4%
ANGLE	2.2906 °

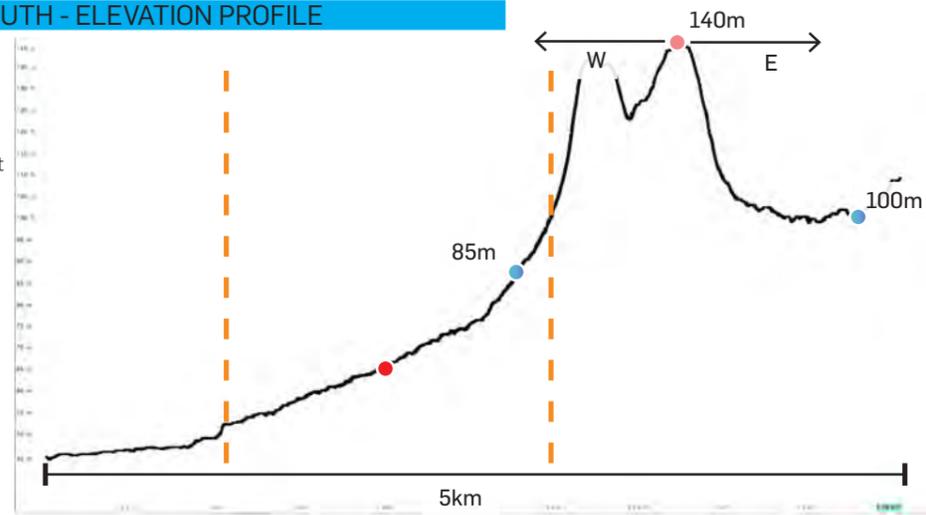
**Figure 6 E03 - 1KM SOUTH - ELEVATION PROFILE**

E - 1KM WEST	NUMBER
RISE	40m
RUN	1000m
GRADE	4%
ANGLE	2.2906 °

W - 1KM WEST	NUMBER
RISE	55m
RUN	1000m
GRADE	5.5%
ANGLE	3.148 °

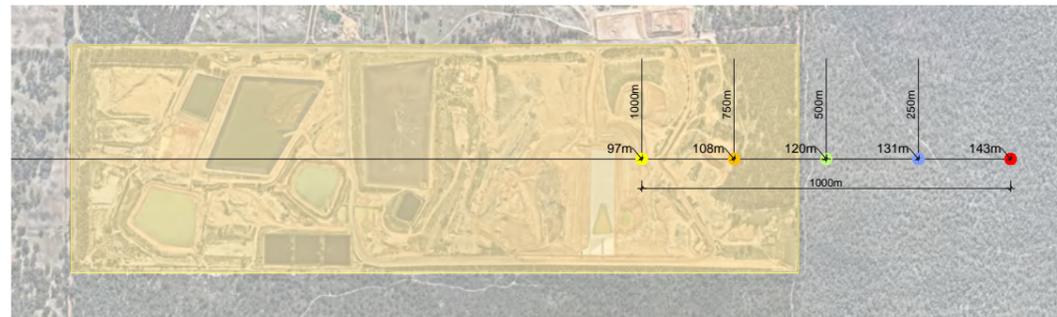
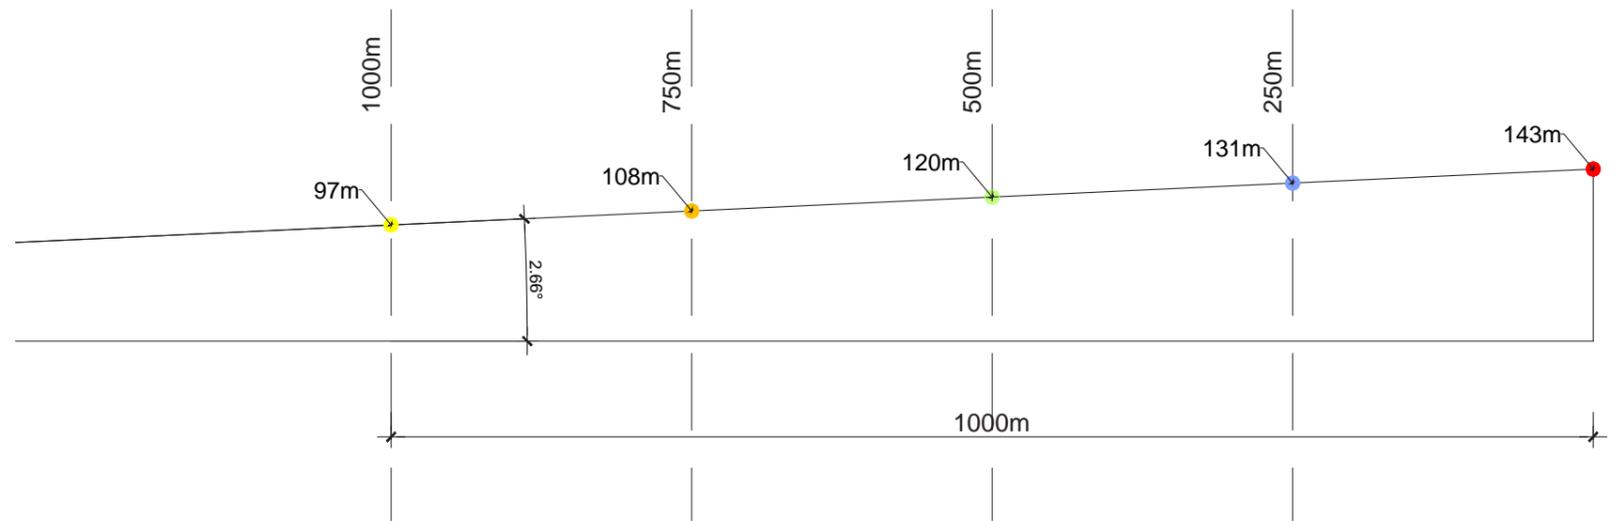
Projecting the natural topography from the identified highpoint into the site and using a batter grade percentage of 4.65% the height of the proposed landfill will be approximately 97m.

This average slope can be expressed as a 1/21.5 grade ratio.

- IDENTIFIED GRADE WITHIN THE EPCAD LANDSCAPE AND VISUAL ASSESSMENT IS AN OBSERVED GRADE OF 1:28
- SURROUNDING COMMON SLOPE - OBSERVED GRADE 1:21.5
- SURROUNDING GENTLE SLOPE - OBSERVED GRADE 1:40
- SURROUNDING STEEP SLOPES (LIMITED EXAMPLES IDENTIFIED IN VALLEYS) - OBSERVED GRADE 1:6
- CURRENT CLEANAWAY PROPOSED LANDFILL BATTER GRADE - <1:3.5
- SUGGESTED BATTER GRADE - 1:6
- SUGGESTED MAXIMUM HEIGHT OF LANDFILL TO BE 130M AHD
