## **Report on Geotechnical Investigation**

**Proposed Industrial Park**

**Lot 2010 Giorgi Road, Picton East, WA**

**Project 236293.01**

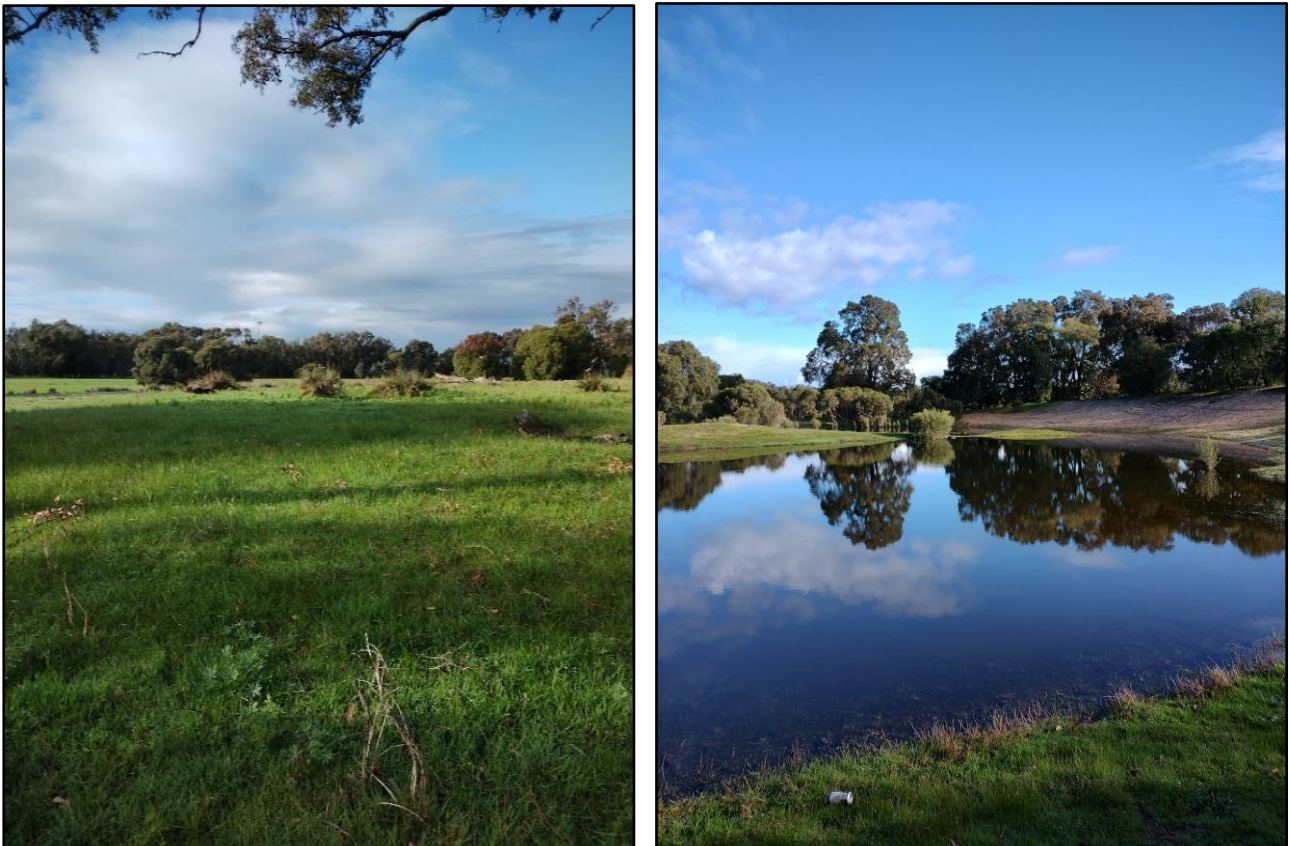
**Figure 1: Site Photographs (August 2025)**

During the field work on 26 and 27 August 2025, the site was generally covered with short grass with some surface water also observed. The topography was predominantly flat with some slight undulations, with surface elevations across the site at the test locations varying from a minimum RL 8.5 (TP2) to maximum RL 14.0 (TP13). Large to medium sized trees were present across most of the periphery of the site, especially along South Western Highway and around two farm dams towards the northern boundary.

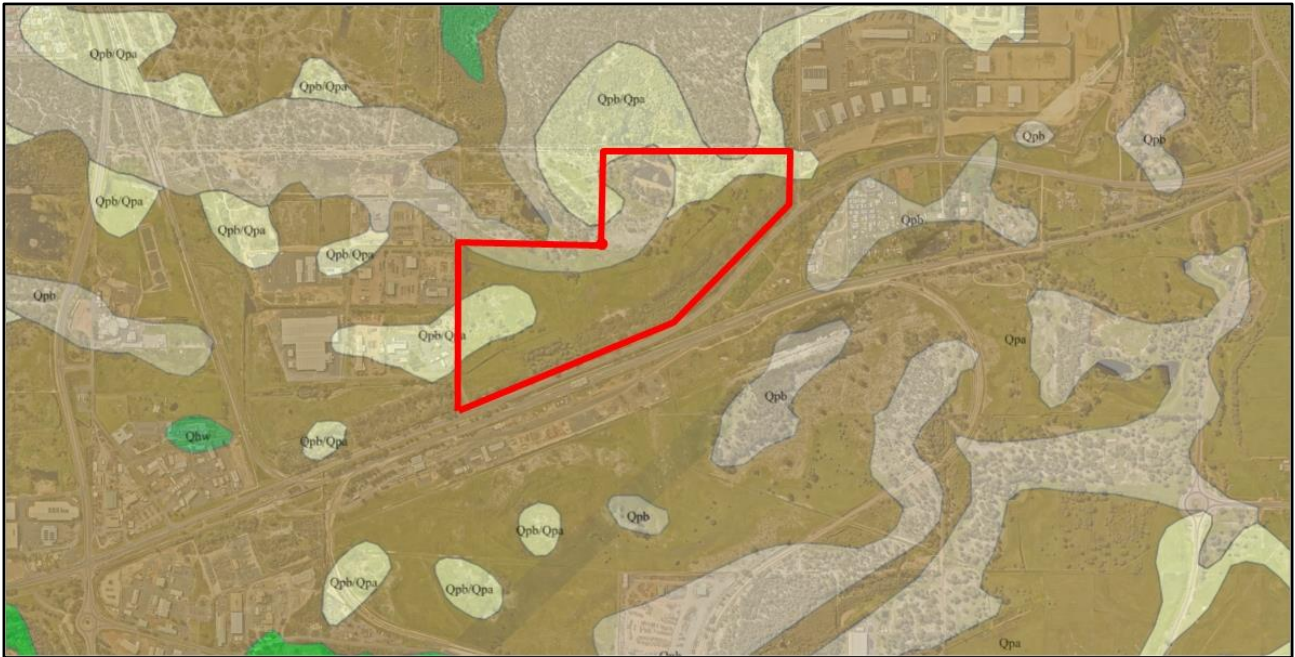
**Figure 3: Geological Mapping with approximate site location. Q<sub>pa</sub>: Guildford Formation (in dark brown). Q<sub>pb</sub>: Bassendean Sand (in light brown). Q<sub>pb</sub>/Q<sub>pa</sub>: Bassendean Sand over Guildford Formation (in light yellow).**

The 1:50,000 Bunbury-Burekup Environmental Geology sheet indicate that subsurface conditions across the site comprise three soil units (Figure 3):

The waterlogged ground observed in low lying parts of the site during the field work approximately correlates with the mapped Guildford Formation ( $Q_{pa}$ ) of the geological map.

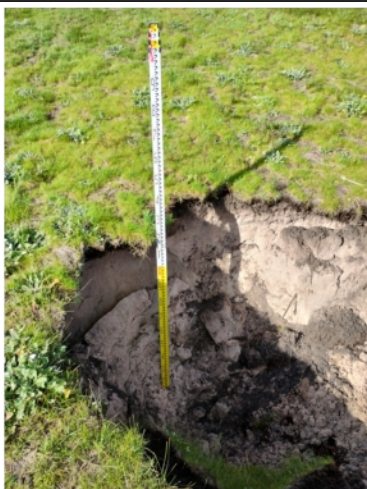
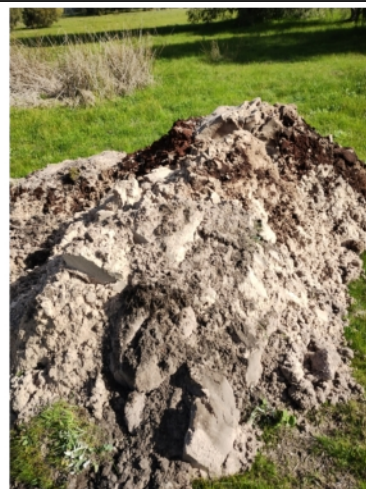
| CONDITIONS ENCOUNTERED | | | | | | | SAMPLE | | | TESTING AND REMARKS | | | |
|---|---|---|---|---|---|---|---|---|---|---|---|---|---|
| Groundwater observed at 0.6 m depth<br>26/08/25 | | 0.10 | TOPSOIL / Organic SAND (SP-SM) with silt: dark grey-brown; fine to medium; trace rootlets.<br>SAND (SP) trace silt: pale grey; fine to medium. Bassendean Sand. | | TOP | | M | | D | | 0.10 | | |
| | | 1.70 | Silty SAND (SM): dark brown and brown; fine to medium; moderately to strongly cemented, 'Coffee Rock'. Bassendean Sand. | | AEO | (D)<br>(VD) | M | | D | | 2.00 | | |
| | | 2 | Test Pit discontinued at 2.00m depth.<br>(Collapsing conditions). | | | | | | | | | | |

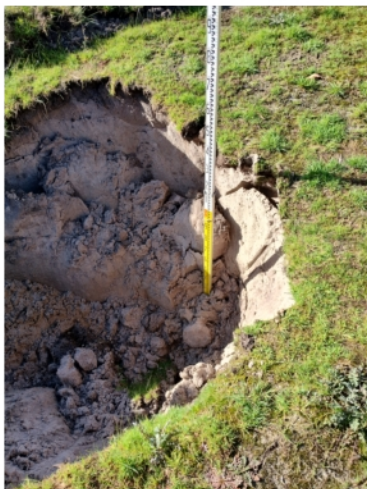
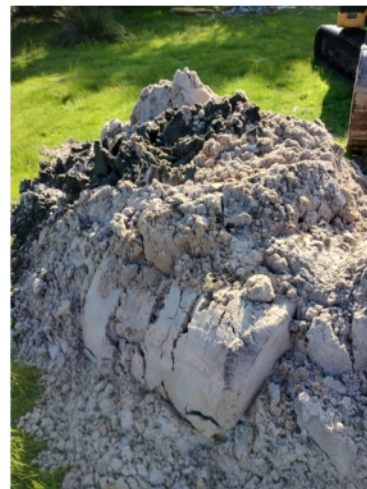
| CONDITIONS ENCOUNTERED | | | | | | | | | | | | | | SAMPLE | | | | TESTING AND REMARKS | | | |
|---|---|---|---|---|---|---|---|---|---|---|---|---|---|---|--|--|--|---|--|--|--|
| <div>▼</div> <div>26/08/25</div> <div>Groundwater observed at 0.4 m depth</div> | 8 | 0.15 | TOPSOIL / SAND (SP-SM) with silt trace rootlets: dark grey-brown; fine to medium. | | TOP | | | M to W | | | | | <div>↕</div> <div>PSP/150</div> <div></div> | <div>5</div> <div>10</div> <div>15</div> | | | | | | | |
| | | | Test Pit discontinued at 1.60m depth. (Collapsing conditions). | | | | | | | | | | | | | | | | | | |

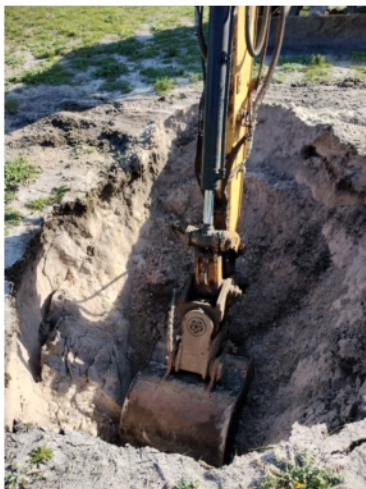
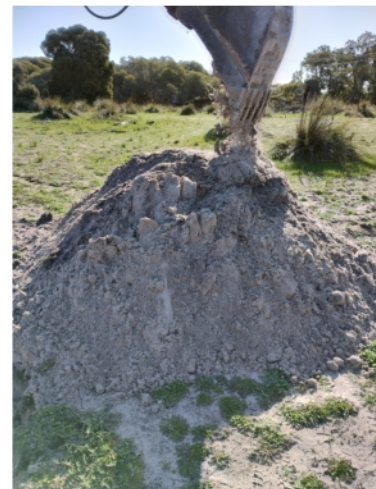
| CONDITIONS ENCOUNTERED | | | | | | | | | | | | | | SAMPLE | | | | TESTING AND REMARKS | | | |
|---|---|---|---|---|---|---|---|---|---|---|---|---|---|---|--|--|--|---|--|--|--|
| 26/08/25 No free groundwater observed | | 0.10 | TOPSOIL / SAND (SP) trace rootlets trace silt: grey; fine to medium. | | TOP | | | | | | | | | | | | | | | | |
| | | | SAND (SP) trace silt: pale grey; fine to medium. Bassendean Sand. | | | | | | | | | | | | | | | | | | |

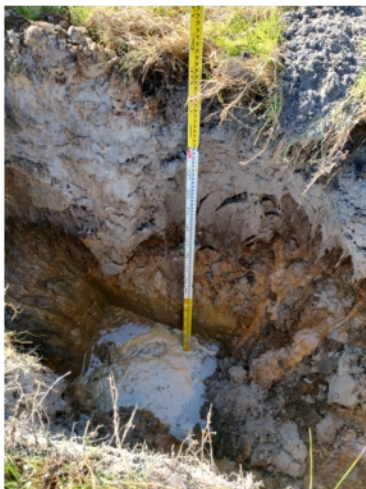
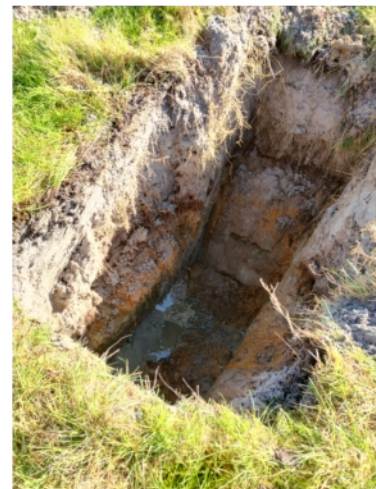
| CONDITIONS ENCOUNTERED | | | | | | SAMPLE | | | TESTING AND REMARKS | |
|---|---|---|---|---|---|---|---|---|---|---|
| | 2.20 | CLAY (CI) with sand: dark grey; medium plasticity. Guildford Formation. | | ALV | St | | w=PL | | | |
| | | Test Pit discontinued at 2.50m depth. (Target depth). | | | | | | | D | 2.50 |

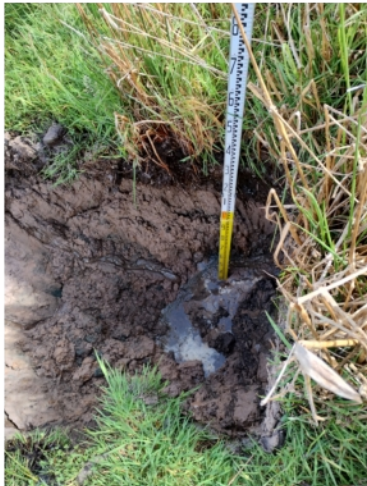
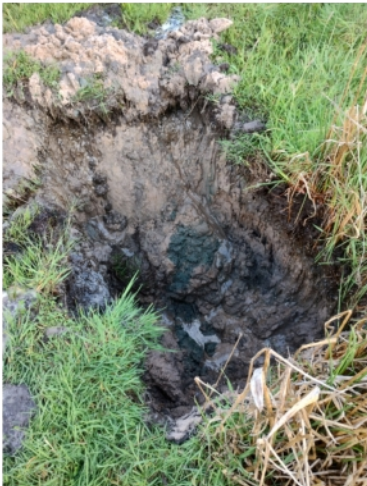
| CONDITIONS ENCOUNTERED | | | | | | | | | | | | | | SAMPLE | | | | TESTING AND REMARKS | | | |
|---|---|---|---|---|---|---|--|---|---|---|---|---|---|---|---|--|--|---|--|--|--|
| Groundwater observed at the surface<br>26/08/25 | 0.15 | 10 | TOPSOIL / SAND (SP-SM) with silt: dark grey; fine to medium. | | TOP | | | | W | | | | 0.50 | PSP/ISO | | | | | | | |
| | | | Test Pit discontinued at 1.50m depth. (Collapsing conditions). | | | | | | | | | | | | | | | | | | |

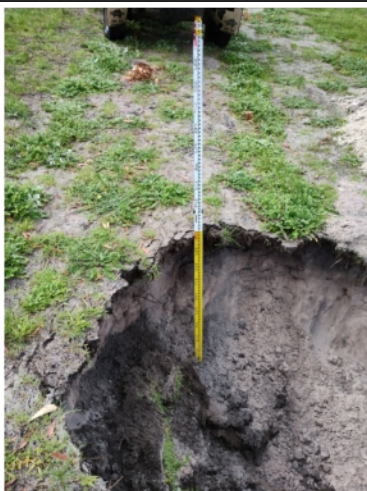
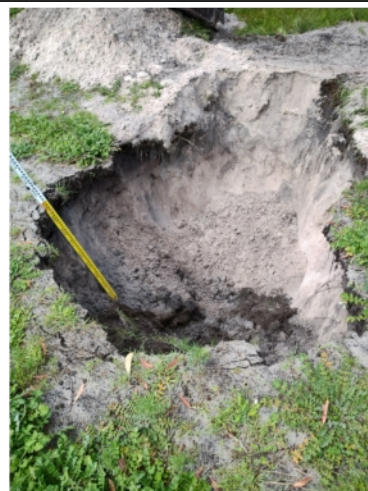
| CONDITIONS ENCOUNTERED | | | | | | | | | | SAMPLE | | | TESTING AND REMARKS | | |
|---|---|---|---|---|---|---|---|---|---|---|---|---|---|---|--|
| 26/08/25 No free groundwater observed | 12 | 0.10 | TOPSOIL / SAND (SP-SM) with silt trace rootlets: dark grey-brown; fine to medium.<br>SAND (SP) trace silt: pale grey; fine to medium.<br>Bassendean Sand. | | TOP | | | M | | | D | 1.00 | | | |
| Test Pit discontinued at 1.50m depth.<br>(Collapsing conditions). | | | | | | | | | | | | | | | |

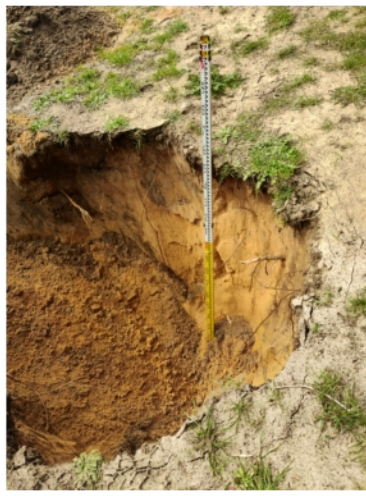
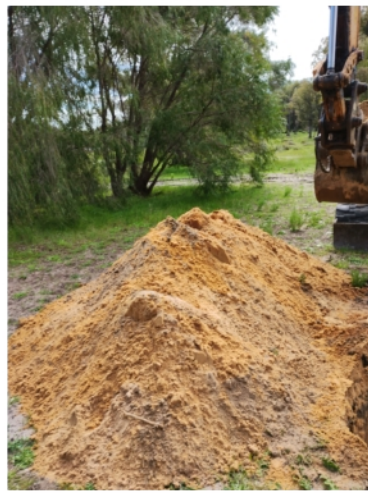
| CONDITIONS ENCOUNTERED | | | | | | | | | | | | | | SAMPLE | | | | TESTING AND REMARKS | | | |
|---|---|---|---|---|---|---|---|---|---|---|---|---|---|---|--|--|--|---|--|--|--|
| 26/08/25 No free groundwater observed | | 0.10 | TOPSOIL / SAND (SP) trace rootlets trace silt: grey-brown; fine to medium. | | TOP | | | | | D | | 0.10 | | | | | | | | | |
| h | | 2 | Test Pit discontinued at 1.50m depth. (Collapsing conditions). | | | | | | | | | | | | | | | | | | |

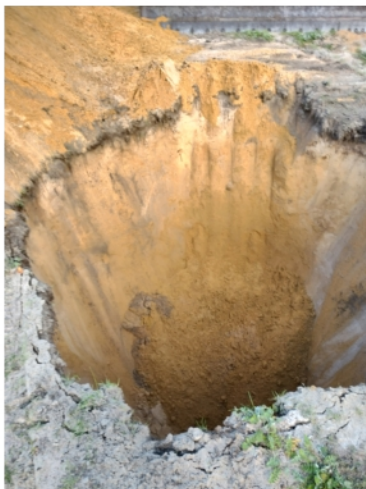
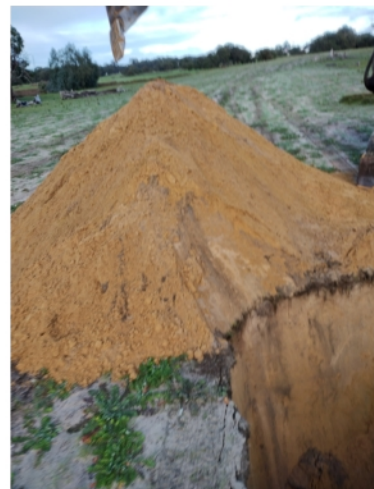
| CONDITIONS ENCOUNTERED | | | | | | | | | | | | | | SAMPLE | | | TESTING AND REMARKS | |
|---|---|---|---|---|---|---|---|---|---|---|---|---|---|---|--|--|---|--|
| 27/08/25 No free groundwater observed | 0.10 | TOPSOIL / SAND (SP) trace rootlets trace silt: grey-brown; fine to medium. | TS | TOP | | | | | D | | 0.10 | PSP/150 | <div><div></div><div>5</div><div>10</div><div>15</div></div> | | | | | |
| Test Pit discontinued at 2.50m depth. (Target depth). | | | | | | | | | | | | | | | | | | |

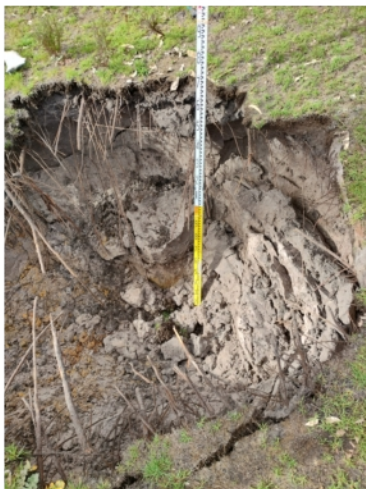
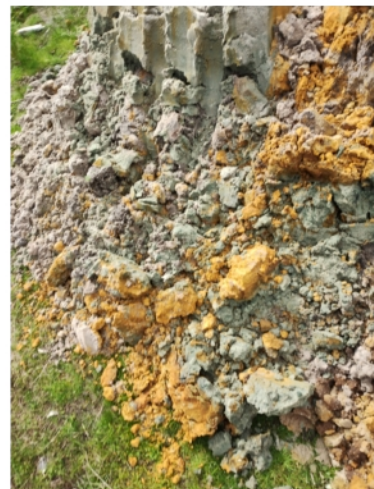
| CONDITIONS ENCOUNTERED | | | | | | | SAMPLE | | | TESTING AND REMARKS | | | |
|---|---|---|---|---|---|---|---|---|---|---|---|---|---|
| Groundwater observed at 0.5 m depth<br>27/08/25 | | 0.15 | TOPSOIL / SAND (SP-SM) with roots and rootlets with silt: dark grey-brown; fine to medium.<br>SAND (SP) trace silt: pale grey; fine to medium.<br>Bassendean Sand. | | TOP | | M to W | | | | | <br>PSP/150 | <br>PP 100kPa |
| | | 2.10 | SAND (SP-SM) with silt: blue-grey; fine to medium. Bassendean Sand. | | AEO | (MD) | W | | | | | | |
| | | | Test Pit discontinued at 2.50m depth. (Target depth). | | | | | | | | | 2.50 | |

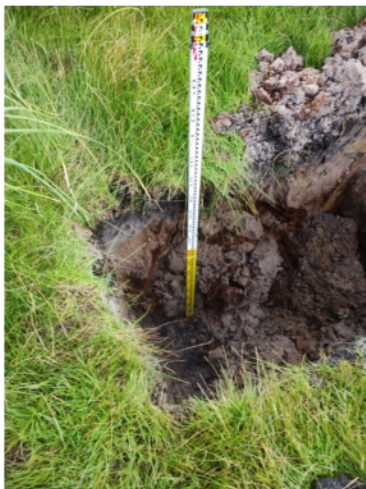
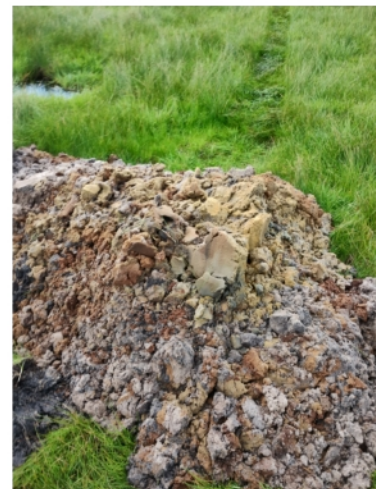
| GROUNDWATER | | CONDITIONS ENCOUNTERED | | | | | SAMPLE | | | TESTING AND REMARKS | | |
|---|---|---|---|---|---|---|---|---|---|---|---|---|
| Groundwater observed at 0.2 m depth<br>26/08/25 | 0.20 | TOPSOIL / SAND (SP-SM) with silt: dark grey; fine to medium; with rootlets. | | TOP | | M to W | | | | | | |
| | 1.50 | Clayey SAND (SC): blue-grey mottled yellow brown; fine to medium; low to medium plasticity clay. Guildford Formation. | | ALV | MD to D | | | | | | | |
| | 2 | Test Pit discontinued at 2.00m depth. (Collapsing conditions). | | | | | | | | | | Refusal 30 |

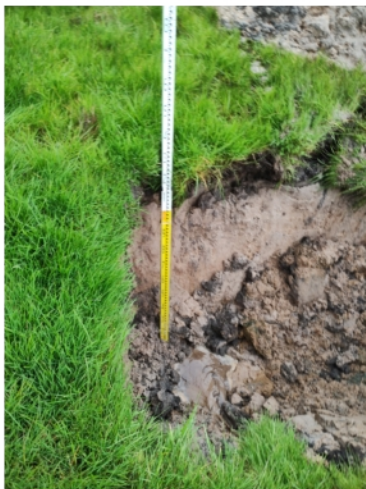
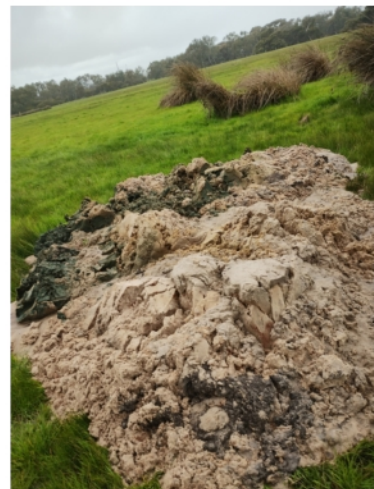
| CONDITIONS ENCOUNTERED | | | | | | | | | | | | | SAMPLE | | | TESTING AND REMARKS | | |
|---|---|---|---|---|---|---|---|---|---|---|---|---|---|---|---|---|---|---|
| Groundwater observed at the surface 26/08/25 | 10 | 0.15 | TOPSOIL / SAND (SP-SM) with silt trace rootlets: dark grey-brown; fine to medium. | | TOP | | | | | | | | | PSP/150 | | 5 | 10 | 15 |
| | 1.30 | | Clayey SAND (SC) with gravel: blue-grey mottled brown; fine to medium; low to medium plasticity clay. Guildford Formation. | | ALV | F to St | | w<PL | | | | 1.00 | | | | | | |
| | 1.50 | | Test Pit discontinued at 1.50m depth. (Collapsing conditions). | | | | | | | ASS/D | | 1.50 | PP | | 50-100kPa | | | |
