Appendix D **Geotechnical Report**

LOT 564 GARVEY ROAD

**GEOTECHNICAL
INVESTIGATION
CROOKED BROOK
WA**

June 2024
11207-G-R-002 Rev1

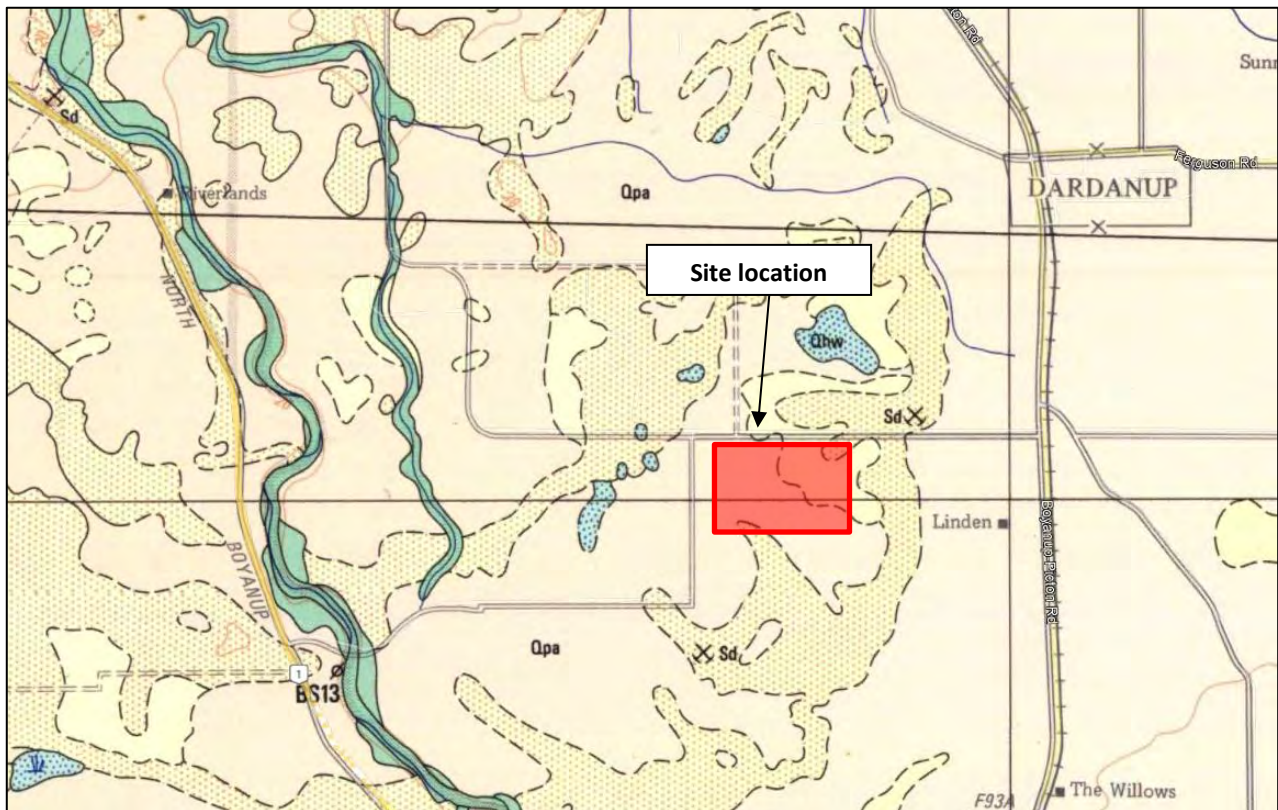
Figure 1: Extract from 1:50,000 Geological Map 'Bunbury'

- 'Q_{pa}'-Guildford Formation: Mainly alluvial sandy clay
- 'Q_{pb}'-Bassendean sand: Low rounded dunes. Isolated low dunes with loose sands.
- 'Q_{pb}/ Q_{pa}'- Thin Bassendean sand over Guildford formation

The Bassendean sand is represented by the ridge and had varying thickness of sand often overlaying with Guildford formation. The soils encountered during the investigation are generally consistent with the geological map ground profile.

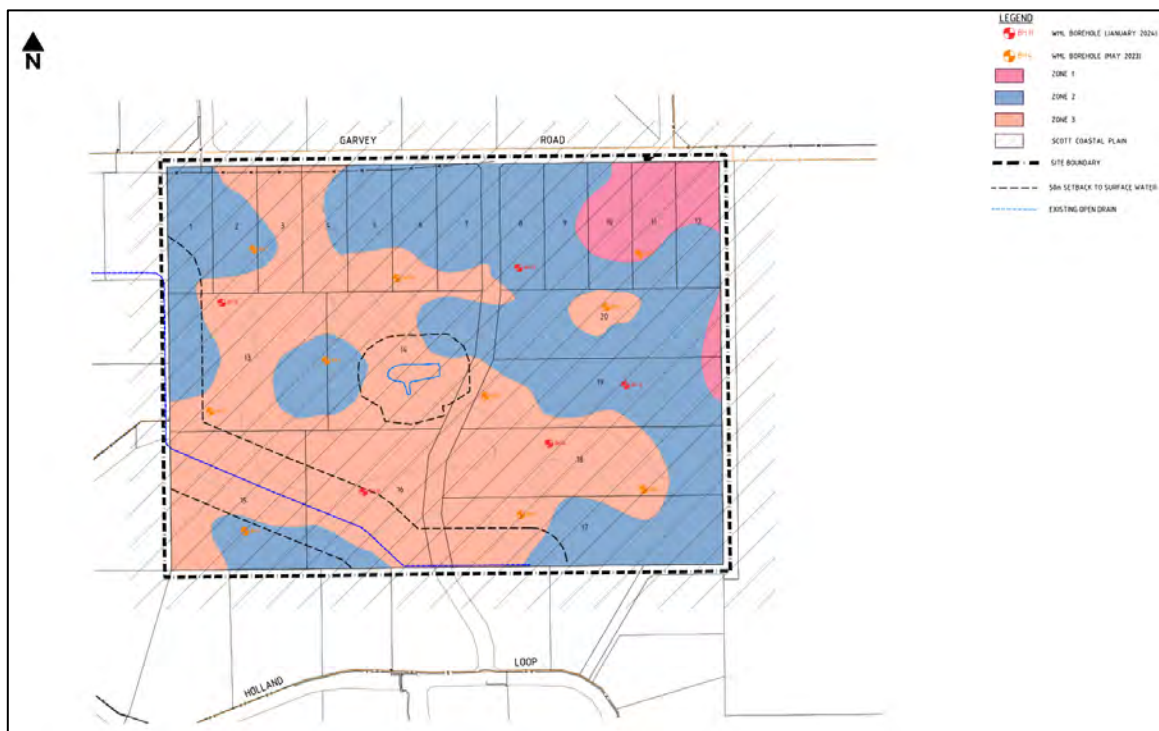
Figure 2: Soil profile zoning map

The subsurface profile is typically consistent across the site, with layer thickness variations due to the deposition history and natural topography of the site. Three subsurface profiles have been identified on-site with similar material compositions but varying sand thicknesses. The site has been divided into three subsurface profiles, denoted by Zones 1-3, with an excerpt from drawing 11207-G1-DG-002 B (attached in the Drawings) shown below. The encountered soil profiles for each zone are summarised below in Table 10, Table 11 and Table 12.

Several subsurface profiles have been identified on-site and are detailed in Table 10, Table 11 and Table 12. These profiles have been used to divide the Lot into three Zones (1, 2 and 3) based on the similarity of borehole profiles across the site. Areas have been defined based on investigation findings and site landform to develop preliminary site classifications and remedial works across the entire Lot. These areas are presented on a site map drawing, 10207-G1-DG-002, along with the location of borehole excavations. The geotechnical investigation identified that the majority of the site gets locally inundated during the wet seasons.

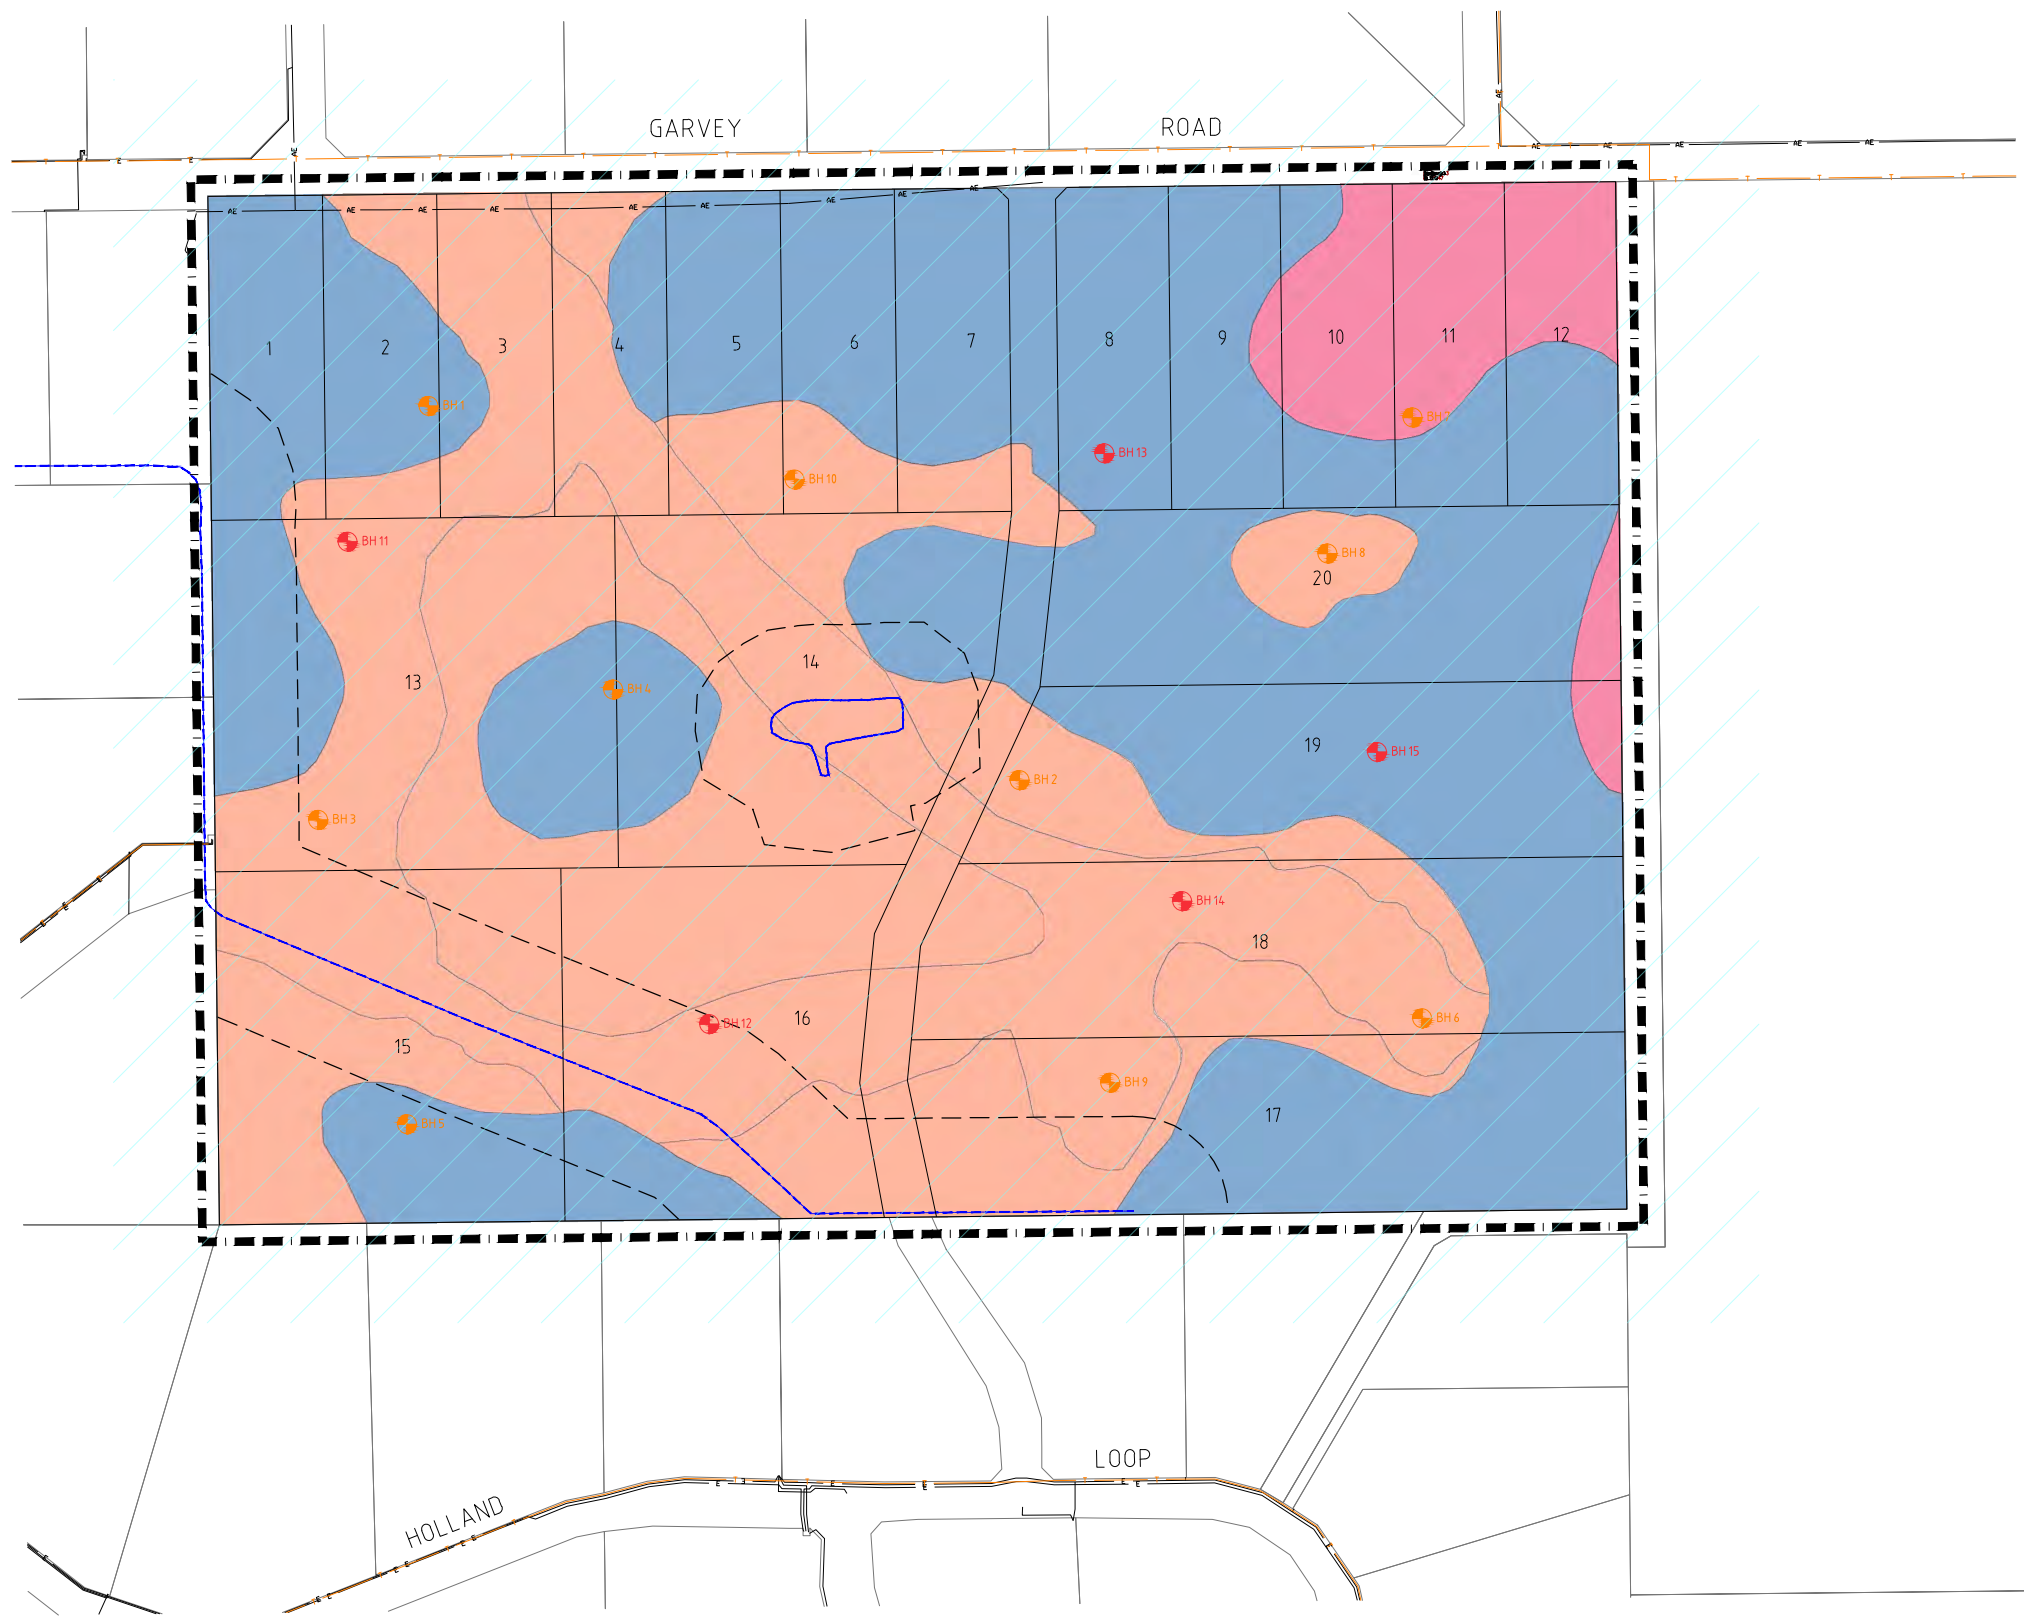
DRAWING NUMBER 11207-G1-DG-002
REVISION B

- BH 11 WML BOREHOLE (JANUARY 2024)
- BH 4 WML BOREHOLE (MAY 2023)
- ZONE 1
- ZONE 2
- ZONE 3
- SCOTT COASTAL PLAIN
- SITE BOUNDARY
- 50m SETBACK TO SURFACE WATER
- EXISTING OPEN DRAIN

The site investigation was undertaken in general accordance with Australian Standard AS 1726:2017 '*Geotechnical Site Investigations*'. A qualified geotechnical engineer from WML completed the fieldwork, logged the materials encountered in the boreholes, carried out in-situ testing, collected soil samples, and took record photographs. All boreholes were backfilled as close to the original conditions as possible. The approximate test locations are presented on the site map, 10207-G1-DG-002 B attached to the end of this report under the 'Drawings' Appendix.

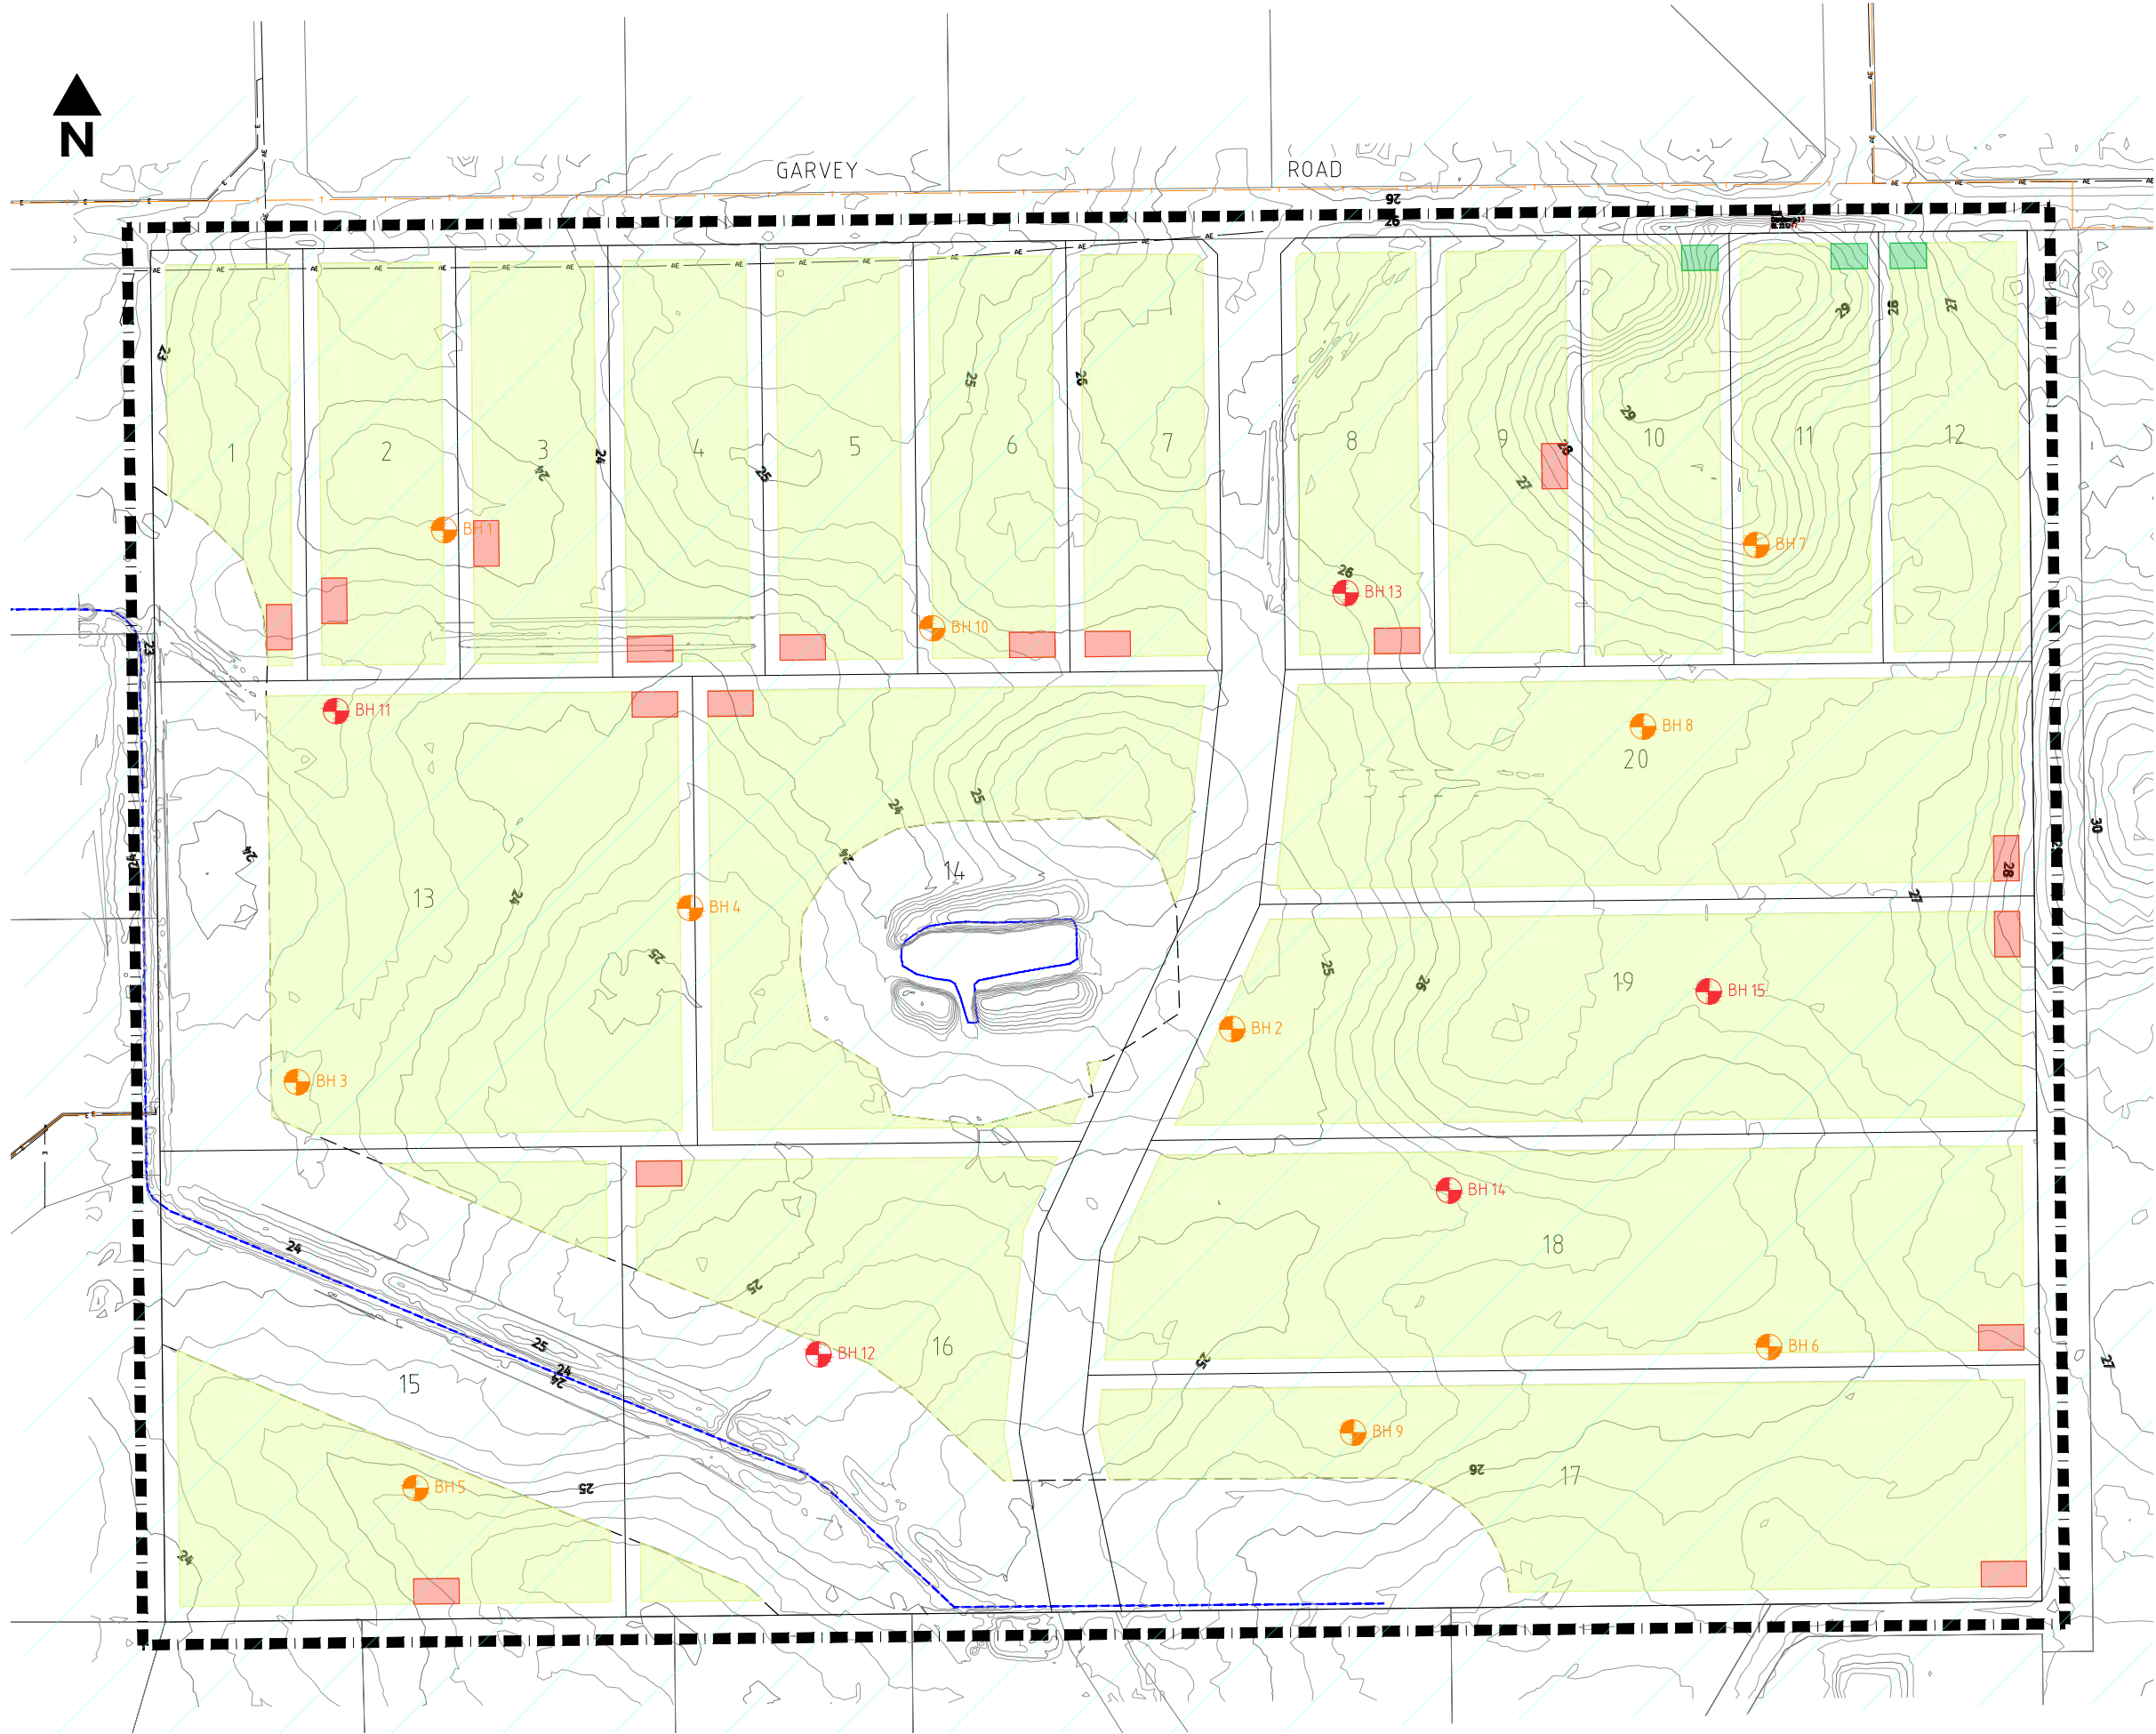
- LEGEND**
- BH 11 WML BOREHOLE (JANUARY 2024)
 - BH 4 WML BOREHOLE (MAY 2023)
 - 1 PREFERRED LAND APPLICATION AREA (144m²)
 - 2/3 PREFERRED LAND APPLICATION AREA (180m²)
 - LAND AVAILABLE FOR APPLICATION AREA
 - SCOTT COASTAL PLAIN SEWERAGE SENSITIVE AREA
 - 50m SETBACK TO SURFACE WATER
 - EXISTING OPEN DRAIN
 - SITE EXTENTS

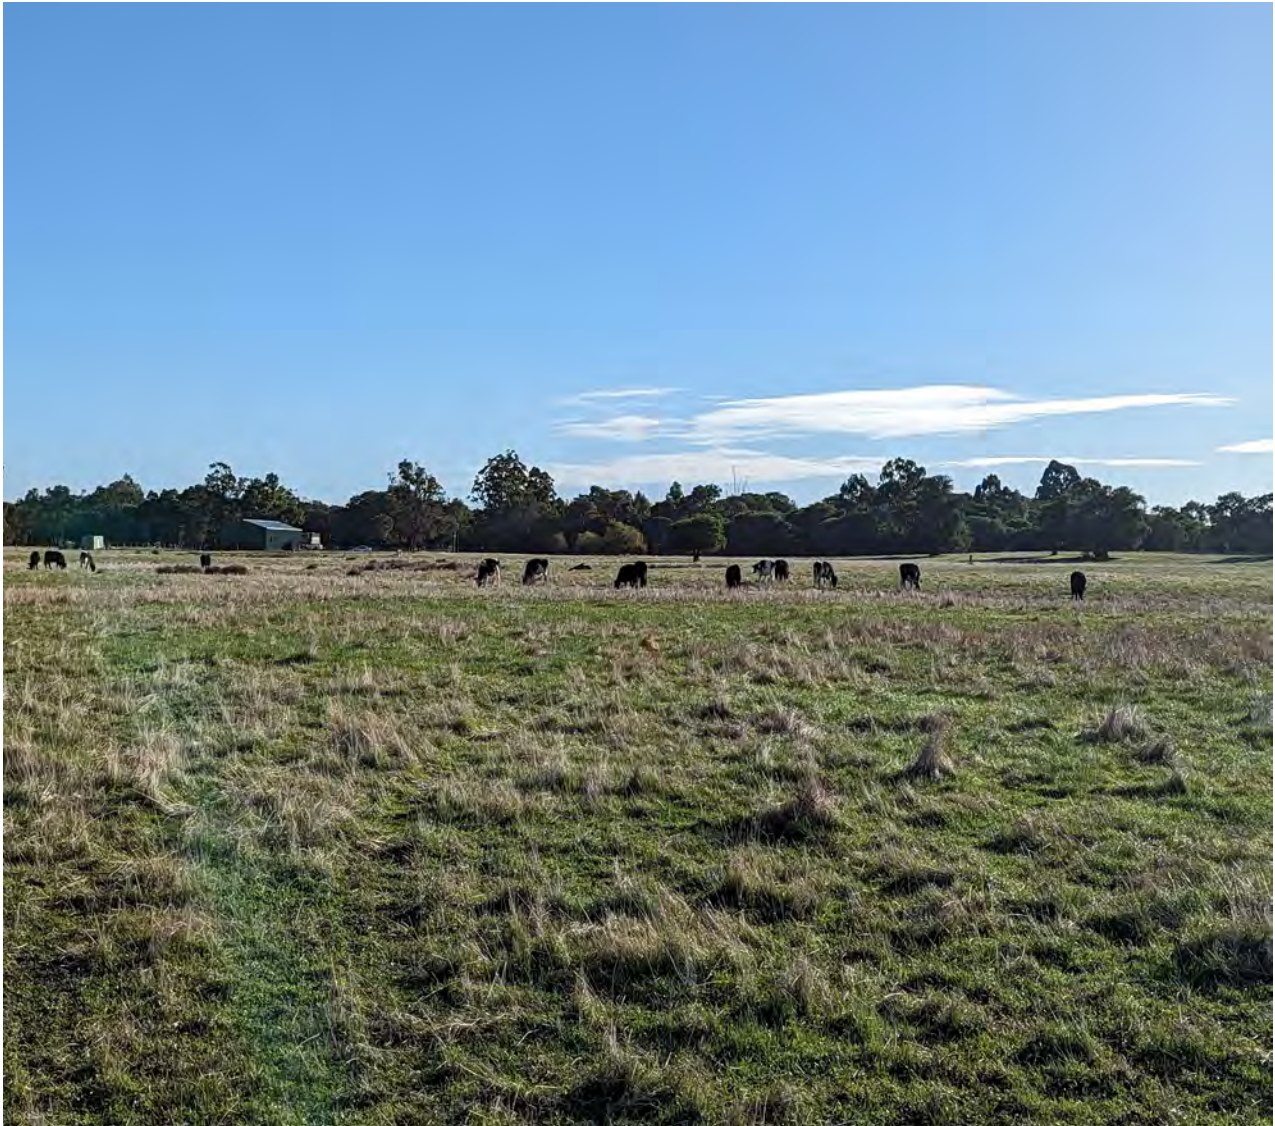
Photo 1: General view of site

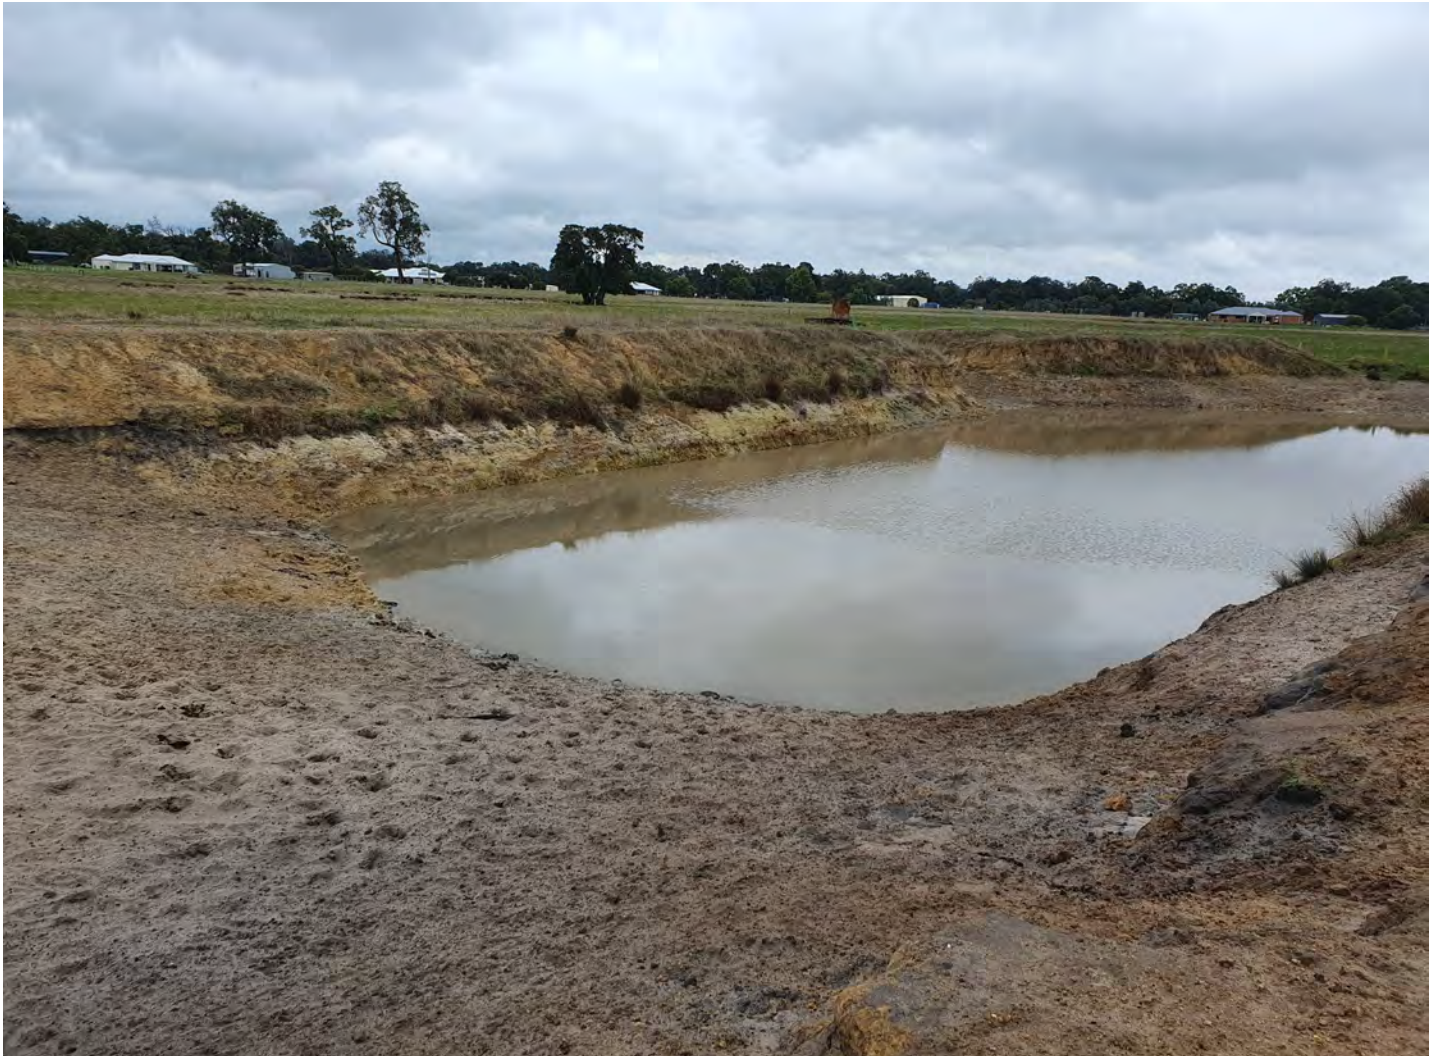
Photo 2: Dam observed at centre of site

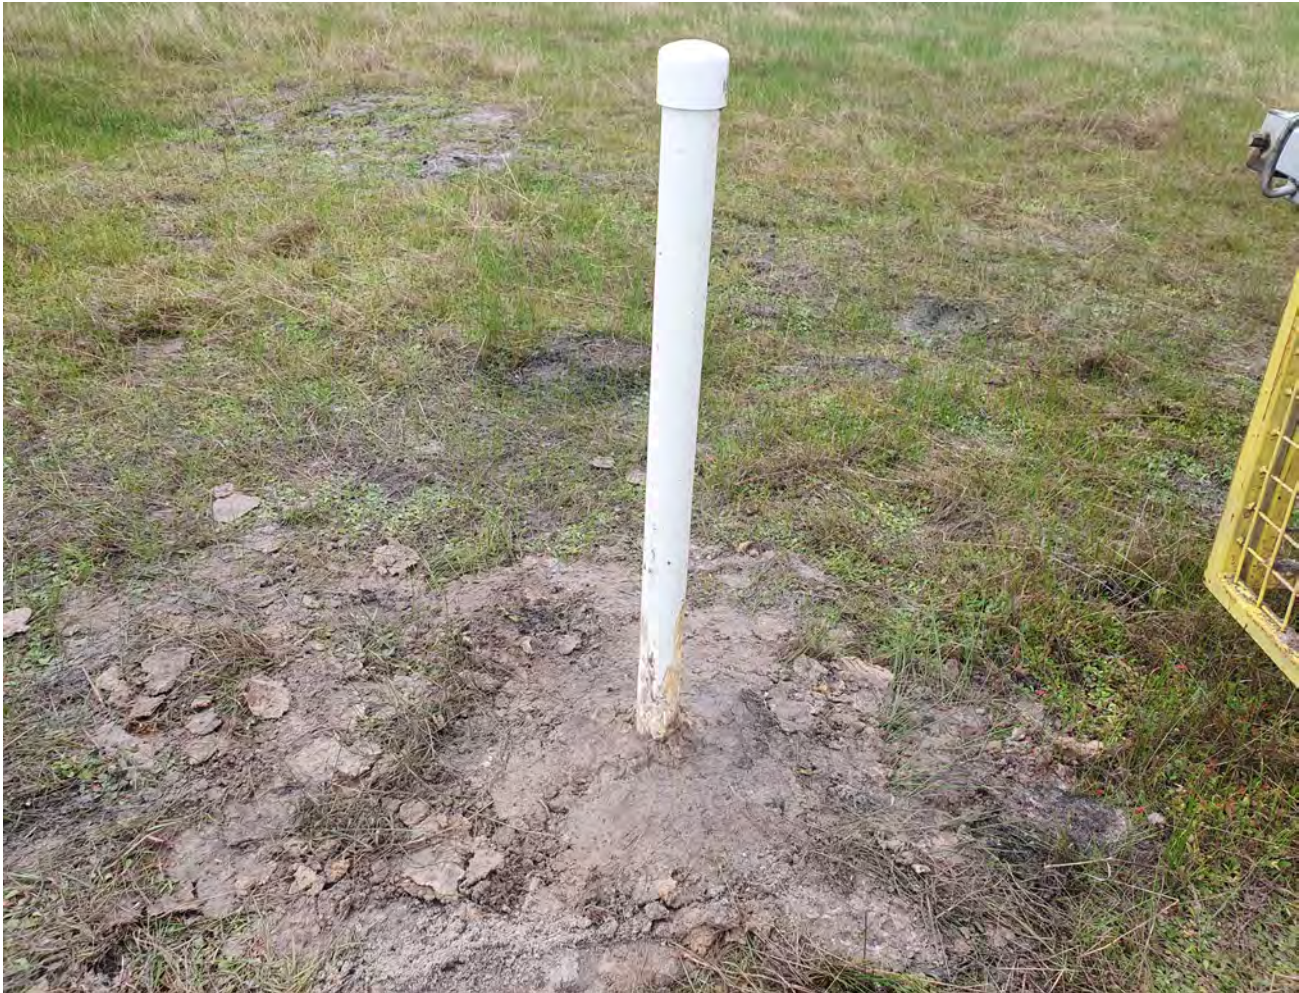
Photo 3: Typical groundwater monitoring well

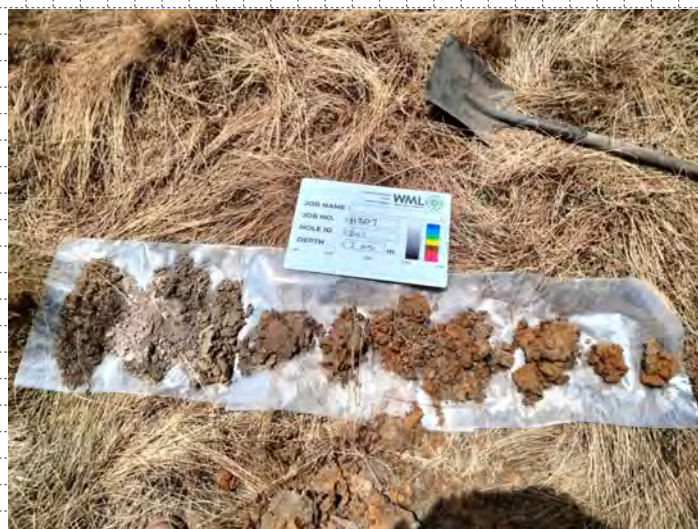
METHOD	WATER	DEPTH (m)	GRAPHIC LOG	USCS	SOIL/ROCK MATERIAL DESCRIPTION	MOISTURE CONDITION	CONSISTENCY/ DENSITY	IN-SITU TESTING	SAMPLE	DCP TEST
Solid flight auger		0.25		SM	TOPSOIL; Silty SAND (SM) : medium dense, brown, fine to medium grained, dry, with roots .	D	MD			
				SW	SAND (SW) : medium dense, medium plasticity clay, grey brown, fine to medium grained, with medium plasticity clay, dry.	D	MD		B:	
		0.75		CL	Sandy CLAY (CL) : soft to firm, low plasticity, yellow brown, fine to medium grained sand, dry.	D	S-F			
		1.25		CI	CLAY (CI) : firm, medium plasticity, yellow brown, with fine to medium grained sand, moist.	M	F		D:	
		2.2		CI	CLAY (CI) : hard, medium plasticity, yellow brown, trace fine to medium grained sand, moist, trace silt.	M	H			
		3			BH11 Terminated at 2.65m (Permeability test 133.5ml to 107ml @0.50m in 60secs)

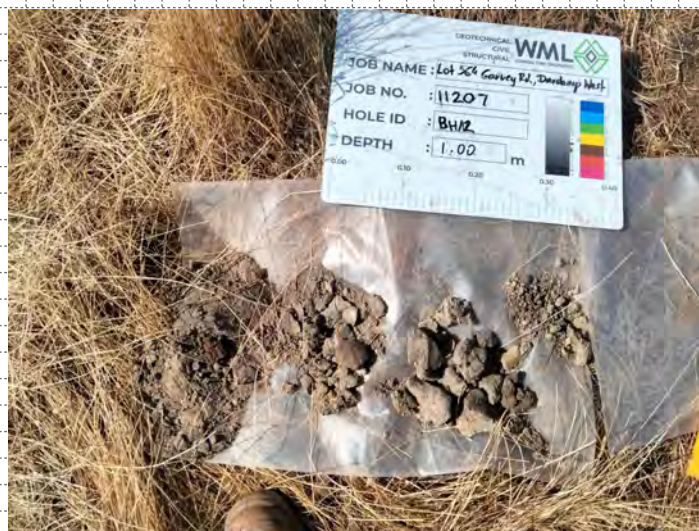
CL	Sandy CLAY (CL) : stiff, low plasticity, grey, fine to medium grained sand, inorganic, dry.	D	St		B:	
		1			BH12 refusal at 1m					
		2								
		3

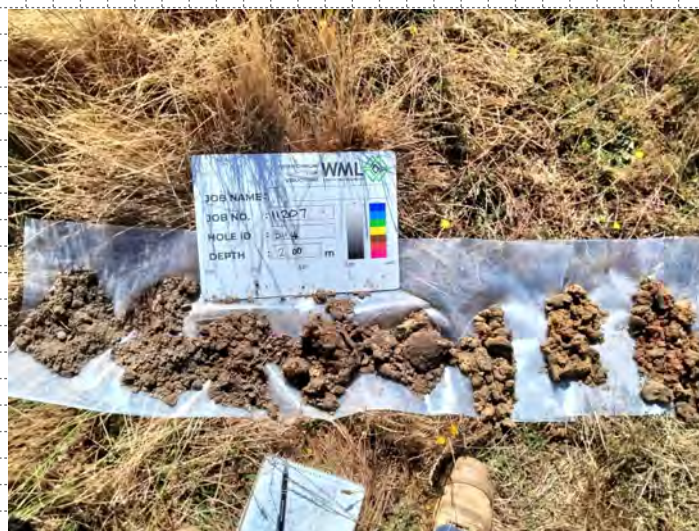
SM	Silty SAND (SM) : dense, brown, fine to medium grained, dry.	D	D		D:	
		0.75							B:	
		1		SC	Clayey SAND (SC) : dense, low plasticity clay, brown, fine to medium grained, dry.	D	D			
		1.25		CL	CLAY (CL) : stiff, low plasticity, orange brown, with fine to medium grained sand, inorganic, dry.	D	St			
		1.75		CL	CLAY (CL) : very stiff, low plasticity, red brown, with fine to medium grained sand, inorganic, dry.	D	VSt			
		2		BH14 refusal at 2m						
		3

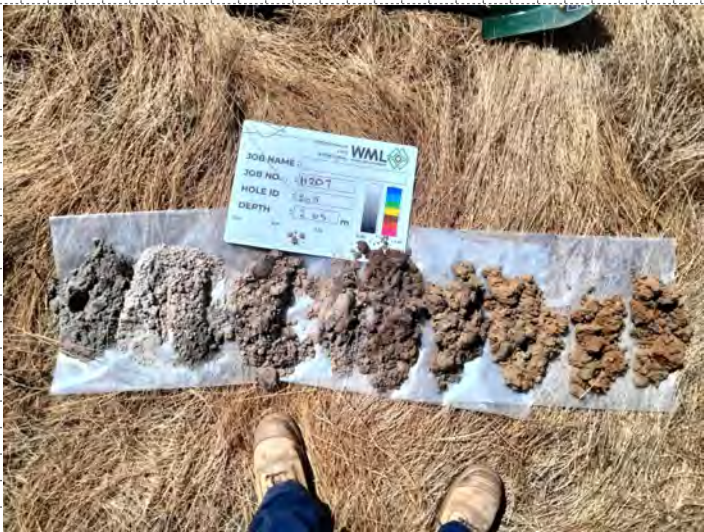
METHOD	WATER	DEPTH (m)	GRAPHIC LOG	USCS	SOIL/ROCK MATERIAL DESCRIPTION	MOISTURE CONDITION	CONSISTENCY/ DENSITY	IN-SITU TESTING	SAMPLE	DCP TEST
		0.25		SW	TOPSOIL; SAND (SW) : medium dense, grey brown, fine to medium grained, trace silt, trace roots, dry.	D	MD			
		1		SW	SAND (SW) : medium dense, grey, fine to medium grained, trace silt, dry.	D	MD			
		1.25		SW						
		1.75		SW	SAND (SW) : medium dense, brown, fine to medium grained, with silt, dry.	D	MD			
		2		CL	CLAY (CL) : stiff, low plasticity, brown, with fine to medium grained sand, inorganic, dry.	D	St			
		2.65		CL	Sandy CLAY (CL) : very stiff, low plasticity, orange brown, fine to medium grained sand, inorganic, dry.	D	VSt			
					BH15 Terminated at 2.65m

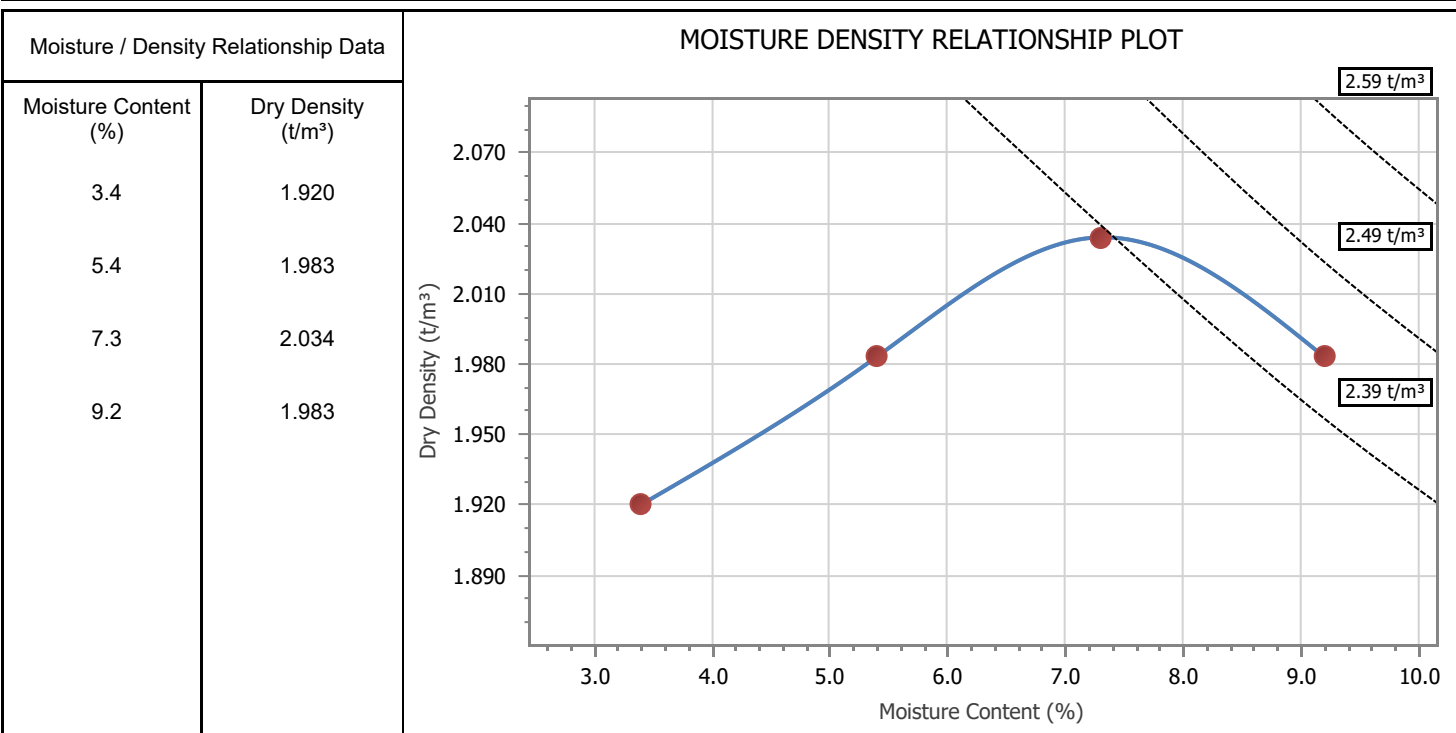
Test Procedures	WA133.1, WA110.1, WA115.2, WA105.1	Bore hole No	BH12
Sample Number	5022/S/112477	Depth	m 0.3
Sampling Method	Tested As Received		
Date Sampled	28/11/2023		
Sampled By	Client Sampled		
Date Tested	21/01/2024	Compactive Effort	Modified
Material Source	Borehole	Percent Retained 37.5mm (%)	0
Material Type		Percent Retained 19.0mm (%)	0
Liquid Limit Method	n/a	Total Curing Time (hrs)	71.8
Material Description	Brown SAND

Maximum Dry Density (t/m³):	2.034	Optimum Moisture Content (%):	7.3
---	--------------	--------------------------------------	------------

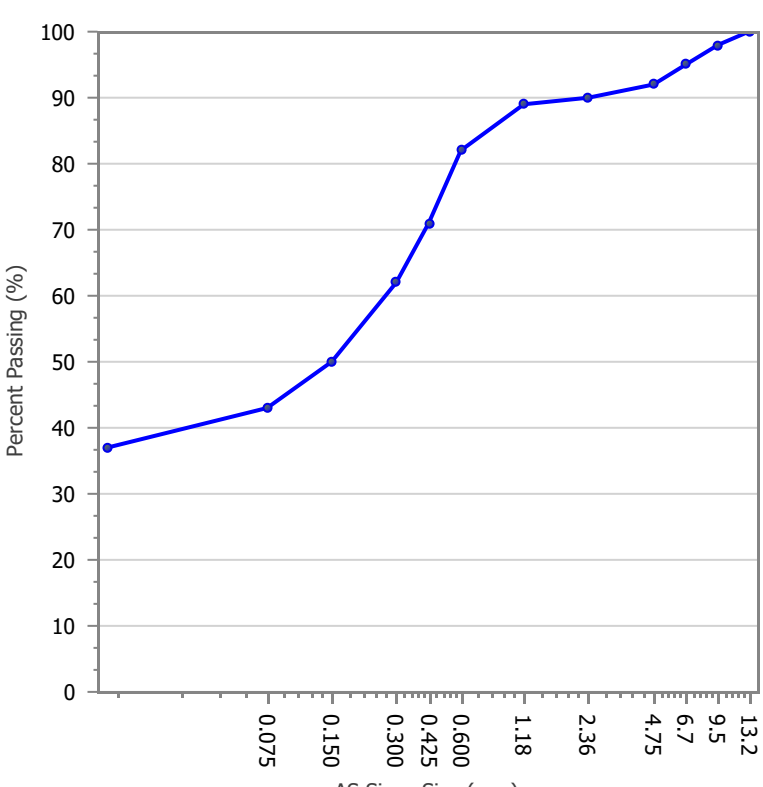
PARTICLE SIZE DISTRIBUTION GRAPH

AS Sieve (mm)	Specification Minimum (%)	Percent Passing (%)	Specification Maximum (%)
13.2		100	
9.5		98	
6.7		95	
4.75		92	
2.36		90	
1.18		89	
0.600		82	
0.425		71	
0.300		62	
0.150		50	
0.075		43	
0.0135		37

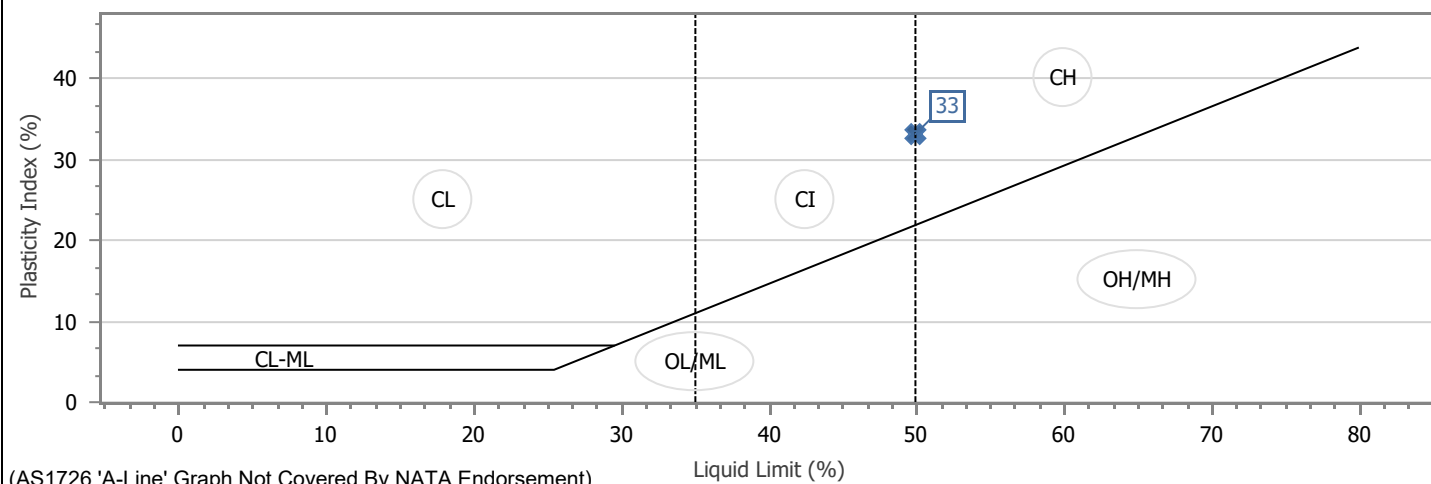
Atterberg Limits 'A-Line' Graph

Atterberg Limit	Specification Minimum	Test Result	Specification Maximum
Liquid Limit (%)		50	
Plastic Limit (%)		17	
Plasticity Index (%)		33	
Linear Shrinkage (%)		12.0	
Linear Shrinkage Observations:	-

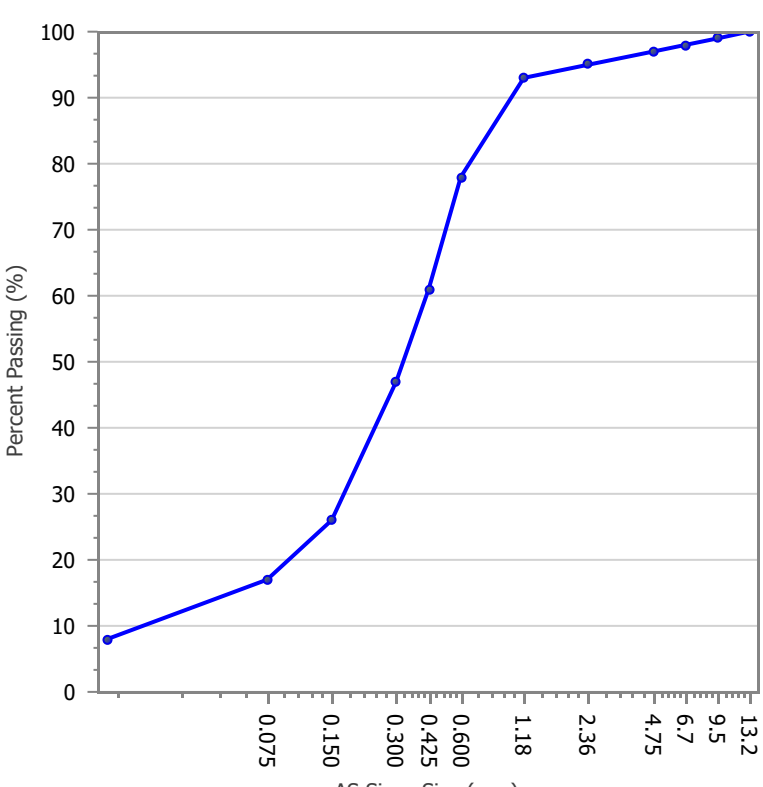
PARTICLE SIZE DISTRIBUTION GRAPH

AS Sieve (mm)	Specification Minimum (%)	Percent Passing (%)	Specification Maximum (%)
13.2		100	
9.5		99	
6.7		98	
4.75		97	
2.36		95	
1.18		93	
0.600		78	
0.425		61	
0.300		47	
0.150		26	
0.075		17	
0.0135		8

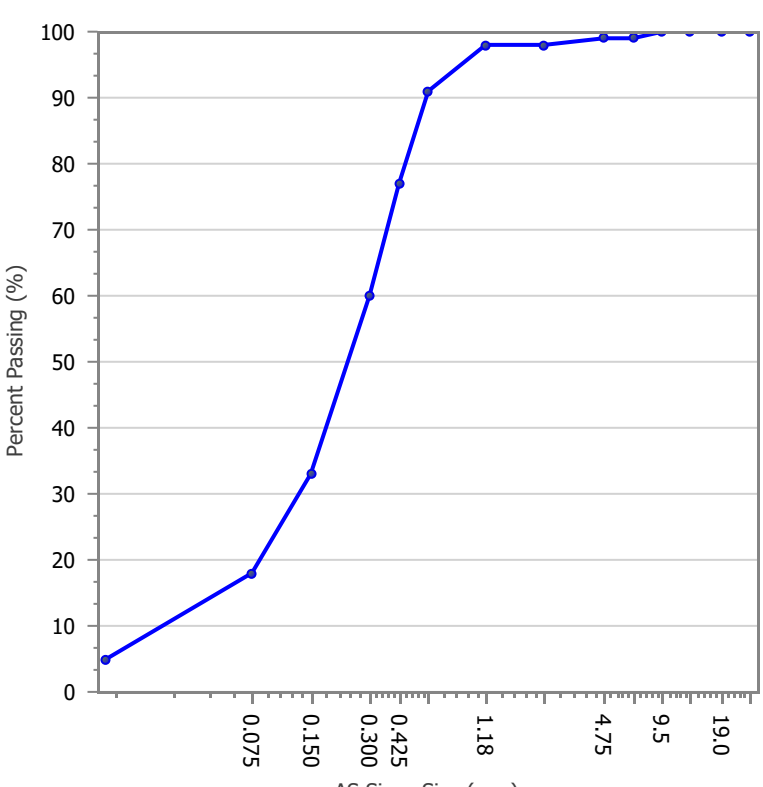
PARTICLE SIZE DISTRIBUTION GRAPH

AS Sieve (mm)	Specification Minimum (%)	Percent Passing (%)	Specification Maximum (%)
26.5		100	
19.0		100	
13.2		100	
9.5		100	
6.7		99	
4.75		99	
2.36		98	
1.18		98	
0.600		91	
0.425		77	
0.300		60	
0.150		33	
0.075		18	
0.0135		5

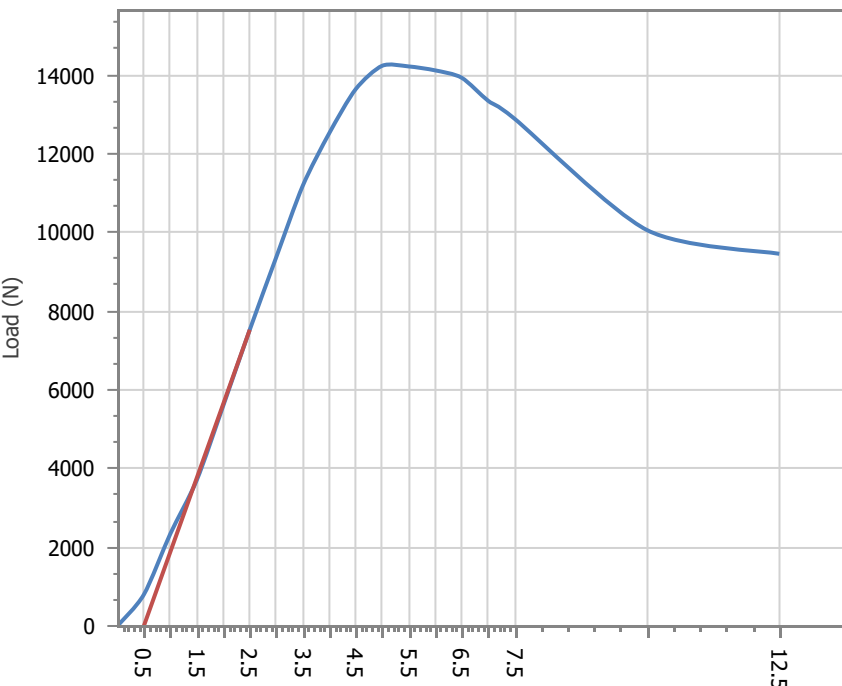
Maximum Dry Density (t/m³):	2.034	<div> CBR PENETRATION PLOT

</div>
Optimum Moisture Content (%):	7.3	
Field Moisture Content (%):	2.5	
Sample Percent Oversize (%):	0.0	
Oversize Included / Excluded	Excluded	
Target Density Ratio (%):	95	
Target Moisture Ratio (%):	100	
Placement Dry Density (t/m³):	1.937	
Placement Dry Density Ratio (%):	95.2	
Placement Moisture Content (%):	7.1	
Placement Moisture Ratio (%):	97.3	
Test Condition / Soaking Period:	Soaked / 4 Days	
CBR Surcharge (kg)	9.0	
Dry Density Ratio After Soak (%)	95.4	
Moisture / Ratio After Soak (% / t/m³)	10.5 / 144.0	
Moisture (top 30mm) After Pen (%):	10.8	
Mst Ratio (top 30mm) After Pen (%)	148.0	
Moisture (remainder) After Pen (%):	9.9	
Mst Ratio (remainder) After Pen (%)	135.5	
CBR Swell (%):	0.0	
Minimum CBR Specification (%):	-	
CBR Value @ 2.5mm (%):	70

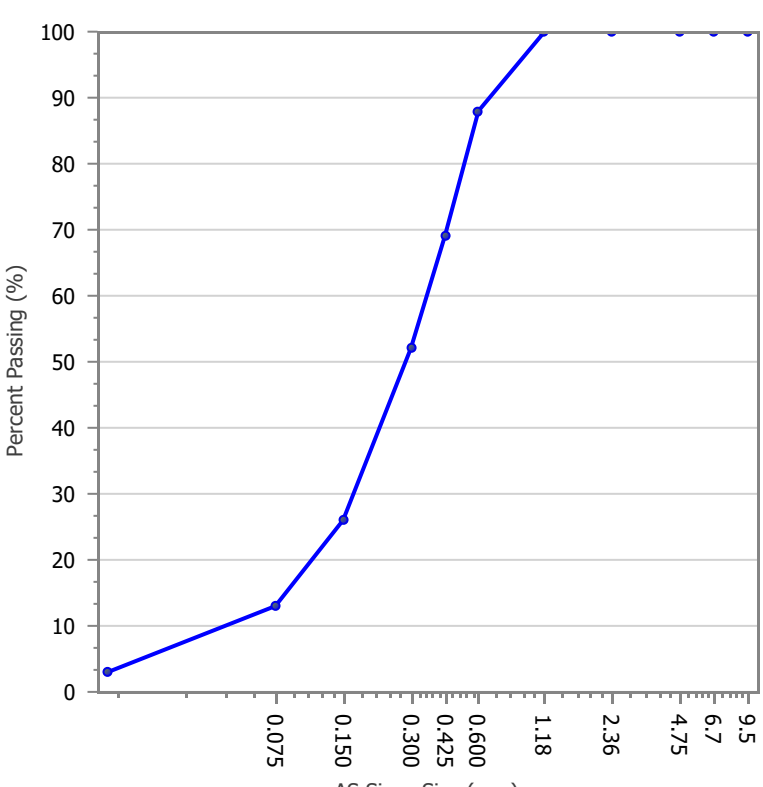
PARTICLE SIZE DISTRIBUTION GRAPH

AS Sieve (mm)	Specification Minimum (%)	Percent Passing (%)	Specification Maximum (%)
9.5		100	
6.7		100	
4.75		100	
2.36		100	
1.18		100	
0.600		88	
0.425		69	
0.300		52	
0.150		26	
0.075		13	
0.0135		3
