ORDINARY COUNCIL MEETING

Wednesday, 22nd of March 2023

STRUCTURAL BUILDING INSPECTION REPORT

FERGUSON HALL

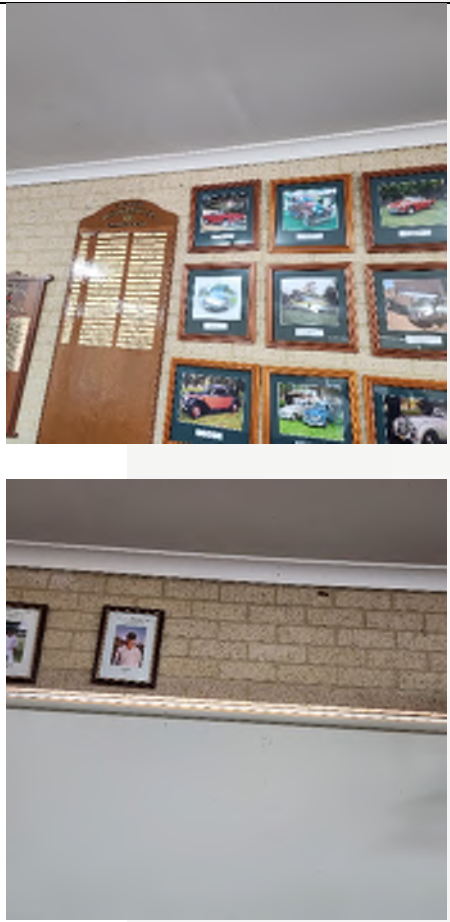
<p>Internal wall finishes: This is a minor defect. With passage of time and age of building, the cornices can deteriorate, crack split and presents gap between the walls. This is a non-structural issue.</p>	<p>Cosmetic Repairs needed.</p>

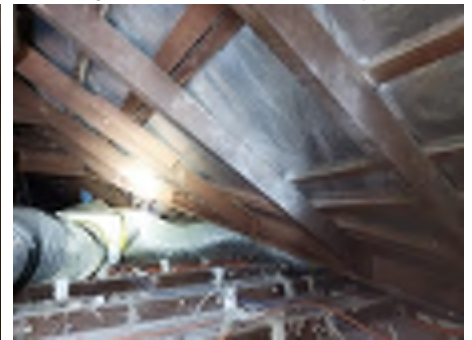
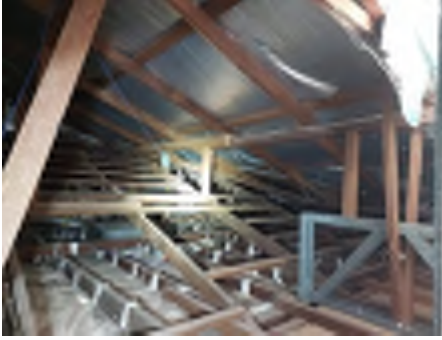
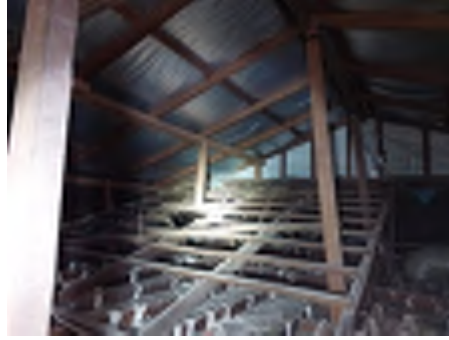
Showing example of framing and low clearance in the roof space

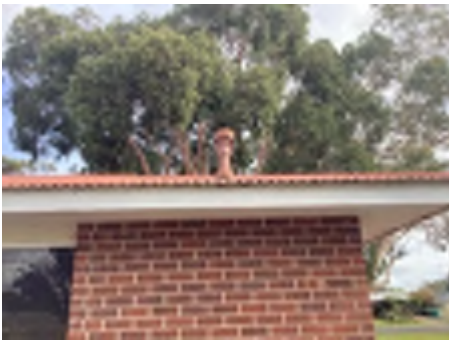
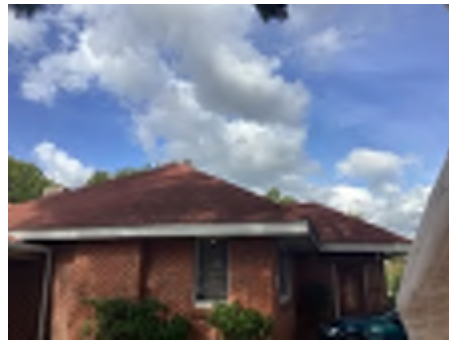
Showing no access to roof exterior due to height restrictions

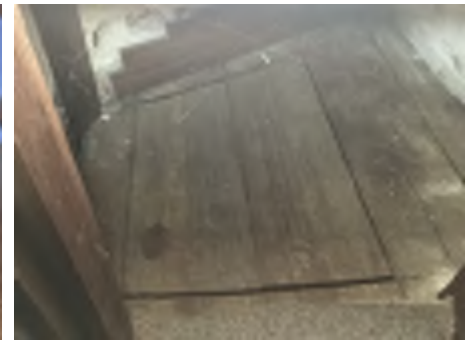
Showing examples of subfloor hatches found

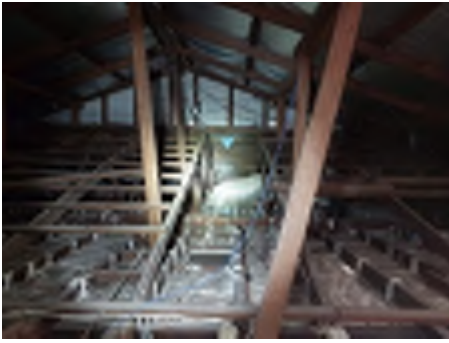
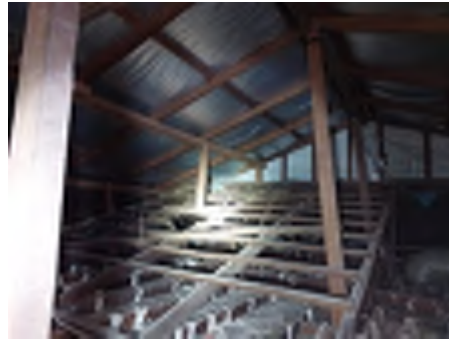
Showing examples of obstructions to roof space areas

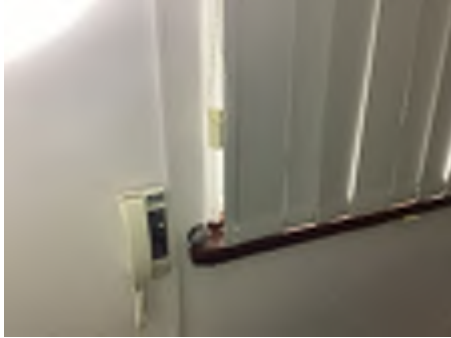
Showing examples of window furnishing cords

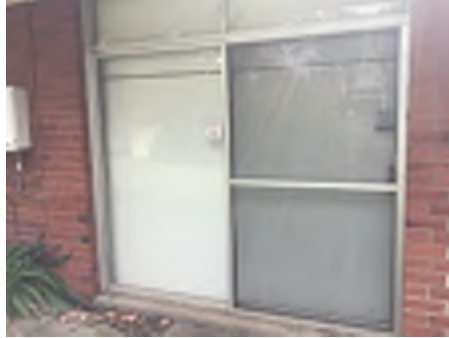
Showing examples of door and/or window glazing panels

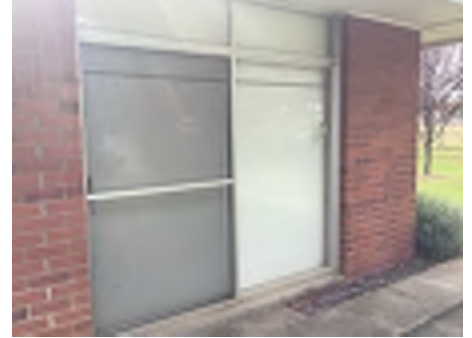
Showing examples of door and/or window glazing panels

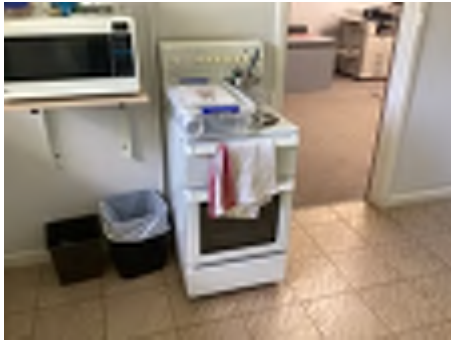
Showing oven

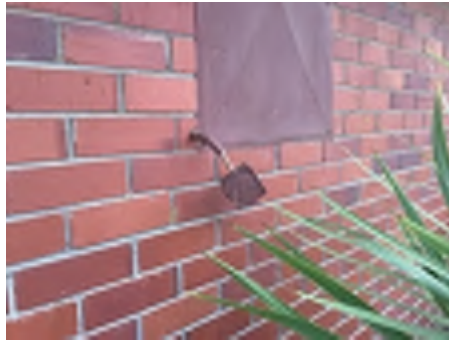
Showing examples of wires

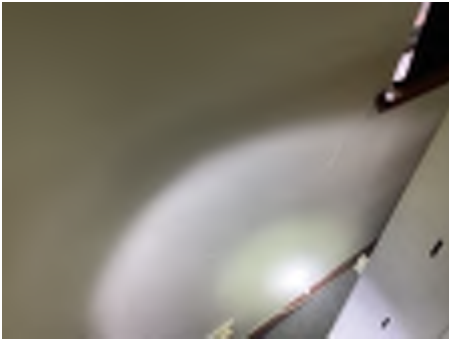
Cracking observed to parts of the internal walls. Recommend a structural engineer be engaged to inspect and provide appropriate advice and recommendations to reduce the risk of further deterioration to the building.

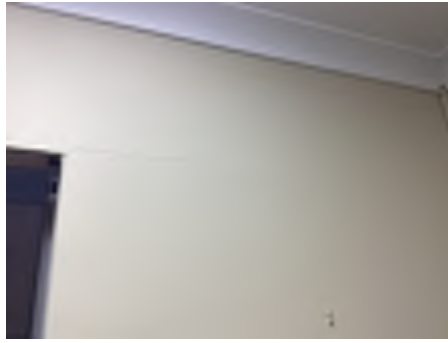
Cracking observed to parts of the internal walls. Recommend a structural engineer be engaged to inspect and provide appropriate advice and recommendations to reduce the risk of further deterioration to the building.

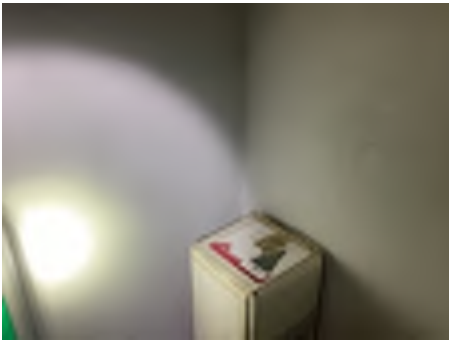
Cracking observed to parts of the internal walls. Recommend a structural engineer be engaged to inspect and provide appropriate advice and recommendations to reduce the risk of further deterioration to the building.

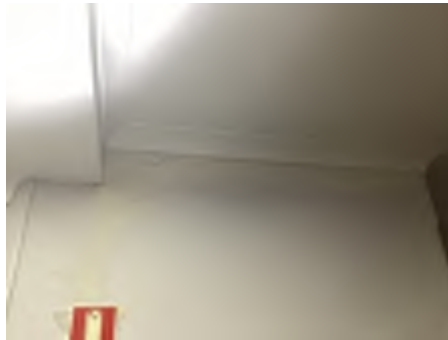
Cracking observed to parts of the internal walls. Recommend a structural engineer be engaged to inspect and provide appropriate advice and recommendations to reduce the risk of further deterioration to the building.

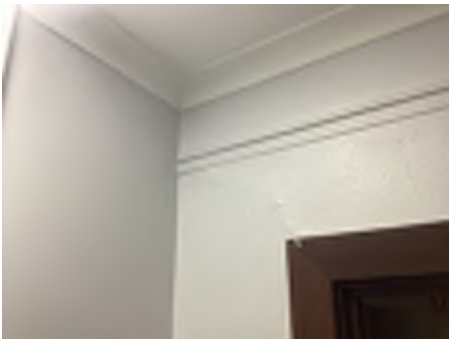
Cracking observed to parts of the internal walls. Recommend a structural engineer be engaged to inspect and provide appropriate advice and recommendations to reduce the risk of further deterioration to the building.

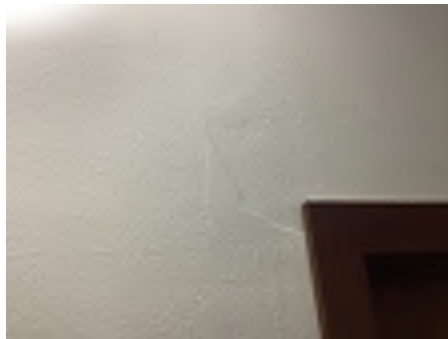
Cracking observed to parts of the internal walls. Recommend a structural engineer be engaged to inspect and provide appropriate advice and recommendations to reduce the risk of further deterioration to the building.

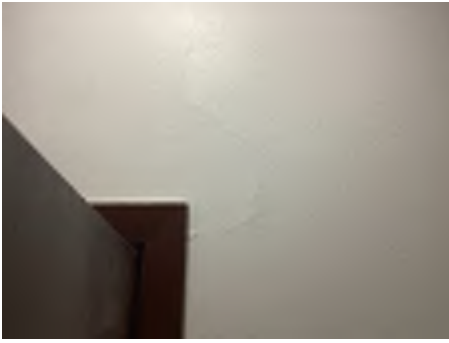
Cracking observed to parts of the internal walls. Recommend a structural engineer be engaged to inspect and provide appropriate advice and recommendations to reduce the risk of further deterioration to the building.

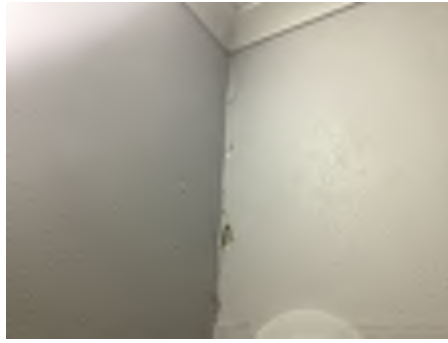
Cracking observed to parts of the internal walls. Recommend a structural engineer be engaged to inspect and provide appropriate advice and recommendations to reduce the risk of further deterioration to the building.

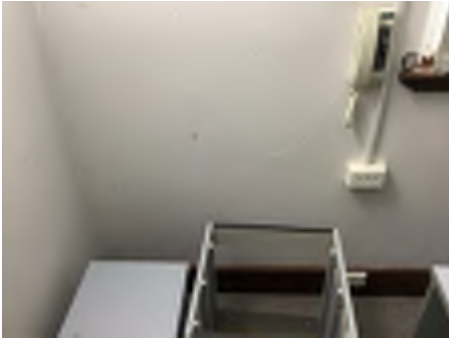
Cracking observed to parts of the internal walls. Recommend a structural engineer be engaged to inspect and provide appropriate advice and recommendations to reduce the risk of further deterioration to the building.

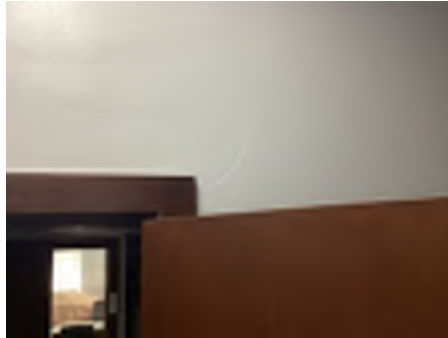
Cracking observed to parts of the internal walls. Recommend a structural engineer be engaged to inspect and provide appropriate advice and recommendations to reduce the risk of further deterioration to the building.

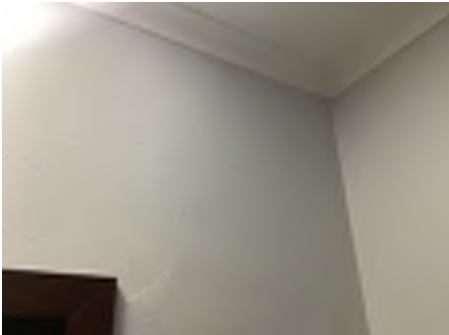
Cracking observed to parts of the internal walls. Recommend a structural engineer be engaged to inspect and provide appropriate advice and recommendations to reduce the risk of further deterioration to the building.

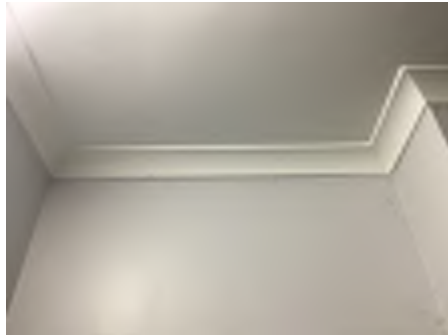
Cracking observed to parts of the internal walls. Recommend a structural engineer be engaged to inspect and provide appropriate advice and recommendations to reduce the risk of further deterioration to the building.

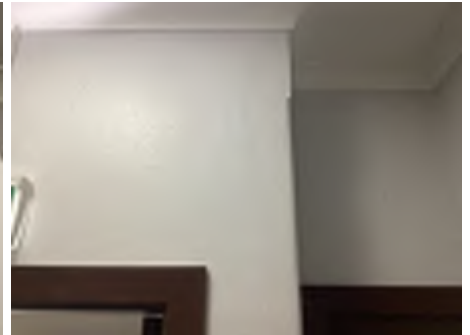
Cracking observed to parts of the internal walls. Recommend a structural engineer be engaged to inspect and provide appropriate advice and recommendations to reduce the risk of further deterioration to the building.

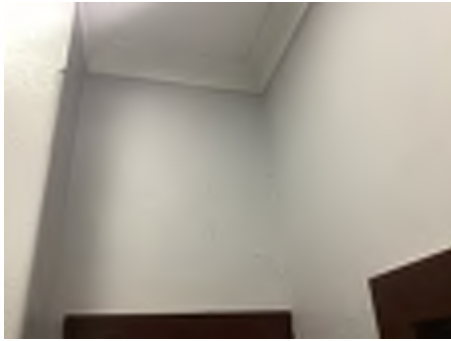
Cracking observed to parts of the internal walls. Recommend a structural engineer be engaged to inspect and provide appropriate advice and recommendations to reduce the risk of further deterioration to the building.

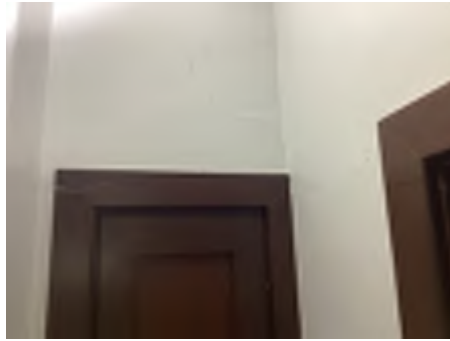
Cracking observed to parts of the internal walls. Recommend a structural engineer be engaged to inspect and provide appropriate advice and recommendations to reduce the risk of further deterioration to the building.

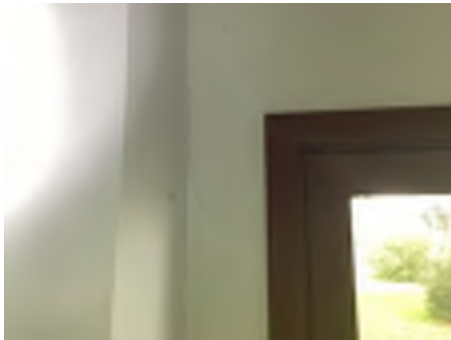
Cracking observed to parts of the internal walls. Recommend a structural engineer be engaged to inspect and provide appropriate advice and recommendations to reduce the risk of further deterioration to the building.

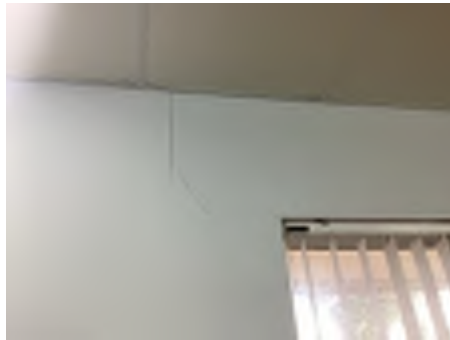
Cracking observed to parts of the internal walls. Recommend a structural engineer be engaged to inspect and provide appropriate advice and recommendations to reduce the risk of further deterioration to the building.

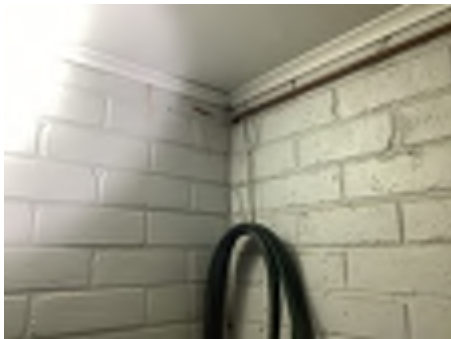
Cracking observed to parts of the internal walls. Recommend a structural engineer be engaged to inspect and provide appropriate advice and recommendations to reduce the risk of further deterioration to the building.

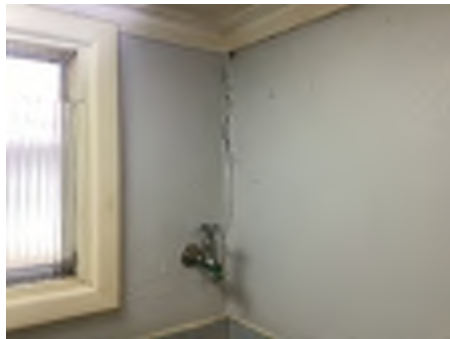
Cracking observed to parts of the internal walls. Recommend a structural engineer be engaged to inspect and provide appropriate advice and recommendations to reduce the risk of further deterioration to the building.

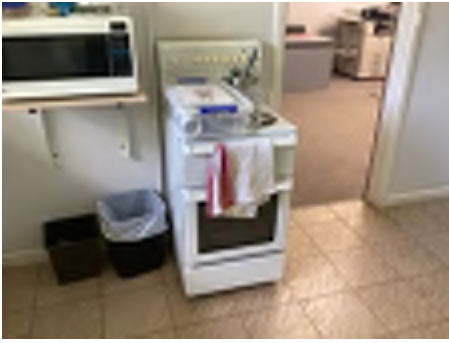
Safety issue only (non structural). It is a requirement of the inspection standard to report observed safety issues within the main body of the report. The freestanding oven is not visibly secured with an anti tilt chain or bracket - recommend engaging an appliance installer to repair to reduce the risk of damage and personal injury.

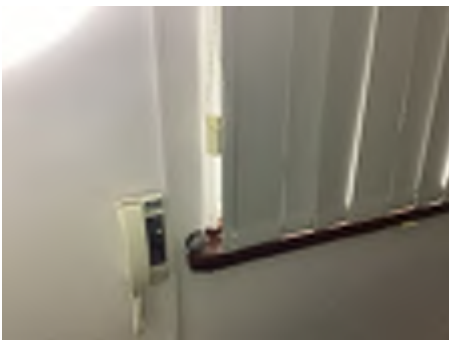
Safety issue only (non structural). It is a requirement of the inspection standard to report observed safety issues within the main body of the report. Cords to the window furnishings are not secured with a closed loop in the cords - recommend securing or repairing to reduce the risk of personal injury.

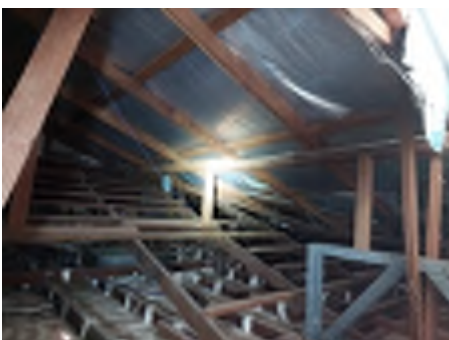
Some underpurlins and roof timber where the extension overrides the original roof are not supported at the end. Recommend engaging a builder to repair to reduce the risk of movement and damage.

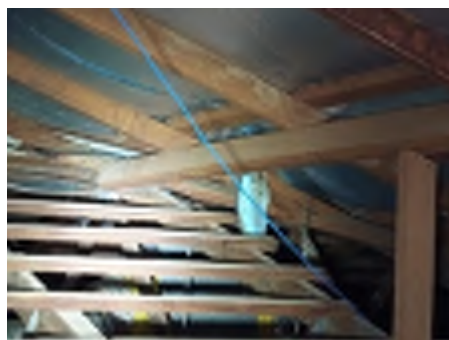
Some underpurlins and roof timber where the extension overrides the original roof are not supported at the end. Recommend engaging a builder to repair to reduce the risk of movement and damage.

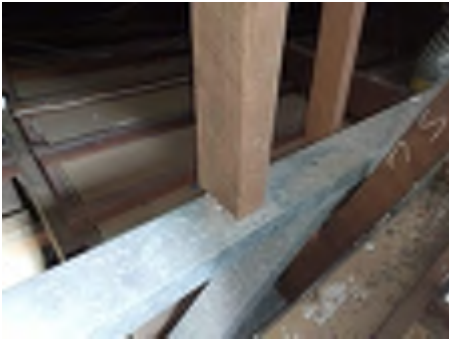
Angled bracing to beams to prevent rotation or movement is not observed to all areas. Recommend engaging a builder to repair to reduce the risk of movement and damage.

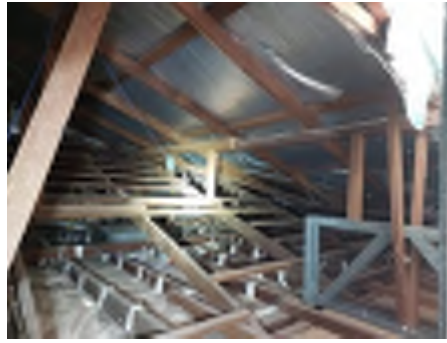
Timber struts bearing onto metal truss beams have no visual fasteners to the beams in some locations. Recommend engaging an engineer to investigate and a builder to repair to reduce the risk of movement and damage.

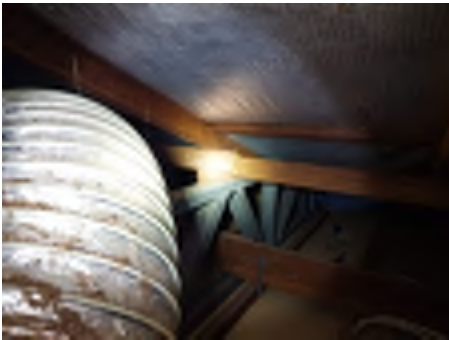
Timber struts bearing onto metal truss beams have no visual fasteners to the beams in some locations. Recommend engaging an engineer to investigate and a builder to repair to reduce the risk of movement and damage.

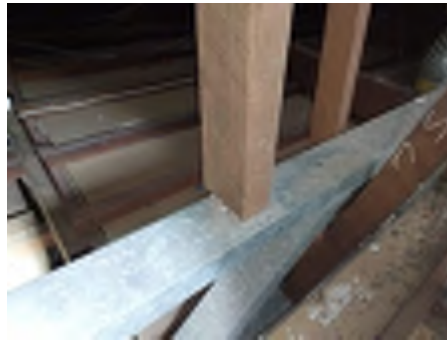
Timber struts bearing onto metal truss beams have no visual fasteners to the beams in some locations. Recommend engaging an engineer to investigate and a builder to repair to reduce the risk of movement and damage.

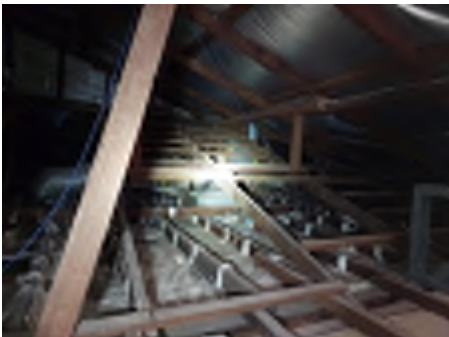
Some of the extension roofing members are propped onto the original roof structure with no additional support observed under the support load point. Recommend engaging an engineer to investigate and a builder to repair to reduce the risk of movement and damage.

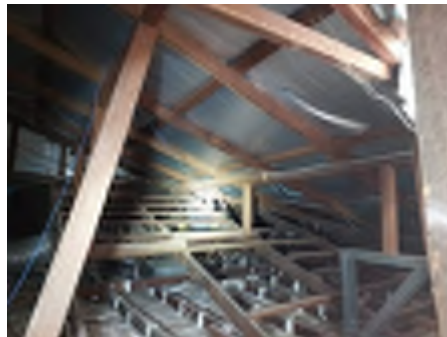
Some of the extension roofing members are propped onto the original roof structure with no additional support observed under the support load point. Recommend engaging an engineer to investigate and a builder to repair to reduce the risk of movement and damage.

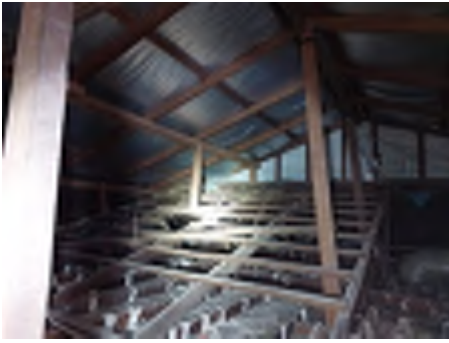
Some of the extension roofing members are propped onto the original roof structure with no additional support observed under the support load point. Recommend engaging an engineer to investigate and a builder to repair to reduce the risk of movement and damage.

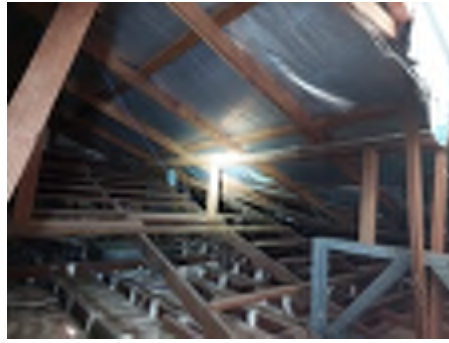
Spans to underpurlins are greater than typically allowed in several areas throughout the roof. Recommend engaging a builder to investigate and repair to reduce the risk of movement and damage.

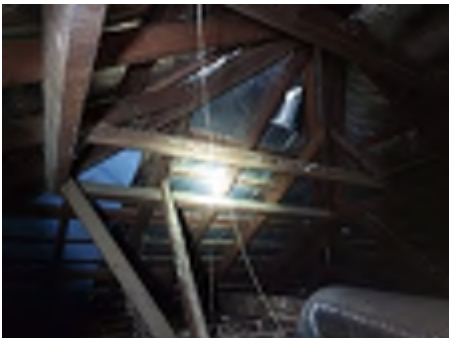
Spans to underpurlins are greater than typically allowed in several areas throughout the roof. Recommend engaging a builder to investigate and repair to reduce the risk of movement and damage.

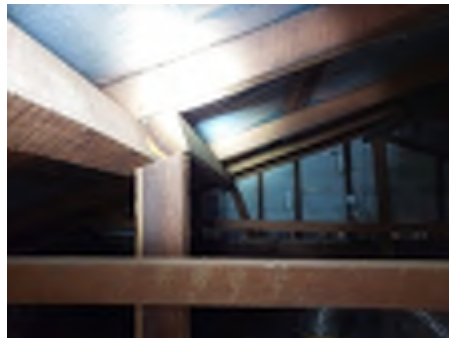
Spans to underpurlins are greater than typically allowed in several areas throughout the roof. Recommend engaging a builder to investigate and repair to reduce the risk of movement and damage.

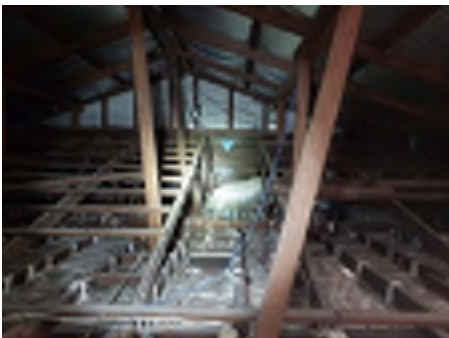
The roof cover appears to have been changed in the past to new roofing iron with modern fasteners. No provision to upgrade supporting timbers and tie downs to the roof to the requirements of the approximate date of the changed roof cover are observed. Recommend engaging an engineer to assess and a builder to install additional timbers, tie downs and strapping or obtaining a signed engineering detail for the roof change as constructed.

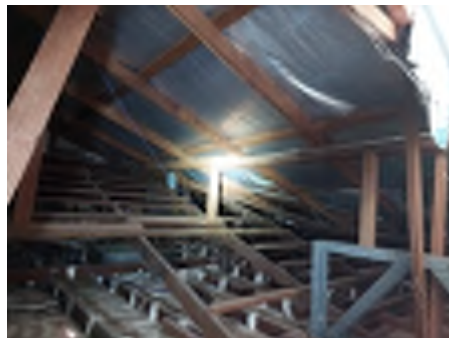
The roof cover appears to have been changed in the past to new roofing iron with modern fasteners. No provision to upgrade supporting timbers and tie downs to the roof to the requirements of the approximate date of the changed roof cover are observed. Recommend engaging an engineer to assess and a builder to install additional timbers, tie downs and strapping or obtaining a signed engineering detail for the roof change as constructed.

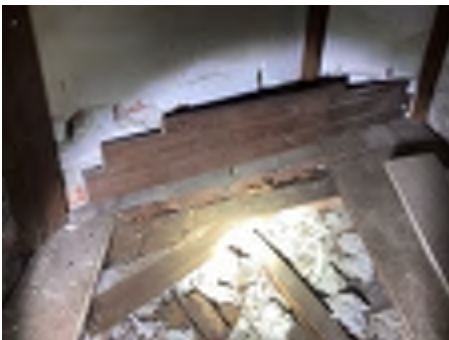
Termite damage observed to the subfloor Timbers around the one visible subfloor hatch. Recommend conducting further, more invasive investigation and engaging a builder to repair to reduce the risk of damage to the structure to reduce the risk of further deterioration.

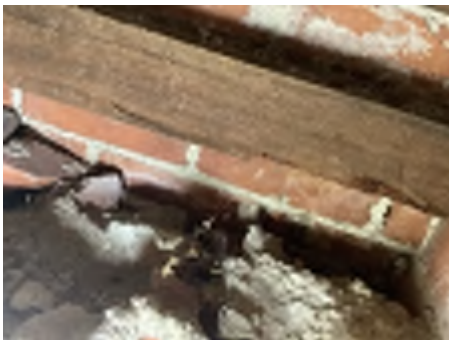
Termite damage observed to the subfloor Timbers around the one visible subfloor hatch. Recommend conducting further, more invasive investigation and engaging a builder to repair to reduce the risk of damage to the structure to reduce the risk of further deterioration.

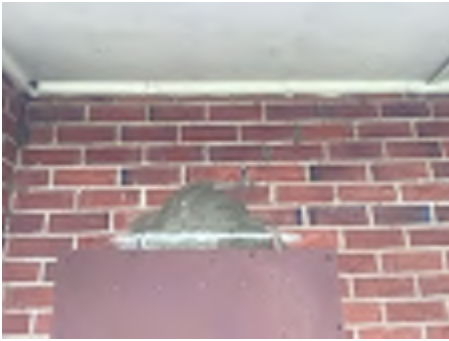
Cracking observed to parts of the external walls. Recommend a structural engineer be engaged to inspect and provide appropriate advice and recommendations to reduce the risk of further deterioration to the building.

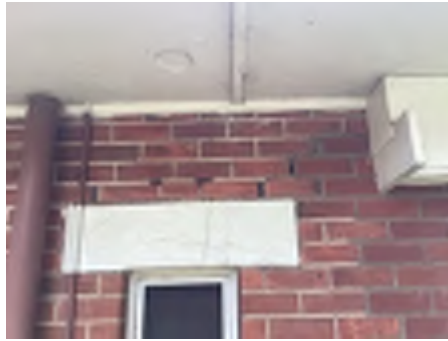
Cracking observed to parts of the external walls. Recommend a structural engineer be engaged to inspect and provide appropriate advice and recommendations to reduce the risk of further deterioration to the building.

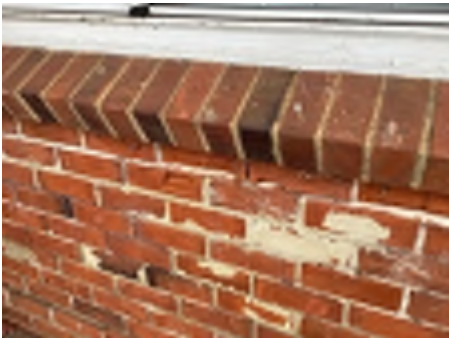
Cracking observed to parts of the external walls. Recommend a structural engineer be engaged to inspect and provide appropriate advice and recommendations to reduce the risk of further deterioration to the building.

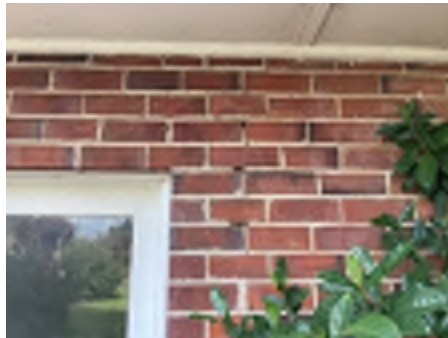
Cracking observed to parts of the external walls. Recommend a structural engineer be engaged to inspect and provide appropriate advice and recommendations to reduce the risk of further deterioration to the building.

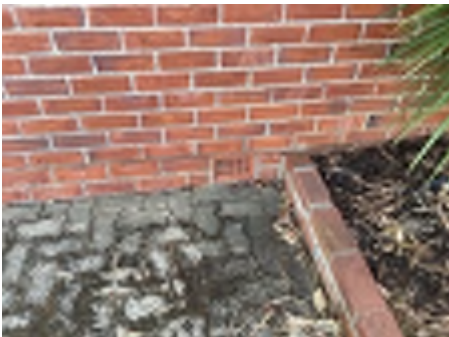
Cracking observed to parts of the external walls. Recommend a structural engineer be engaged to inspect and provide appropriate advice and recommendations to reduce the risk of further deterioration to the building.

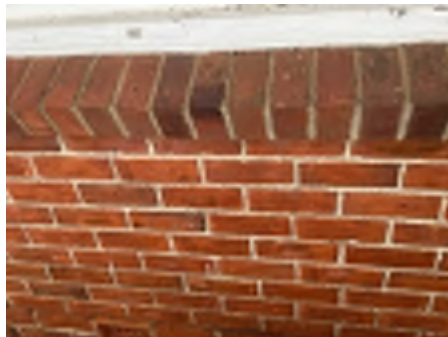
Cracking observed to parts of the external walls. Recommend a structural engineer be engaged to inspect and provide appropriate advice and recommendations to reduce the risk of further deterioration to the building.

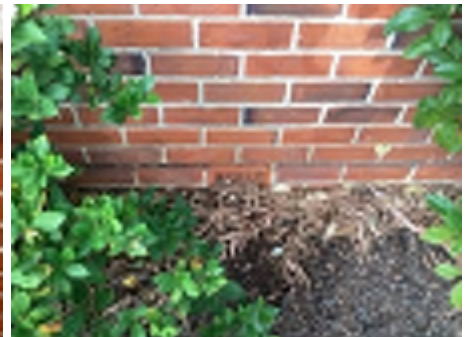
Cracking observed to parts of the external walls. Recommend a structural engineer be engaged to inspect and provide appropriate advice and recommendations to reduce the risk of further deterioration to the building.

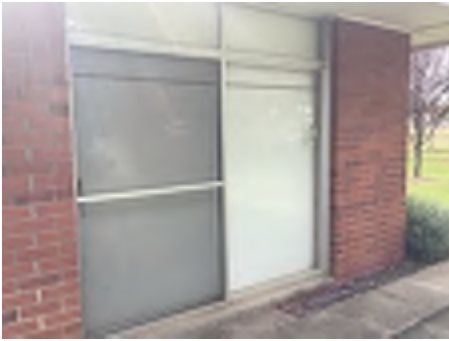
Safety issue only (non structural). It is a requirement of the inspection standard to report observed safety issues within the main body of the report. Large glass panels and door inserts that could be mistaken for openings did not all have an identifiable mark i.e. sticker as required by building requirements. Recommend engaging a glazier to repair to reduce the risk of personal injury.

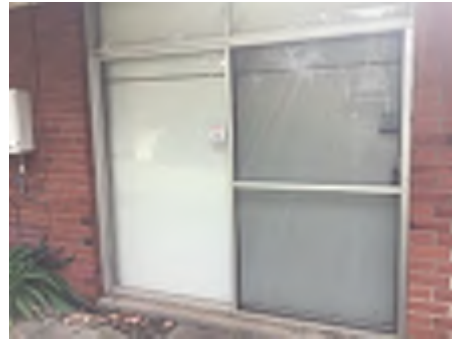
Safety issue only (non structural). It is a requirement of the inspection standard to report observed safety issues within the main body of the report. Large glass panels and door inserts that could be mistaken for openings did not all have an identifiable mark i.e. sticker as required by building requirements. Recommend engaging a glazier to repair to reduce the risk of personal injury.

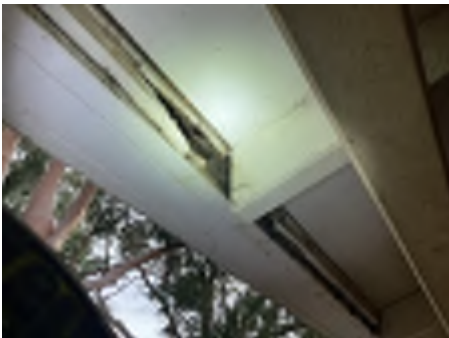
Wood rot to parts of the framing to the patio. Needs repair/replacing to prevent further deterioration. Ensure all exposed timbers are painted to maximise the life of the timbers. To the front verandah.

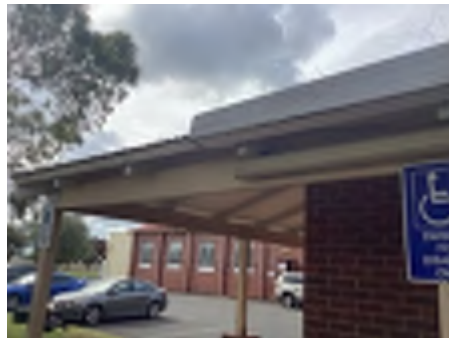
Wood rot to parts of the framing to the patio. Needs repair/replacing to prevent further deterioration. Ensure all exposed timbers are painted to maximise the life of the timbers. To the front verandah.

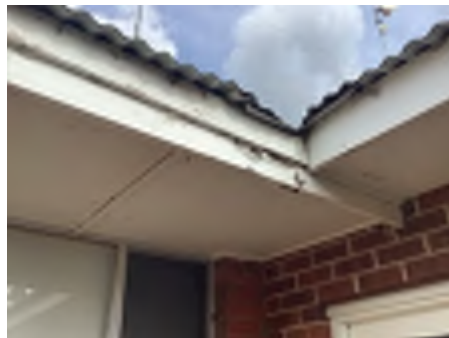
Wood rot to parts of the framing to the patio. Needs repair/replacing to prevent further deterioration. Ensure all exposed timbers are painted to maximise the life of the timbers. To the front verandah.

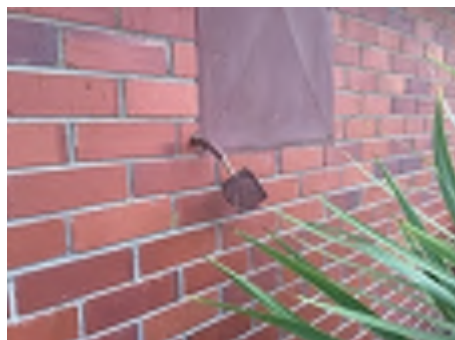
Safety issue only (non structural). It is a requirement of the inspection standard to report observed safety issues within the main body of the report. Exposed wires to some external locations. Recommend engaging an electrician to investigate and repair to reduce the risk of damage and injury.

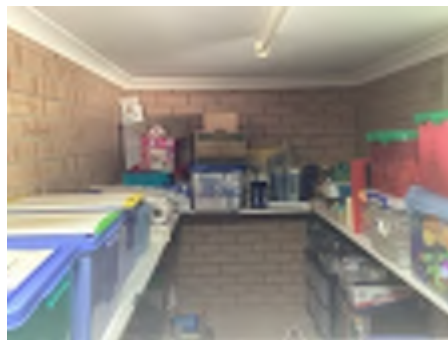
Showing no manhole

<p>Additional comments:</p>	<p>Recommend further inspection once vacant and obstructions removed. Recommend further inspection to the upper roof exterior when safe access is gained. Recommend further inspection when access is gained to all areas.</p>
-----------------------------	--

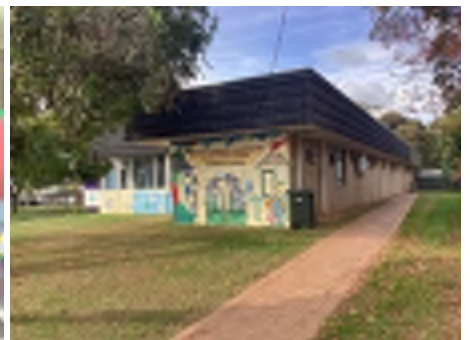
Showing no access to roof exterior due to height restrictions

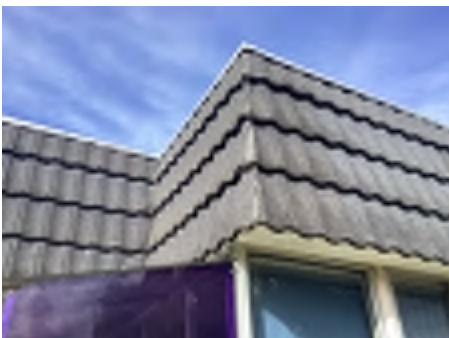
Showing no access to roof exterior due to height restrictions

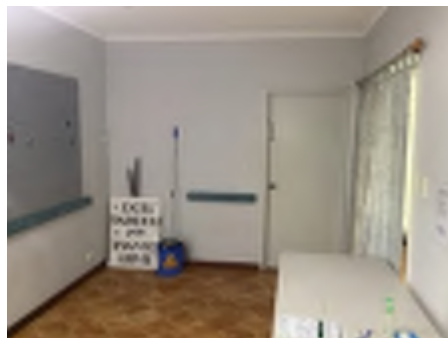
Showing examples of locked storage doors

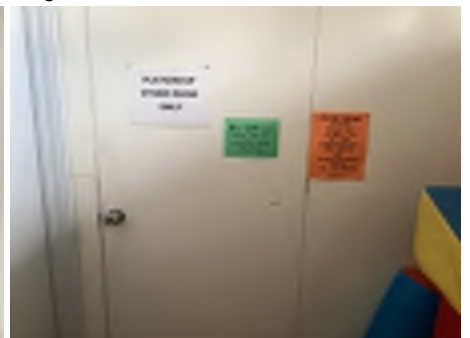
Showing examples of locked storage doors

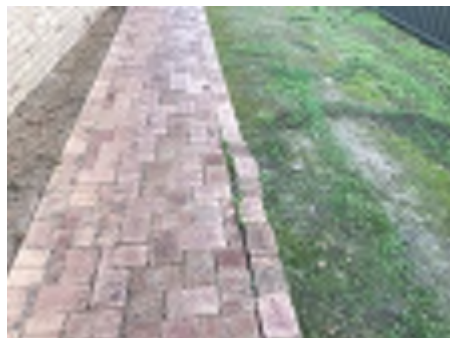
<p>D1 Serious safety hazards: Evidence of any item or matter (within the Consultant's expertise) that may constitute a present or imminent serious safety hazard:</p>	<p>The following evidence was found</p>
<p>Additional Comments:</p>	<p>Undulating/uneven path, rectify to reduce the risk of tripping and personal injury. Some loose ceiling panels are observed. Recommend engaging a builder to repair to reduce the risk of damage and injury. Large glass panels and door inserts that could be mistaken for openings did not all have an identifiable mark i.e. sticker as required by building requirements. Recommend engaging a glazier to repair to reduce the risk of personal injury. The freestanding oven is not visibly secured with an anti tilt chain or bracket - recommend engaging an appliance installer to repair to reduce the risk of damage and personal injury. Earth wire to the dwelling is damaged with loose wire connection - recommend engaging an electrician to repair to reduce the risk of electrocution and personal injury. Some ceiling panels are visibly loose. Recommend engaging a builder to repair to reduce the risk of damage or injury.</p>

Showing undulating/uneven path

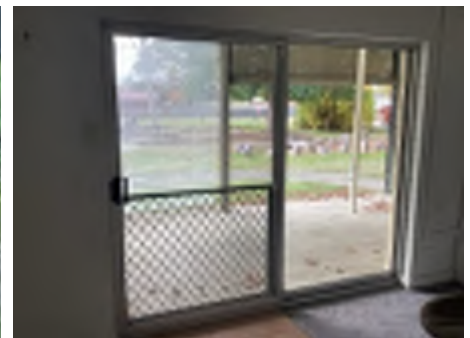
Showing examples of glass doors

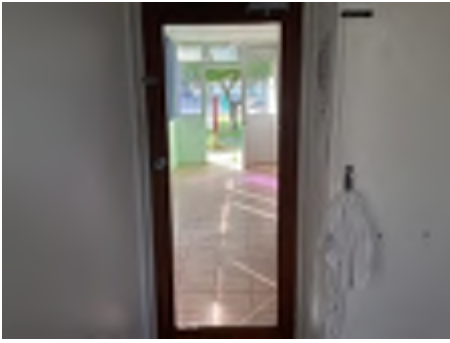
Showing examples of glass doors

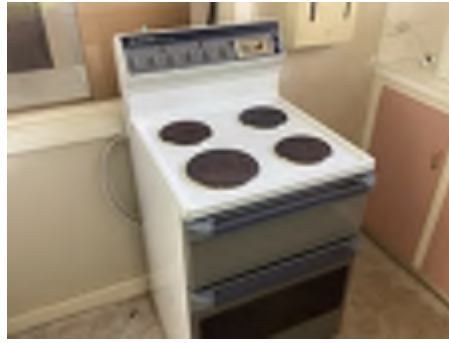
Showing ovens

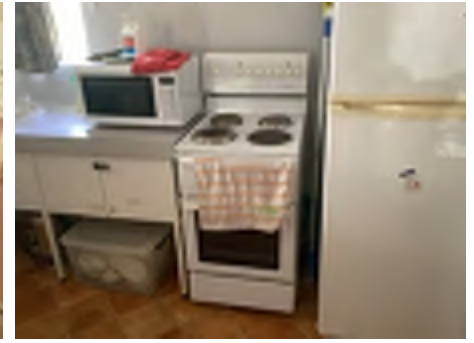
Showing ovens

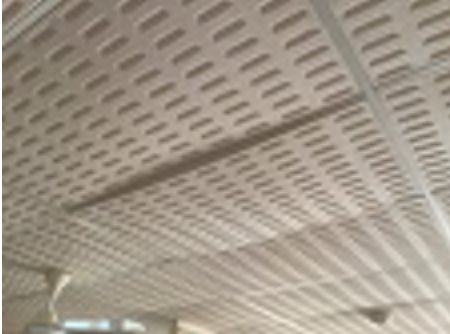
Showing examples of loose ceiling panels

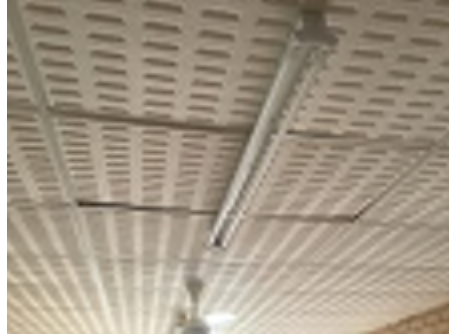
Showing examples of loose ceiling panels

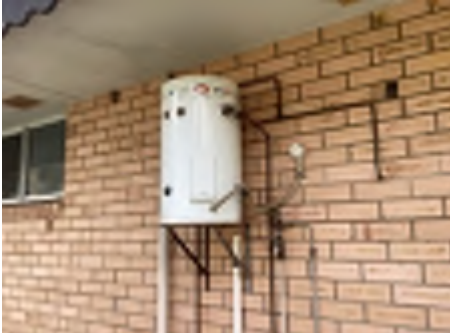
Showing hot water system

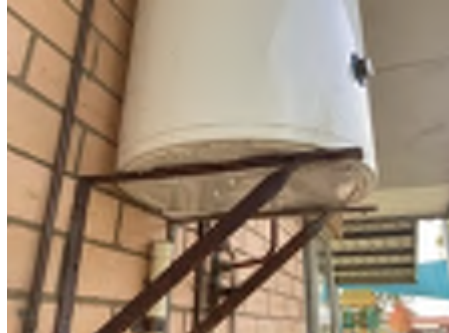
Showing hot water system

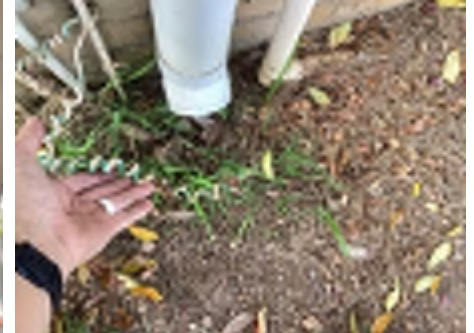
Showing earth wire

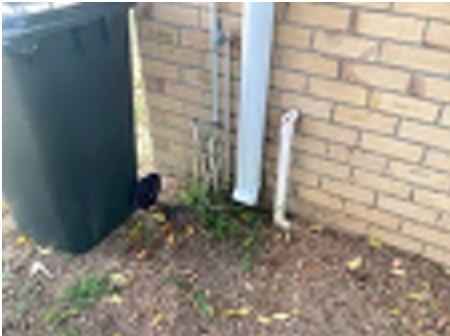
Showing earth wire

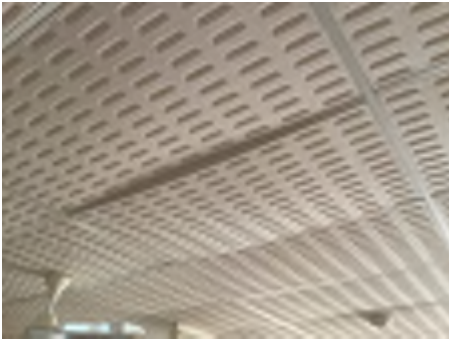
Safety issue only (non structural). It is a requirement of the inspection standard to report observed safety issues within the main body of the report. Some loose ceiling panels are observed. Recommend engaging a builder to repair to reduce the risk of damage and injury.

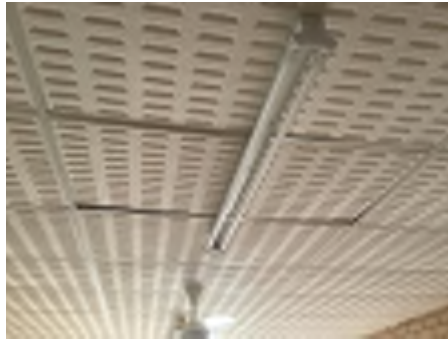
Safety issue only (non structural). It is a requirement of the inspection standard to report observed safety issues within the main body of the report. Some loose ceiling panels are observed. Recommend engaging a builder to repair to reduce the risk of damage and injury.

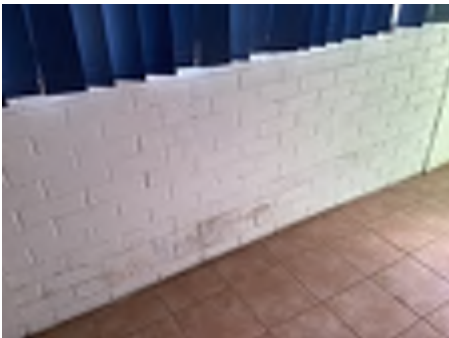
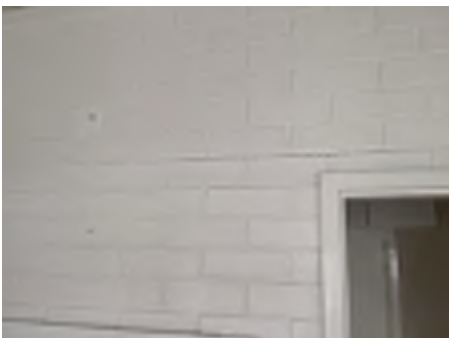
Cracking observed to parts of the internal walls. Recommend a structural engineer be engaged to inspect and provide appropriate advice and recommendations to reduce the risk of further deterioration to the building, To the front community area.

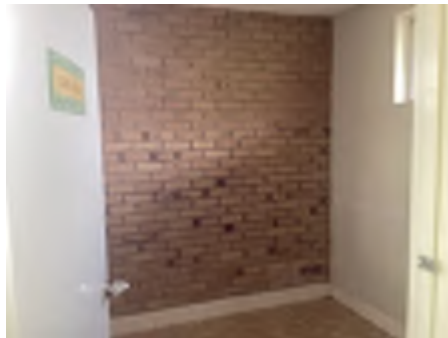
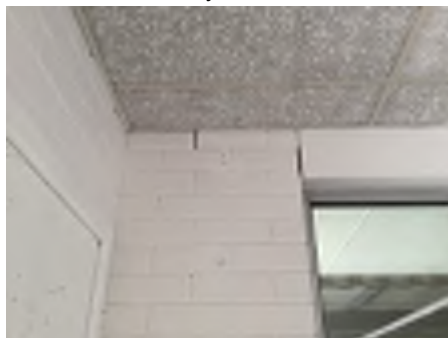
Cracking observed to parts of the internal walls. Recommend a structural engineer be engaged to inspect and provide appropriate advice and recommendations to reduce the risk of further deterioration to the building, To the front community area.

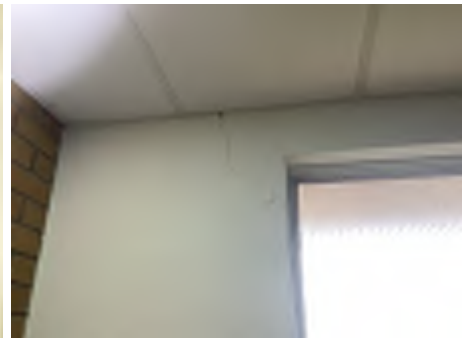
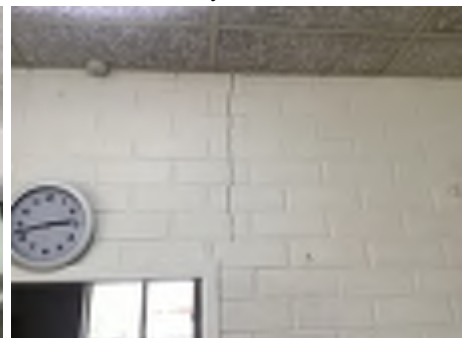
Cracking observed to parts of the internal walls. Recommend a structural engineer be engaged to inspect and provide appropriate advice and recommendations to reduce the risk of further deterioration to the building, To the front community area.

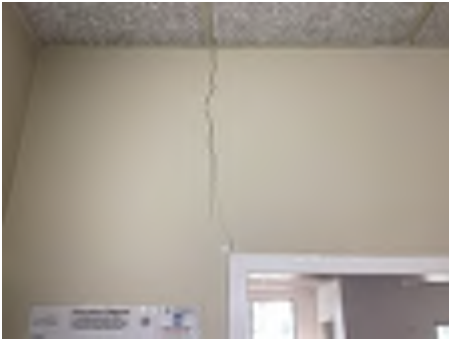
Cracking observed to parts of the internal walls. Recommend a structural engineer be engaged to inspect and provide appropriate advice and recommendations to reduce the risk of further deterioration to the building, To the front community area.

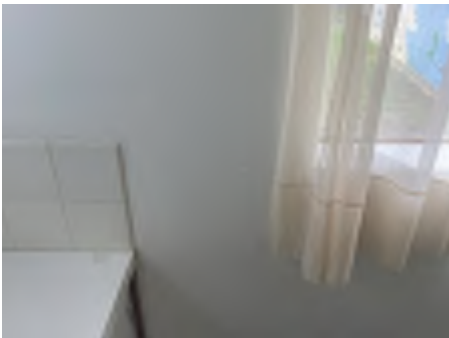
Cracking observed to parts of the internal walls. Recommend a structural engineer be engaged to inspect and provide appropriate advice and recommendations to reduce the risk of further deterioration to the building, To the front community area.

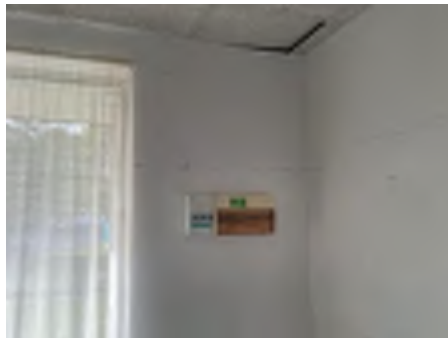
Cracking observed to parts of the internal walls. Recommend a structural engineer be engaged to inspect and provide appropriate advice and recommendations to reduce the risk of further deterioration to the building, To the front community area.

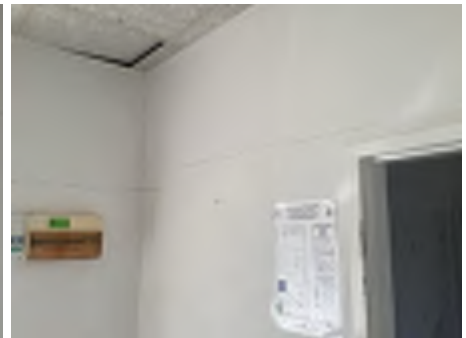
Cracking observed to parts of the internal walls. Recommend a structural engineer be engaged to inspect and provide appropriate advice and recommendations to reduce the risk of further deterioration to the building, To the front community area.

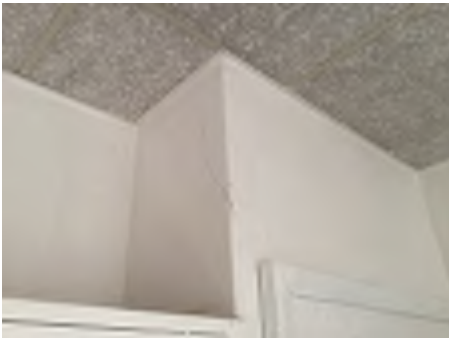
Cracking observed to parts of the internal walls. Recommend a structural engineer be engaged to inspect and provide appropriate advice and recommendations to reduce the risk of further deterioration to the building, To the front community area.

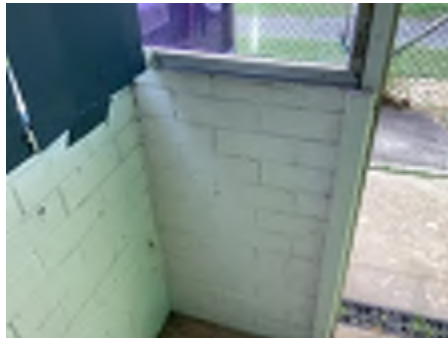
Cracking observed to parts of the internal walls. Recommend a structural engineer be engaged to inspect and provide appropriate advice and recommendations to reduce the risk of further deterioration to the building, To the front community area.

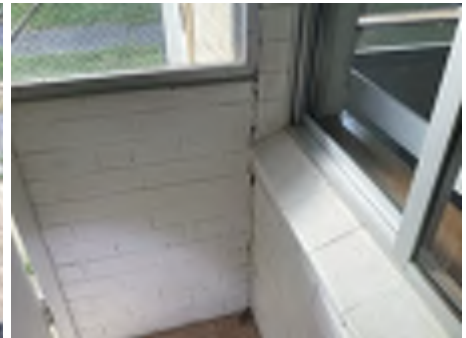
Cracking observed to parts of the internal walls. Recommend a structural engineer be engaged to inspect and provide appropriate advice and recommendations to reduce the risk of further deterioration to the building, To the front community area.

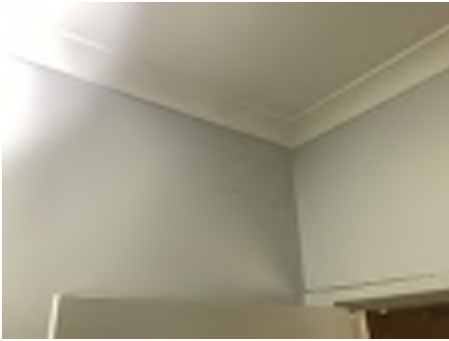
Cracking observed to parts of the internal walls. Recommend a structural engineer be engaged to inspect and provide appropriate advice and recommendations to reduce the risk of further deterioration to the building, To the rear kindergarten area.

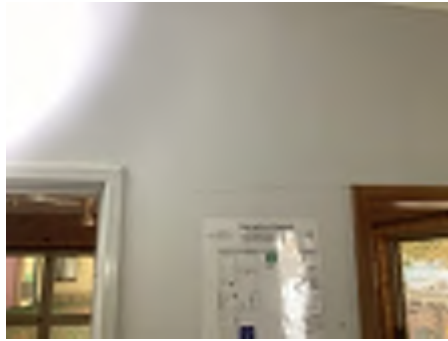
Cracking observed to parts of the internal walls. Recommend a structural engineer be engaged to inspect and provide appropriate advice and recommendations to reduce the risk of further deterioration to the building, To the rear kindergarten area.

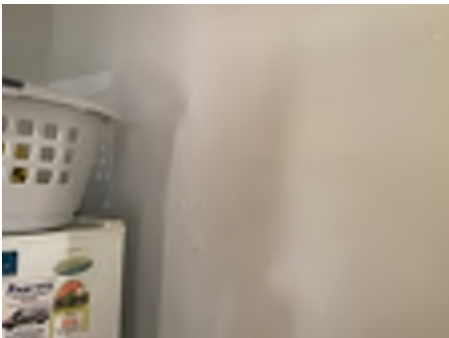
Cracking observed to parts of the internal walls. Recommend a structural engineer be engaged to inspect and provide appropriate advice and recommendations to reduce the risk of further deterioration to the building, To the rear kindergarten area.

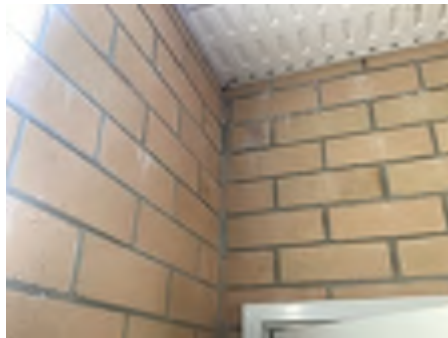
Cracking observed to parts of the internal walls. Recommend a structural engineer be engaged to inspect and provide appropriate advice and recommendations to reduce the risk of further deterioration to the building, To the rear kindergarten area.

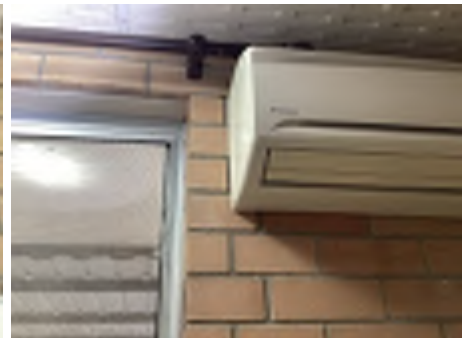
Cracking observed to parts of the internal walls. Recommend a structural engineer be engaged to inspect and provide appropriate advice and recommendations to reduce the risk of further deterioration to the building, To the rear kindergarten area.

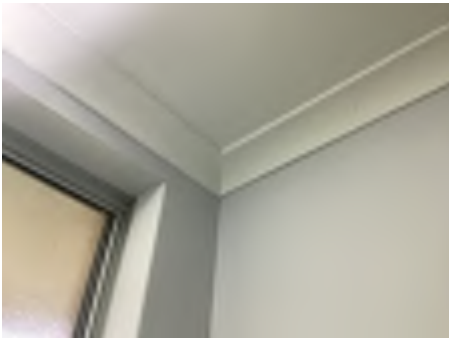
Cracking observed to parts of the internal walls. Recommend a structural engineer be engaged to inspect and provide appropriate advice and recommendations to reduce the risk of further deterioration to the building, To the rear kindergarten area.

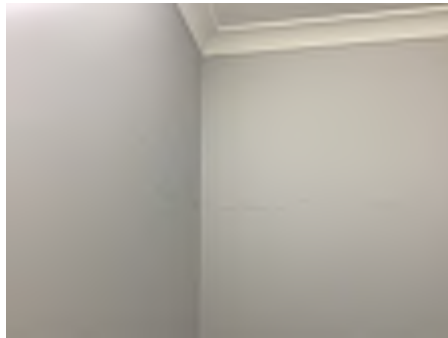
Cracking observed to parts of the internal walls. Recommend a structural engineer be engaged to inspect and provide appropriate advice and recommendations to reduce the risk of further deterioration to the building, To the rear kindergarten area.

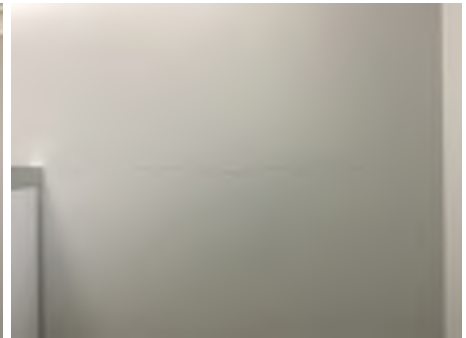
Cracking observed to parts of the internal walls. Recommend a structural engineer be engaged to inspect and provide appropriate advice and recommendations to reduce the risk of further deterioration to the building, To the rear kindergarten area.

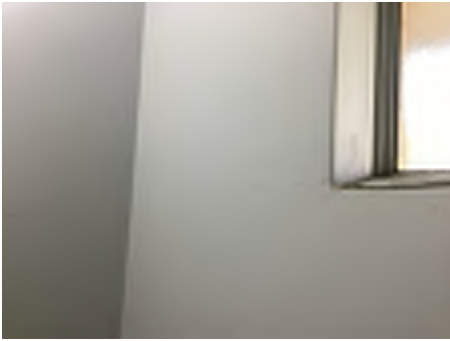
Cracking observed to parts of the internal walls. Recommend a structural engineer be engaged to inspect and provide appropriate advice and recommendations to reduce the risk of further deterioration to the building, To the rear kindergarten area.

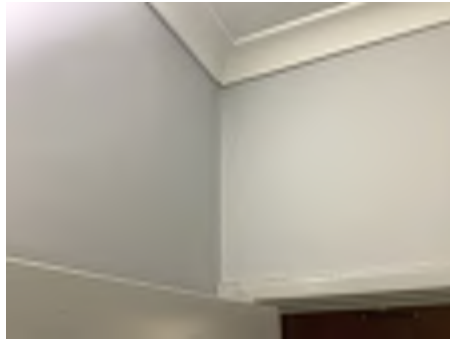
Cracking observed to parts of the internal walls. Recommend a structural engineer be engaged to inspect and provide appropriate advice and recommendations to reduce the risk of further deterioration to the building, To the rear kindergarten area.

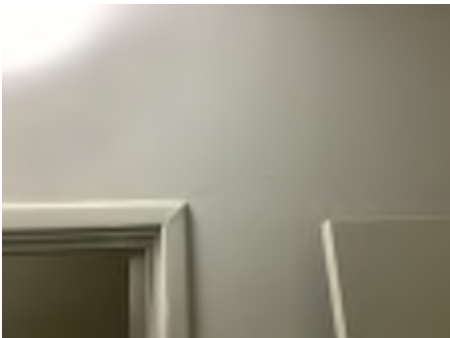
Cracking observed to parts of the internal walls. Recommend a structural engineer be engaged to inspect and provide appropriate advice and recommendations to reduce the risk of further deterioration to the building, To the rear kindergarten area.

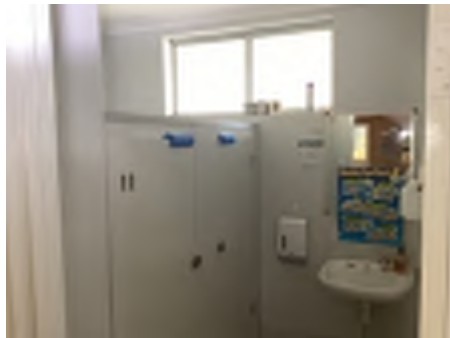
Cracking observed to parts of the internal walls. Recommend a structural engineer be engaged to inspect and provide appropriate advice and recommendations to reduce the risk of further deterioration to the building, To the rear kindergarten area.

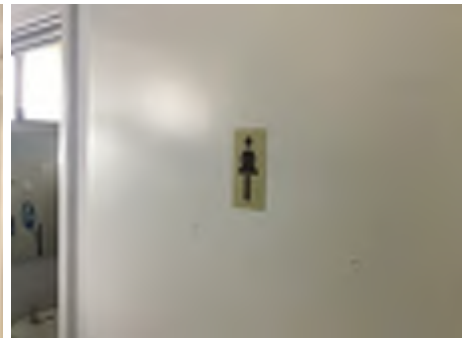
Cracking observed to parts of the internal walls. Recommend a structural engineer be engaged to inspect and provide appropriate advice and recommendations to reduce the risk of further deterioration to the building, To the rear kindergarten area.
