ORDINARY COUNCIL MEETING

Wednesday, 22nd of March 2023

STRUCTURAL BUILDING INSPECTION REPORT

FERGUSON HALL

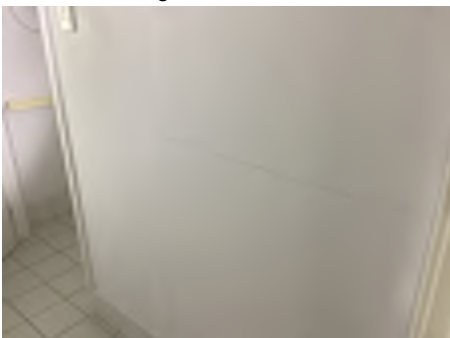
Cracking observed to parts of the internal walls. Recommend a structural engineer be engaged to inspect and provide appropriate advice and recommendations to reduce the risk of further deterioration to the building, To the rear kindergarten area.

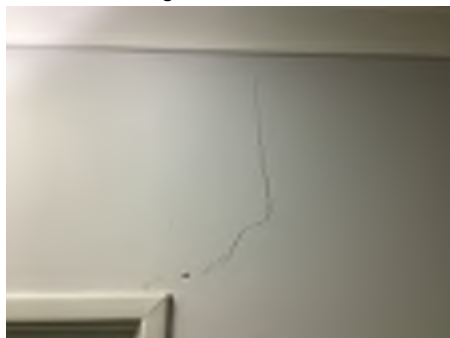
Cracking observed to parts of the internal walls. Recommend a structural engineer be engaged to inspect and provide appropriate advice and recommendations to reduce the risk of further deterioration to the building, To the rear kindergarten area.

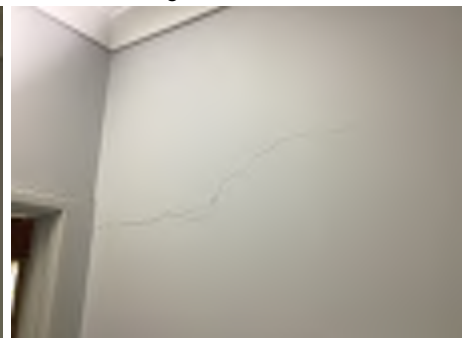
Cracking observed to parts of the internal walls. Recommend a structural engineer be engaged to inspect and provide appropriate advice and recommendations to reduce the risk of further deterioration to the building, To the rear kindergarten area.

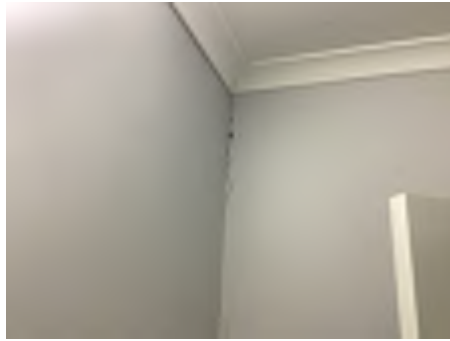
Cracking observed to parts of the internal walls. Recommend a structural engineer be engaged to inspect and provide appropriate advice and recommendations to reduce the risk of further deterioration to the building, To the rear kindergarten area.

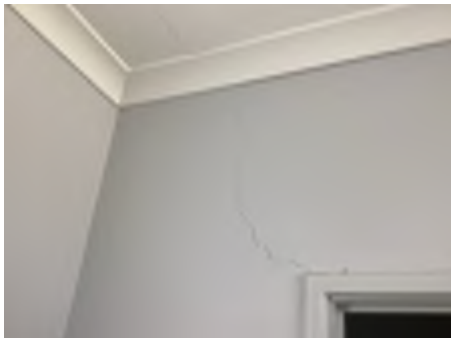
Cracking observed to parts of the internal walls. Recommend a structural engineer be engaged to inspect and provide appropriate advice and recommendations to reduce the risk of further deterioration to the building, To the rear kindergarten area.

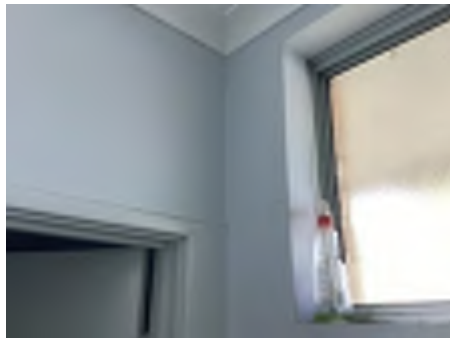
Cracking observed to parts of the internal walls. Recommend a structural engineer be engaged to inspect and provide appropriate advice and recommendations to reduce the risk of further deterioration to the building, To the rear kindergarten area.

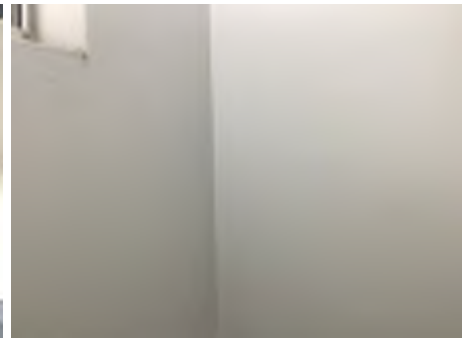
Cracking observed to parts of the internal walls. Recommend a structural engineer be engaged to inspect and provide appropriate advice and recommendations to reduce the risk of further deterioration to the building, To the rear kindergarten area.

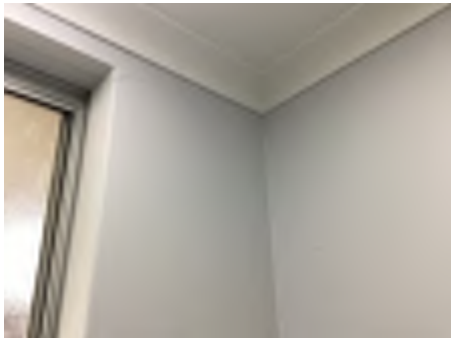
Cracking observed to parts of the internal walls. Recommend a structural engineer be engaged to inspect and provide appropriate advice and recommendations to reduce the risk of further deterioration to the building, To the rear kindergarten area.

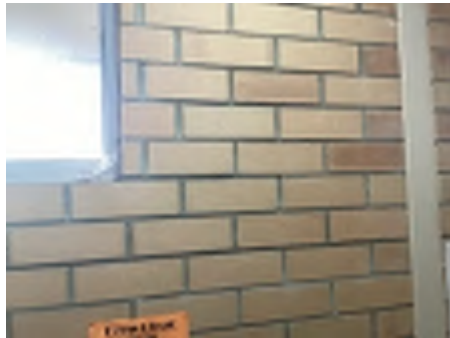
Cracking observed to parts of the internal walls. Recommend a structural engineer be engaged to inspect and provide appropriate advice and recommendations to reduce the risk of further deterioration to the building, To the rear kindergarten area.

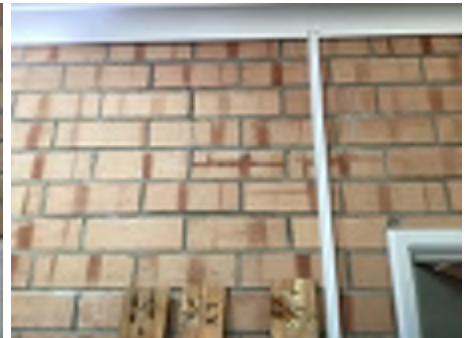
Cracking observed to parts of the internal walls. Recommend a structural engineer be engaged to inspect and provide appropriate advice and recommendations to reduce the risk of further deterioration to the building, To the rear kindergarten area.

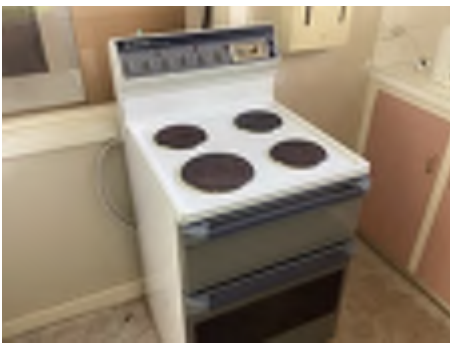
Safety issue only (non structural). It is a requirement of the inspection standard to report observed safety issues within the main body of the report. The freestanding oven is not visibly secured with an anti tilt chain or bracket - recommend engaging an appliance installer to repair to reduce the risk of damage and personal injury.

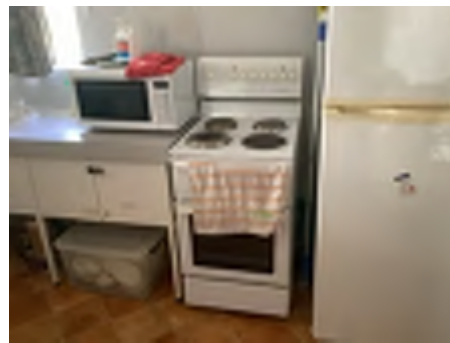
Safety issue only (non structural). It is a requirement of the inspection standard to report observed safety issues within the main body of the report. The freestanding oven is not visibly secured with an anti tilt chain or bracket - recommend engaging an appliance installer to repair to reduce the risk of damage and personal injury.

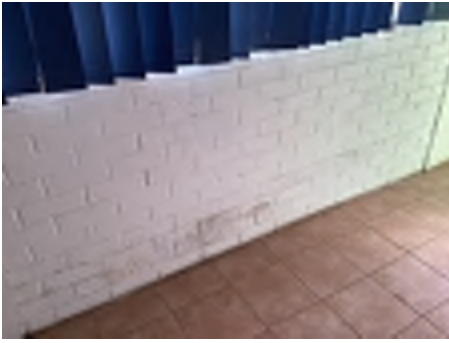
Cracking observed to parts of the external walls. Recommend a structural engineer be engaged to inspect and provide appropriate advice and recommendations to reduce the risk of further deterioration to the building.

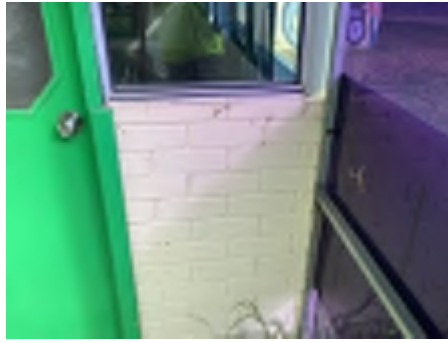
Cracking observed to parts of the external walls. Recommend a structural engineer be engaged to inspect and provide appropriate advice and recommendations to reduce the risk of further deterioration to the building.

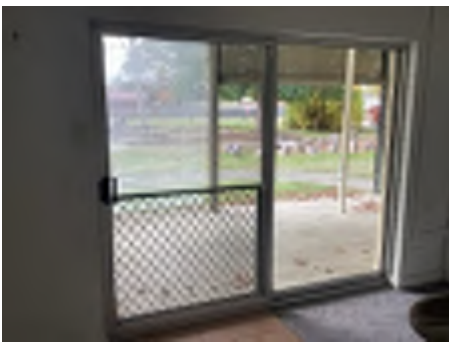
Safety issue only (non structural). It is a requirement of the inspection standard to report observed safety issues within the main body of the report. Large glass panels and door inserts that could be mistaken for openings did not all have an identifiable mark i.e. sticker as required by building requirements. Recommend engaging a glazier to repair to reduce the risk of personal injury.

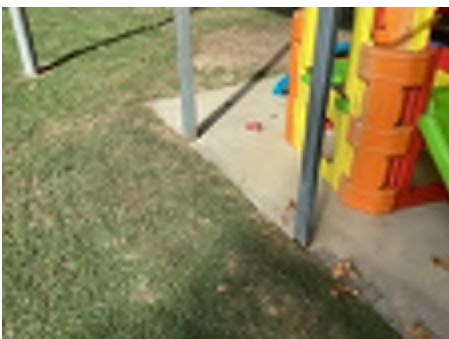
Rusting to steel patio/carport posts, channels and/or purlins - recommend engaging a builder to repair to reduce the risk of deterioration.

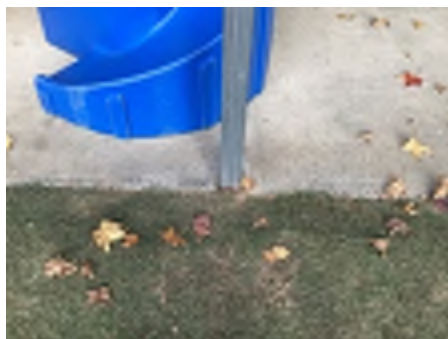
Rusting to steel patio/carport posts, channels and/or purlins - recommend engaging a builder to repair to reduce the risk of deterioration.

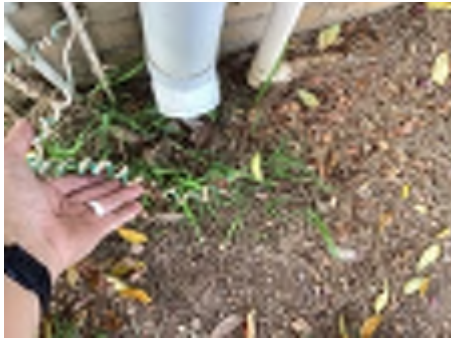
Safety issue only (non structural). It is a requirement of the inspection standard to report observed safety issues within the main body of the report. Earth wire to the dwelling is damaged with loose wire connection - recommend engaging an electrician to repair to reduce the risk of electrocution and personal injury.

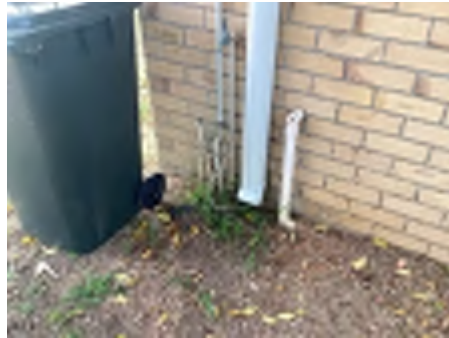
Safety issue only (non structural). It is a requirement of the inspection standard to report observed safety issues within the main body of the report. Earth wire to the dwelling is damaged with loose wire connection - recommend engaging an electrician to repair to reduce the risk of electrocution and personal injury.

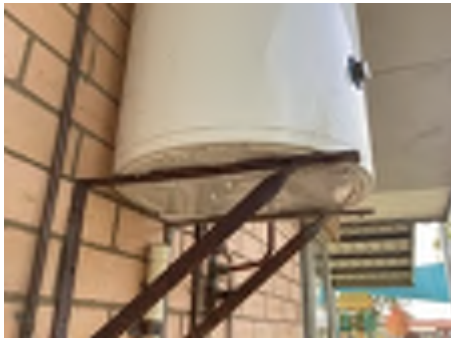
Safety issue only (non structural). It is a requirement of the inspection standard to report observed safety issues within the main body of the report. The rear wall mounted hot water system is not visibly secured with a bracket - recommend engaging an appliance installer to repair to reduce the risk of damage and personal injury.

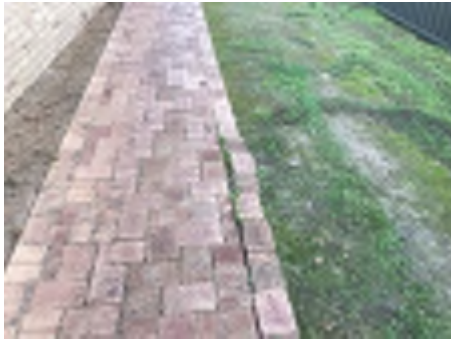
Safety issue only (non structural). It is a requirement of the inspection standard to report observed safety issues within the main body of the report. Unevenness and settling to parts of the pavers. Needs repair/replacing to prevent further deterioration.

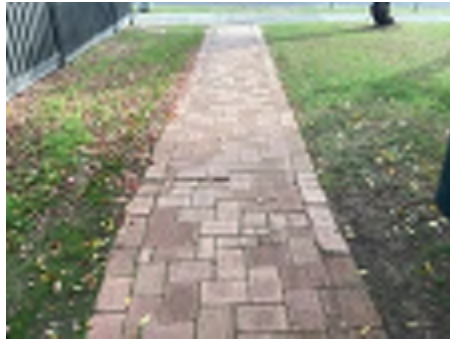
Safety issue only (non structural). It is a requirement of the inspection standard to report observed safety issues within the main body of the report. Unevenness and settling to parts of the pavers. Needs repair/replacing to prevent further deterioration.

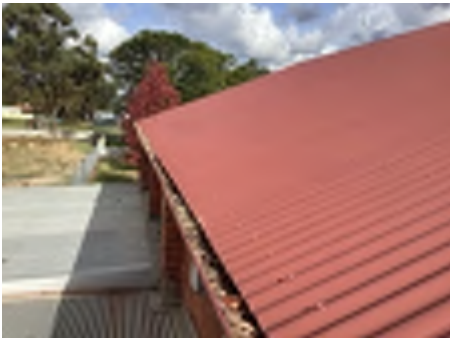
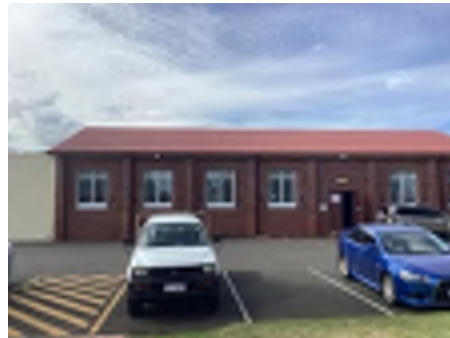
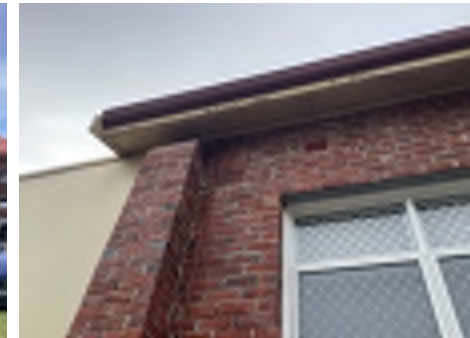
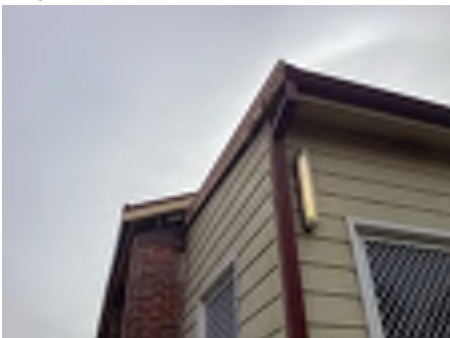
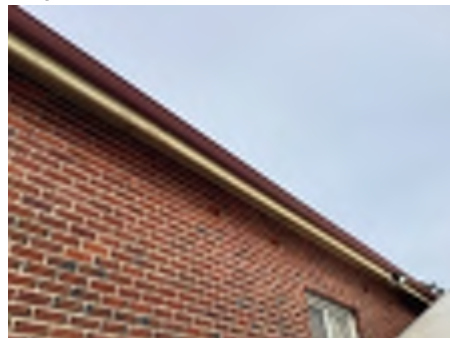
Showing no access to roof exterior due to height restrictions

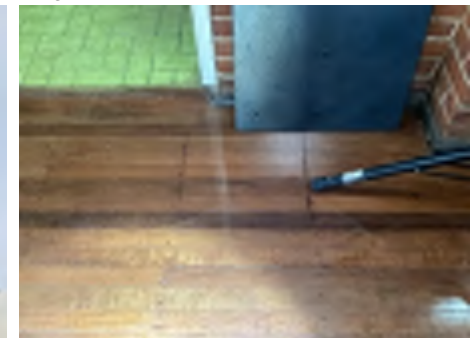
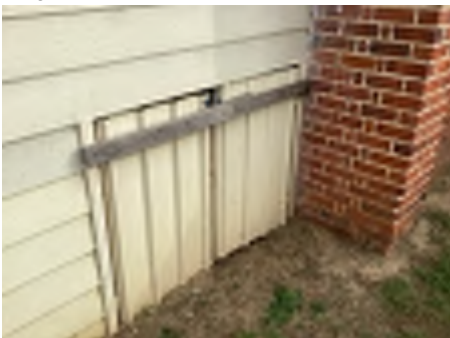
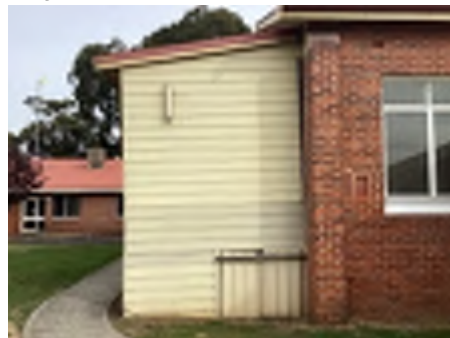
<p>Were there any normally accessible areas that did not permit entry?</p>	<p>There was no inspection of:</p>
<p>Inaccessible Areas:</p>	<p>No inspection of roof exterior where access is restricted due to height restrictions. No inspection of the subfloor due to sealed access hatches.</p>

Showing examples of subfloor hatches

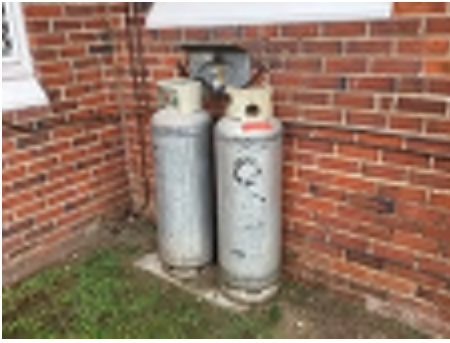
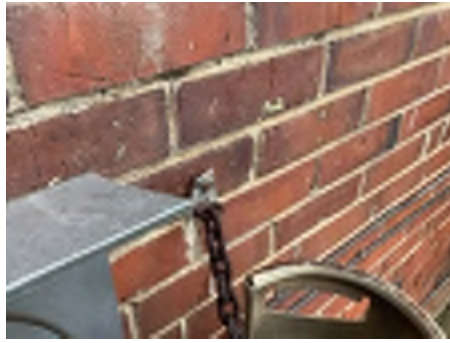
D1 Serious safety hazards: Evidence of any item or matter (within the Consultant's expertise) that may constitute a present or imminent serious safety hazard:	The following evidence was found
Additional Comments:	Gas bottles are not secured to the wall/positioned on a solid stable surface. Recommend securing the bottles to reduce the risk of damage and personal injury. Loose ceiling panels observed to several areas. Recommend engaging a builder to repair to reduce the risk of panels dislodging and causing damage or injury. Possible Mould like material observed food preparation area ceilings and to other ceilings through the structure in wet areas and main hall area. Recommend engaging a mould technician to investigate if the material is hazardous and a builder to repair as required to reduce the risk of illness or further deterioration. Exposed material that is visibly consistent with asbestos is located in the storage room over the entrance and to the gable end cladding over the stage. Recommend engaging a an asbestos technician to investigate and a builder to conduct repairs as required to reduce the risk of serious illness. The mirror to the dance hall shown is cracked. Recommend engaging a glazier to repair to reduce the risk of injury. Uneven / unlevel floors to the rear of the main hall stage. Recommend engaging an engineer to investigate and a builder to make repairs to reduce the risk of falls and injury. Damaged and uneven stairs to several areas around the building. Recommend engaging a builder to repair to reduce the risk of trips and injury. Exposed sewerage outlet pipe to the ladies toilets where the plumbing cap is missing. Recommend engaging a plumber to repair to reduce the risk of exposure to sewerage and illness or injury. Exposed wires to some areas. Recommend engaging an electrician to investigate and repair to reduce the risk of damage and injury.

Showing gas bottle chain connection

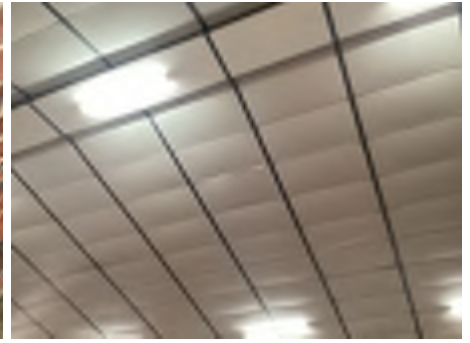
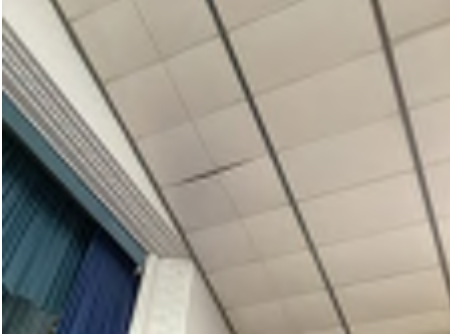
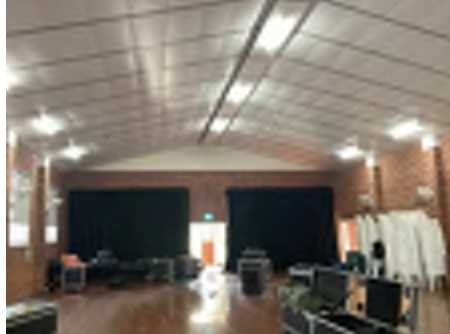
Showing examples of ceiling panels

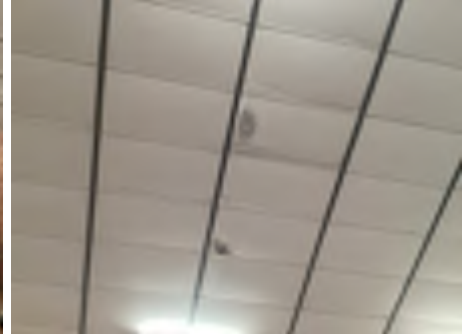
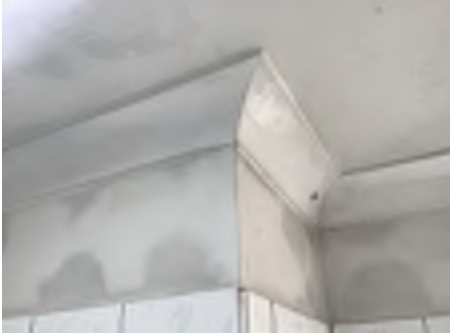
Showing examples of suspected mould

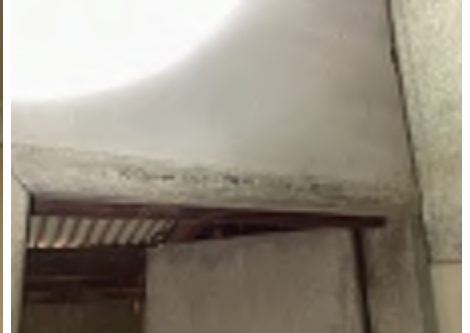
Showing examples of suspected mould

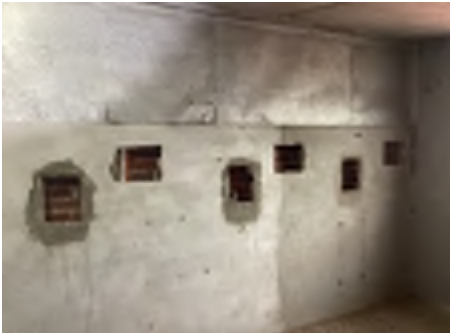
Showing examples of suspected asbestos

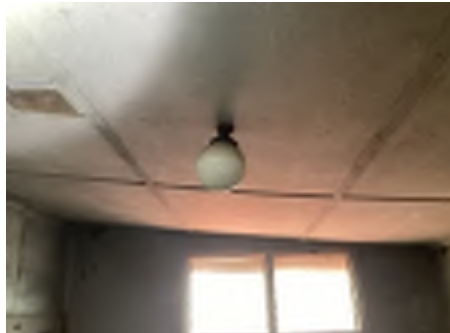
Showing examples of suspected asbestos

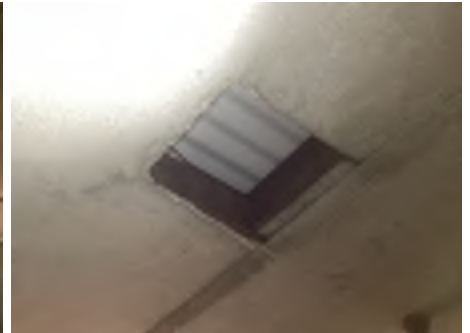
Showing examples of suspected asbestos

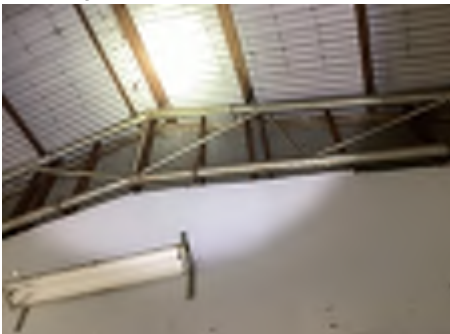
Showing examples of suspected asbestos

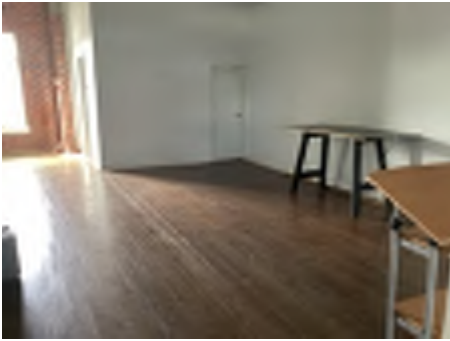
Showing example of uneven flooring

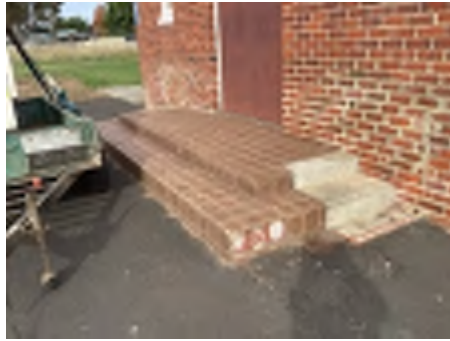
Showing example of uneven flooring

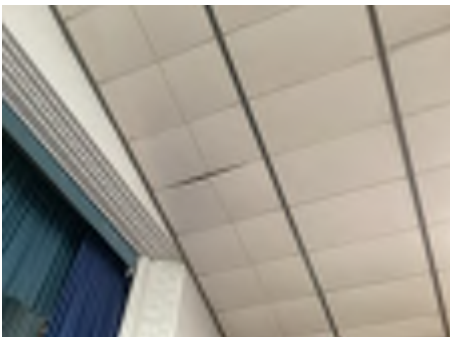
Safety issue only (non structural). It is a requirement of the inspection standard to report observed safety issues within the main body of the report. Loose ceiling panels observed to several areas. Recommend engaging a builder to repair to reduce the risk of panels dislodging and causing damage or injury.

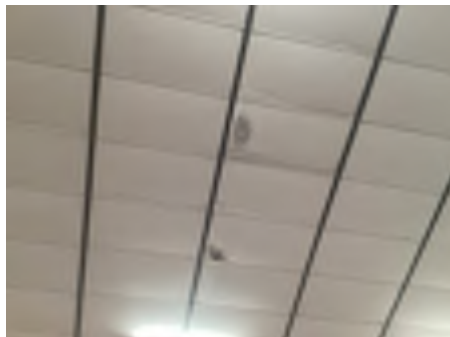
Safety issue only (non structural). It is a requirement of the inspection standard to report observed safety issues within the main body of the report. Loose ceiling panels observed to several areas. Recommend engaging a builder to repair to reduce the risk of panels dislodging and causing damage or injury.

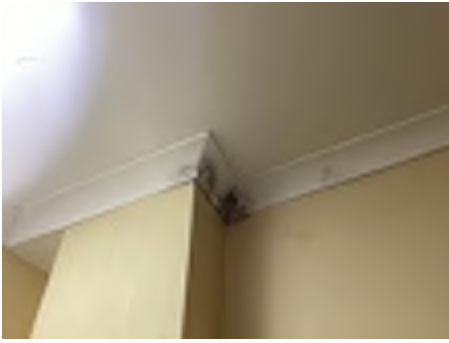
Safety issue only (non structural). It is a requirement of the inspection standard to report observed safety issues within the main body of the report. Mould like material observed to food preparation area. Recommend engaging a mould technician to investigate if the material is hazardous and a builder to repair as required to reduce the risk of illness or further deterioration.

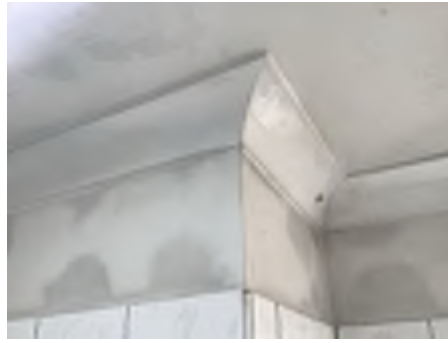
Safety issue only (non structural). It is a requirement of the inspection standard to report observed safety issues within the main body of the report. Possible Mould like material observed to other ceilings through the structure in wet areas and main hall area. Recommend engaging a mould technician to investigate if the material is hazardous and a builder to repair as required to reduce the risk of illness or further deterioration.

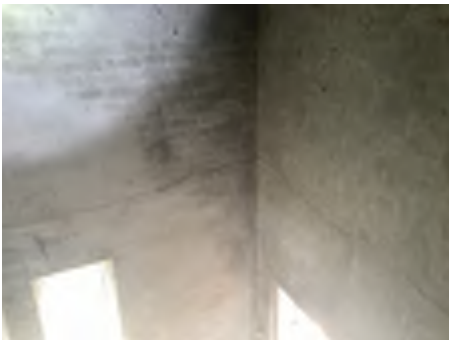
Cracking observed to parts of the internal walls. Recommend a structural engineer be engaged to inspect and provide appropriate advice and recommendations to reduce the risk of further deterioration to the building. To various locations in both halls and the storage area over the entrance.

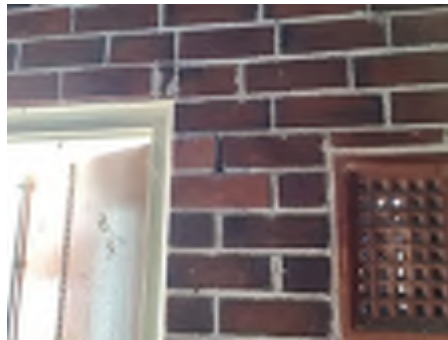
Cracking observed to parts of the internal walls. Recommend a structural engineer be engaged to inspect and provide appropriate advice and recommendations to reduce the risk of further deterioration to the building. To various locations in both halls and the storage area over the entrance.

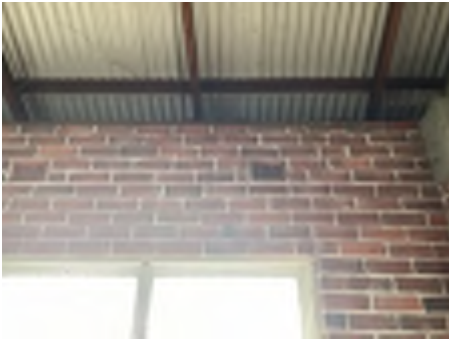
Cracking observed to parts of the internal walls. Recommend a structural engineer be engaged to inspect and provide appropriate advice and recommendations to reduce the risk of further deterioration to the building. To various locations in both halls and the storage area over the entrance.

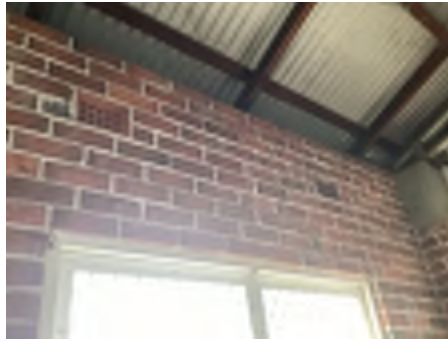
Cracking observed to parts of the internal walls. Recommend a structural engineer be engaged to inspect and provide appropriate advice and recommendations to reduce the risk of further deterioration to the building. To various locations in both halls and the storage area over the entrance.

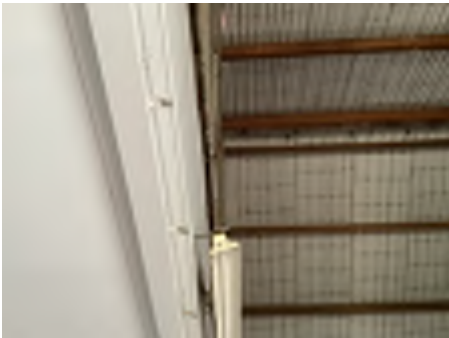
Leaning and distorted walls to the area behind the stage where the cladding section of the building has subsided. Recommend engaging an engineer to investigate and a builder to repair to reduce the risk of further movement or failure of the structure.

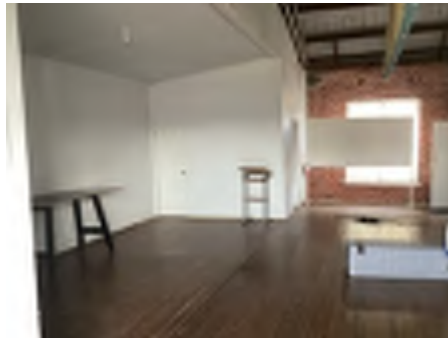
Leaning and distorted walls to the area behind the stage where the cladding section of the building has subsided. Recommend engaging an engineer to investigate and a builder to repair to reduce the risk of further movement or failure of the structure.

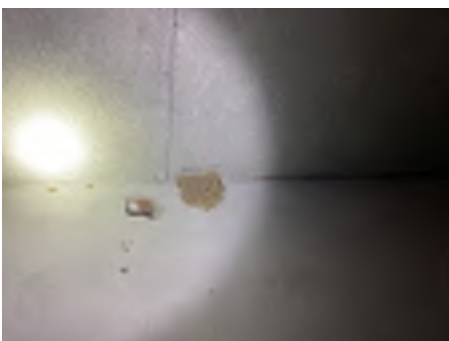
Safety issue only (non structural). It is a requirement of the inspection standard to report observed safety issues within the main body of the report. Exposed material that is visibly consistent with asbestos is located in the storage room over the entrance and to the gable end cladding over the stage. Recommend engaging a an asbestos technician to investigate and a builder to conduct repairs as required to reduce the risk of serious illness.

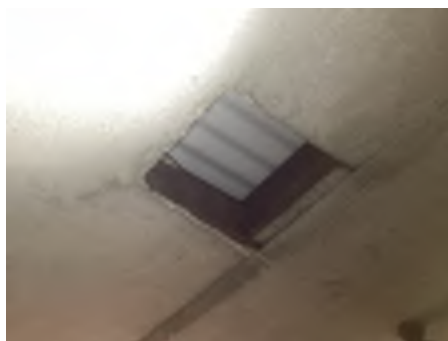
Safety issue only (non structural). It is a requirement of the inspection standard to report observed safety issues within the main body of the report. Exposed material that is visibly consistent with asbestos is located in the storage room over the entrance and to the gable end cladding over the stage. Recommend engaging a an asbestos technician to investigate and a builder to conduct repairs as required to reduce the risk of serious illness.

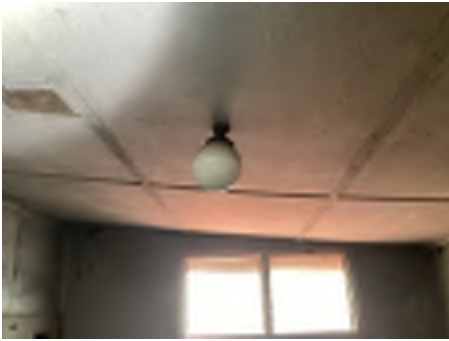
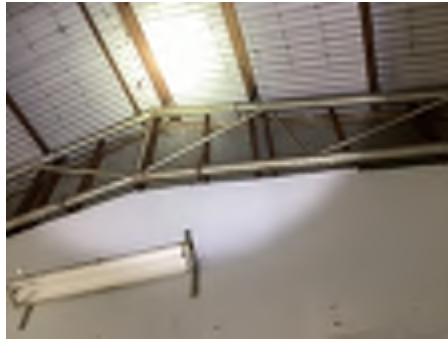
Safety issue only (non structural). It is a requirement of the inspection standard to report observed safety issues within the main body of the report. Exposed material that is visibly consistent with asbestos is located in the storage room over the entrance and to the gable end cladding over the stage. Recommend engaging a an asbestos technician to investigate and a builder to conduct repairs as required to reduce the risk of serious illness.

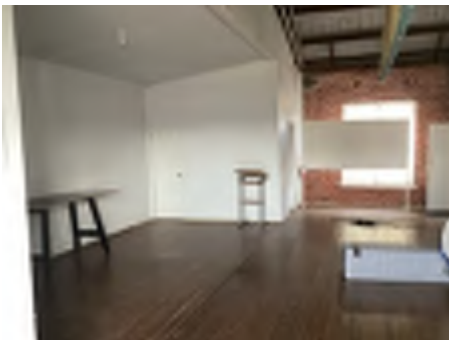
Undulating/uneven floors - recommend engaging a builder to assess appropriate method of rectification to prevent further deterioration, To the rear stage and storage areas.

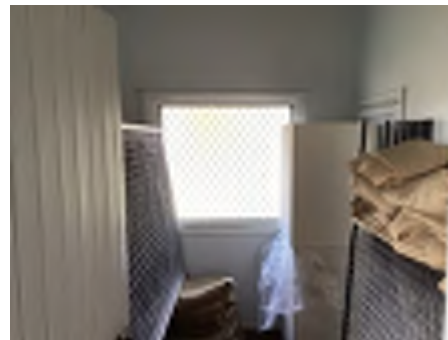
Undulating/uneven floors - recommend engaging a builder to assess appropriate method of rectification to prevent further deterioration, To the rear stage and storage areas.

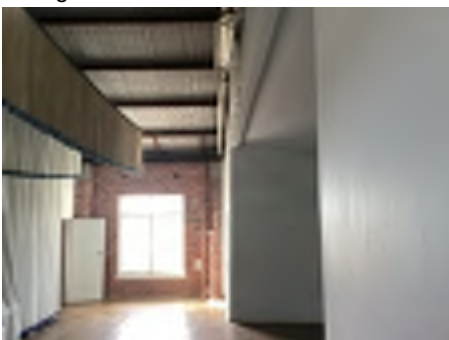
Undulating/uneven floors - recommend engaging a builder to assess appropriate method of rectification to prevent further deterioration, To the rear stage and storage areas.

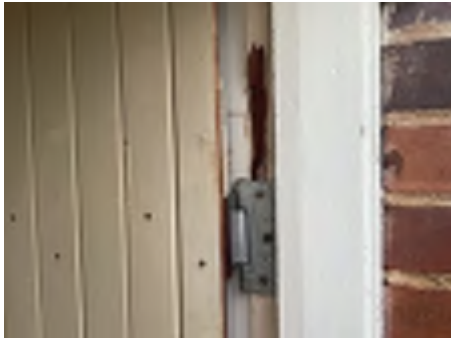
Safety issue only (non structural). It is a requirement of the inspection standard to report observed safety issues within the main body of the report. No lift-off hinges fitted to the toilet door. Recommend engaging a carpenter to install lift-off hinges or make the door to open outward to reduce the risk of people becoming trapped in the toilet.

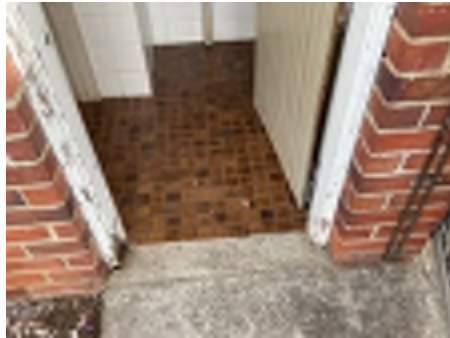
Possible termite damage to the bathroom door jamb Timbers. Recommend engaging a pest technician to investigate to determine if there is concealed damage and if a treatment is required.

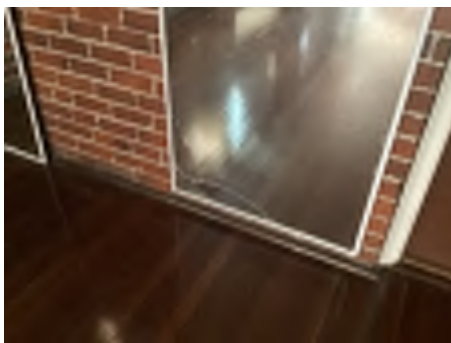
Safety issue only (non structural). It is a requirement of the inspection standard to report observed safety issues within the main body of the report.

The mirror to the dance hall shown is cracked. Recommend engaging a glazier to repair to reduce the risk of injury.

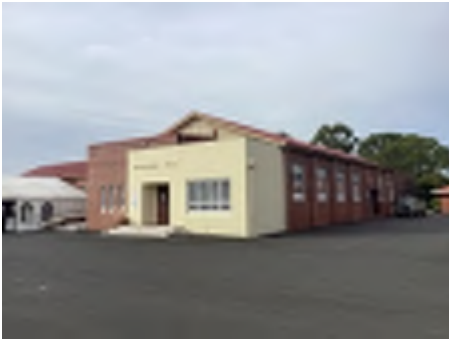
The roof cover appears to have been changed in the past to new roofing iron with modern fasteners. No provision to upgrade supporting timbers and tie downs to the roof to the requirements of the approximate date of the changed roof cover are observed. Recommend engaging an engineer to assess and a builder to install additional timbers, tie downs and strapping or obtaining a signed engineering detail for the roof change as constructed.

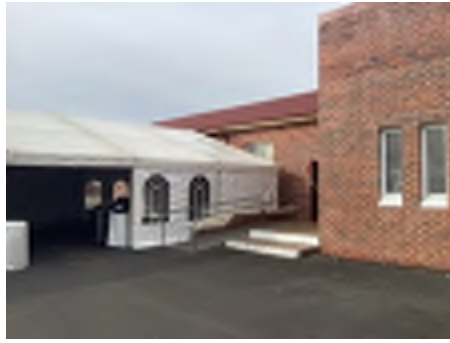
The roof cover appears to have been changed in the past to new roofing iron with modern fasteners. No provision to upgrade supporting timbers and tie downs to the roof to the requirements of the approximate date of the changed roof cover are observed. Recommend engaging an engineer to assess and a builder to install additional timbers, tie downs and strapping or obtaining a signed engineering detail for the roof change as constructed.

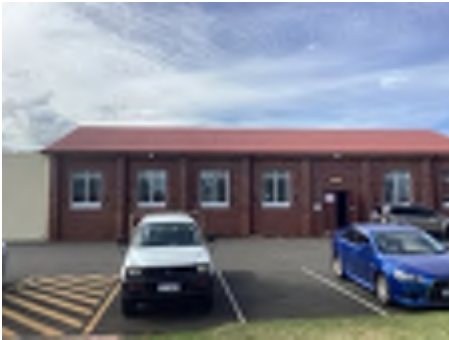
The roof cover appears to have been changed in the past to new roofing iron with modern fasteners. No provision to upgrade supporting timbers and tie downs to the roof to the requirements of the approximate date of the changed roof cover are observed. Recommend engaging an engineer to assess and a builder to install additional timbers, tie downs and strapping or obtaining a signed engineering detail for the roof change as constructed.

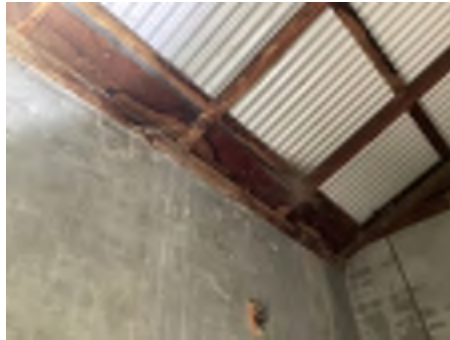
The roof cover appears to have been changed in the past to new roofing iron with modern fasteners. No provision to upgrade supporting timbers and tie downs to the roof to the requirements of the approximate date of the changed roof cover are observed. Recommend engaging an engineer to assess and a builder to install additional timbers, tie downs and strapping or obtaining a signed engineering detail for the roof change as constructed.

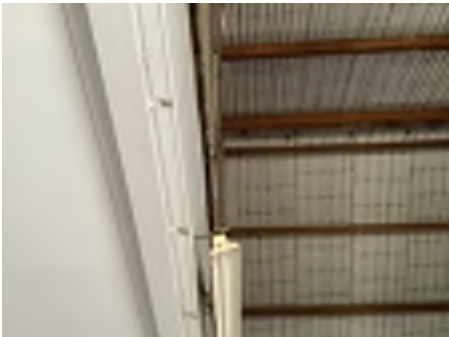
The metal roof truss over the stage in the main hall is visibly displaced where the rear of the stage is subsiding and impacting the roof structure. Recommend engaging an engineer to investigate and a builder to repair to reduce the risk of further movement, deterioration or failure of the structure.

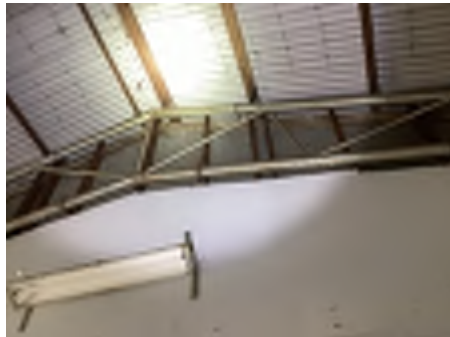
The metal roof truss over the stage in the main hall is visibly displaced where the rear of the stage is subsiding and impacting the roof structure. Recommend engaging an engineer to investigate and a builder to repair to reduce the risk of further movement, deterioration or failure of the structure.

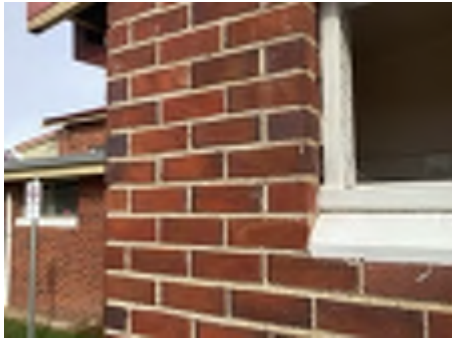
Cracking observed to parts of the external walls. Recommend a structural engineer be engaged to inspect and provide appropriate advice and recommendations to reduce the risk of further deterioration to the building.

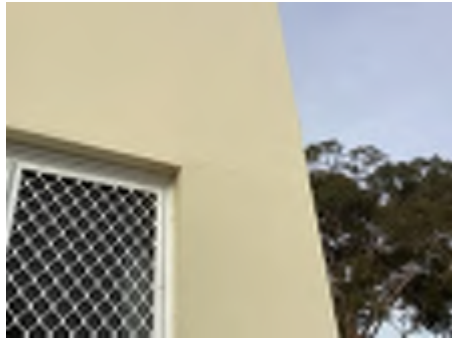
Cracking observed to parts of the external walls. Recommend a structural engineer be engaged to inspect and provide appropriate advice and recommendations to reduce the risk of further deterioration to the building.

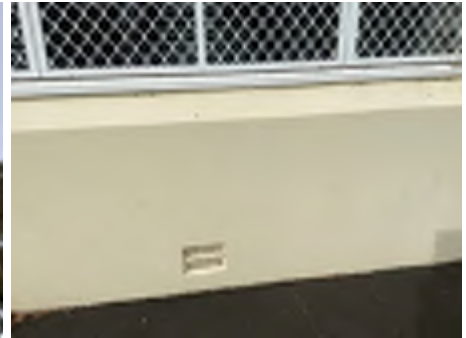
Cracking observed to parts of the external walls. Recommend a structural engineer be engaged to inspect and provide appropriate advice and recommendations to reduce the risk of further deterioration to the building.

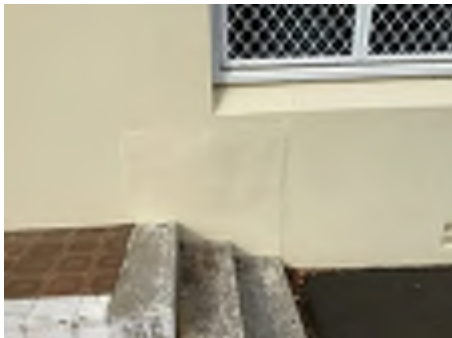
Cracking observed to parts of the external walls. Recommend a structural engineer be engaged to inspect and provide appropriate advice and recommendations to reduce the risk of further deterioration to the building.

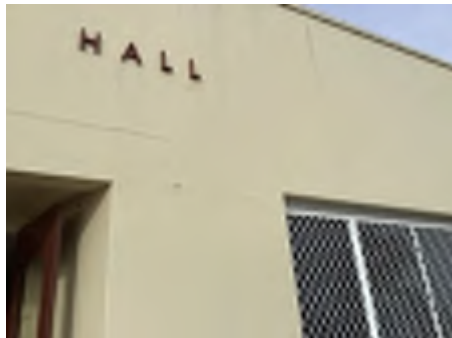
Cracking observed to parts of the external walls. Recommend a structural engineer be engaged to inspect and provide appropriate advice and recommendations to reduce the risk of further deterioration to the building.

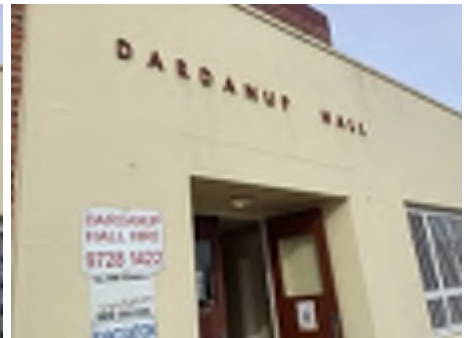
Cracking observed to parts of the external walls. Recommend a structural engineer be engaged to inspect and provide appropriate advice and recommendations to reduce the risk of further deterioration to the building.

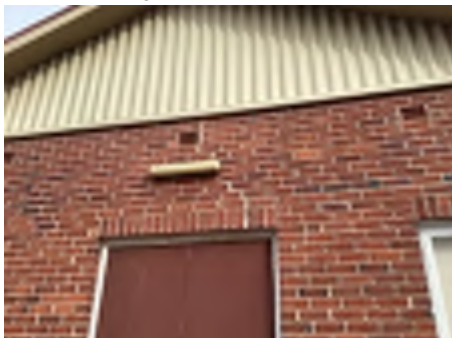
Cracking observed to parts of the external walls. Recommend a structural engineer be engaged to inspect and provide appropriate advice and recommendations to reduce the risk of further deterioration to the building.

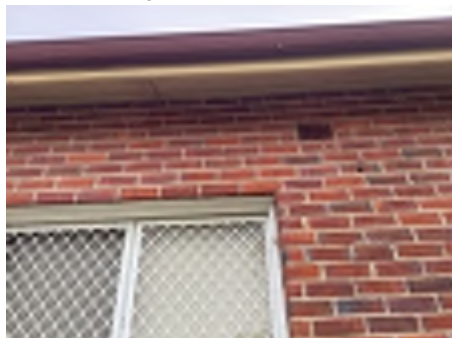
Cracking observed to parts of the external walls. Recommend a structural engineer be engaged to inspect and provide appropriate advice and recommendations to reduce the risk of further deterioration to the building.

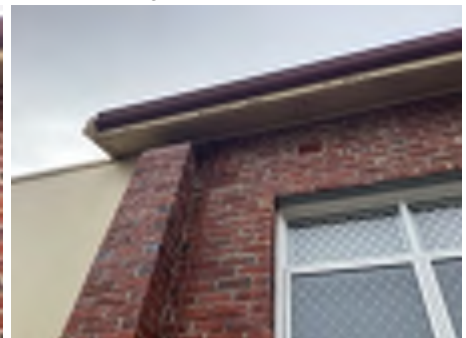
Cracking observed to parts of the external walls. Recommend a structural engineer be engaged to inspect and provide appropriate advice and recommendations to reduce the risk of further deterioration to the building.

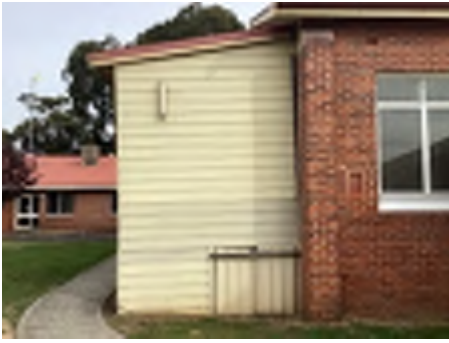
The rear stage clad extension is falling away from the main hall building with cracking to cladding and a large gap opening to the wall at the top to both sides of the extension. Recommend engaging an engineer to investigate and a builder to conduct repairs to reduce the risk of further movement, deterioration or structural failure.

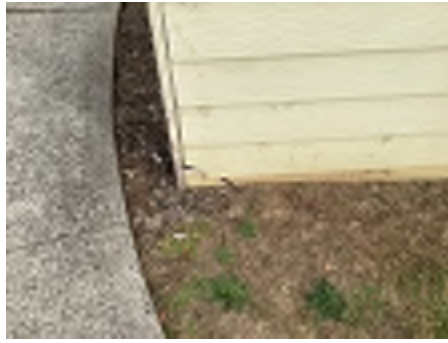
The rear stage clad extension is falling away from the main hall building with cracking to cladding and a large gap opening to the wall at the top to both sides of the extension. Recommend engaging an engineer to investigate and a builder to conduct repairs to reduce the risk of further movement, deterioration or structural failure.

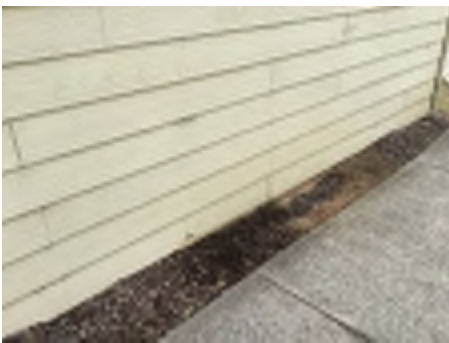
The rear stage clad extension is falling away from the main hall building with cracking to cladding and a large gap opening to the wall at the top to both sides of the extension. Recommend engaging an engineer to investigate and a builder to conduct repairs to reduce the risk of further movement, deterioration or structural failure.

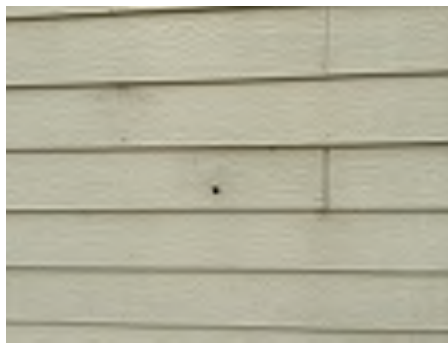
The rear stage clad extension is falling away from the main hall building with cracking to cladding and a large gap opening to the wall at the top to both sides of the extension. Recommend engaging an engineer to investigate and a builder to conduct repairs to reduce the risk of further movement, deterioration or structural failure.

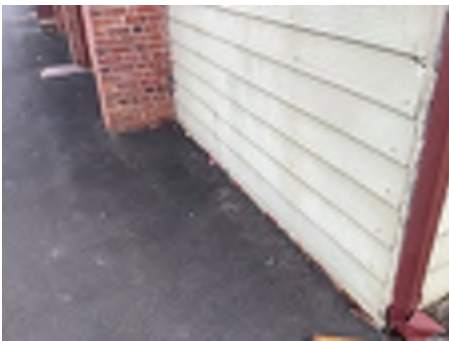
The rear stage clad extension is falling away from the main hall building with cracking to cladding and a large gap opening to the wall at the top to both sides of the extension. Recommend engaging an engineer to investigate and a builder to conduct repairs to reduce the risk of further movement, deterioration or structural failure.

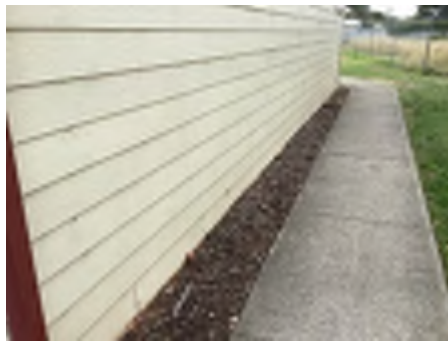
The rear stage clad extension is falling away from the main hall building with cracking to cladding and a large gap opening to the wall at the top to both sides of the extension. Recommend engaging an engineer to investigate and a builder to conduct repairs to reduce the risk of further movement, deterioration or structural failure.

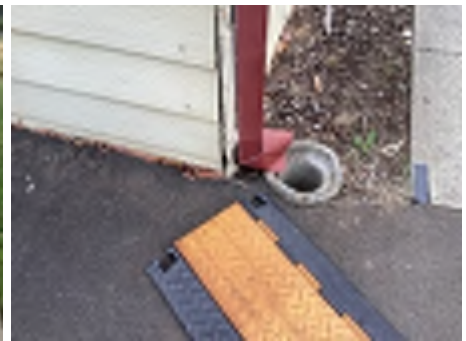
The rear stage clad extension is falling away from the main hall building with cracking to cladding and a large gap opening to the wall at the top to both sides of the extension. Recommend engaging an engineer to investigate and a builder to conduct repairs to reduce the risk of further movement, deterioration or structural failure.

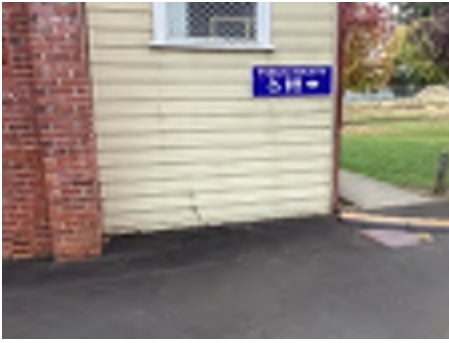
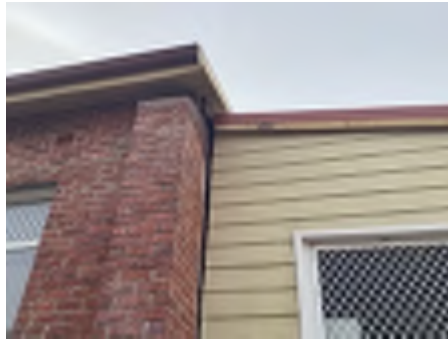
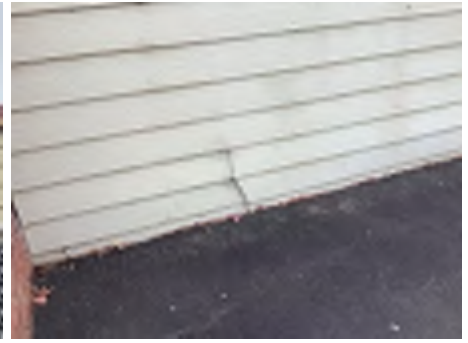
The rear stage clad extension is falling away from the main hall building with cracking to cladding and a large gap opening to the wall at the top to both sides of the extension. Recommend engaging an engineer to investigate and a builder to conduct repairs to reduce the risk of further movement, deterioration or structural failure.

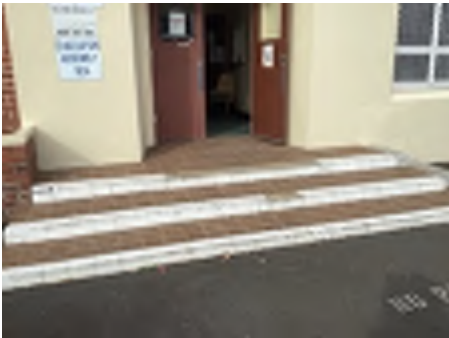
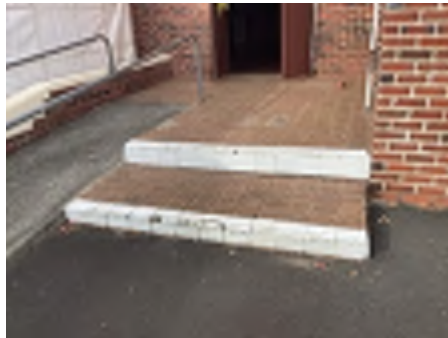
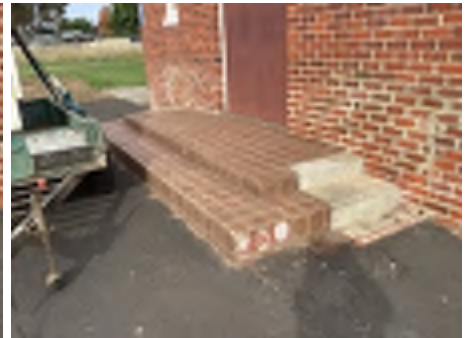
Inconsistent riser heights - recommend engaging a builder to rectify to reduce the risk of people tripping over. Damaged stairs to parts. Recommend engaging a builder to repair to reduce the risk of further deterioration and injury.

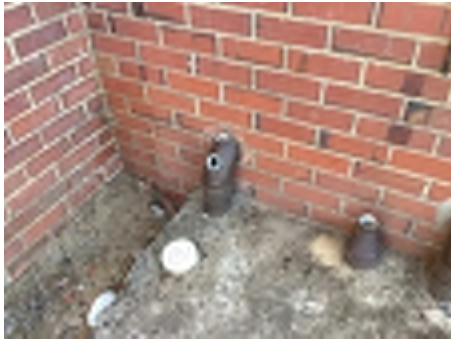
Safety issue only (non structural). It is a requirement of the inspection standard to report observed safety issues within the main body of the report. Exposed sewerage outlet pipe to the ladies toilets where the plumbing cap is missing. Recommend engaging a plumber to repair to reduce the risk of exposure to sewerage and illness or injury.

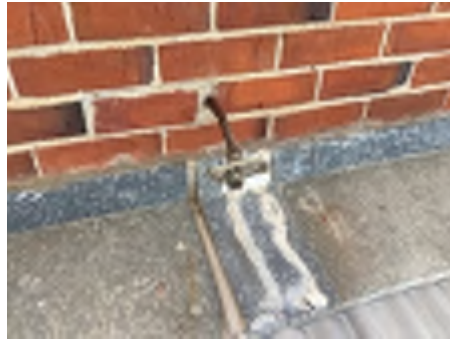
Safety issue only (non structural). It is a requirement of the inspection standard to report observed safety issues within the main body of the report. Exposed wires to the external wall over the ablation block. Recommend engaging an electrician to investigate and repair to reduce the risk of damage or injury.

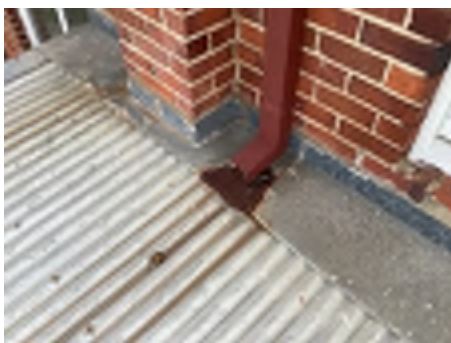
A few loose fixings. Needs repair/replacing to reduce the risk of water leaks and damage and to prevent the sheeting from blowing off.

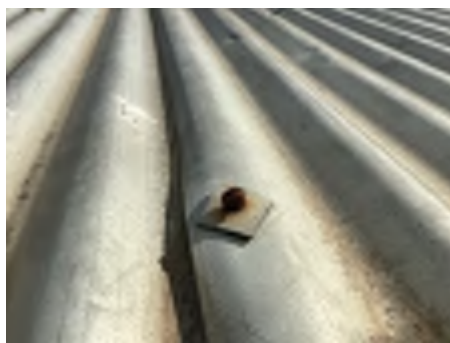
A few loose fixings. Needs repair/replacing to reduce the risk of water leaks and damage and to prevent the sheeting from blowing off.

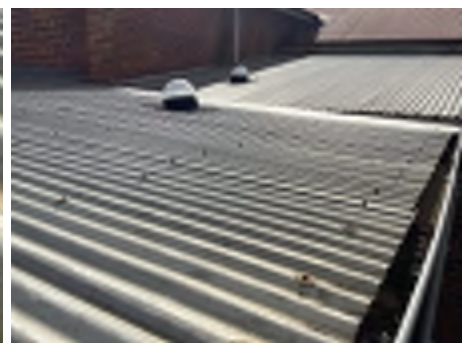
A few loose fixings. Needs repair/replacing to reduce the risk of water leaks and damage and to prevent the sheeting from blowing off.

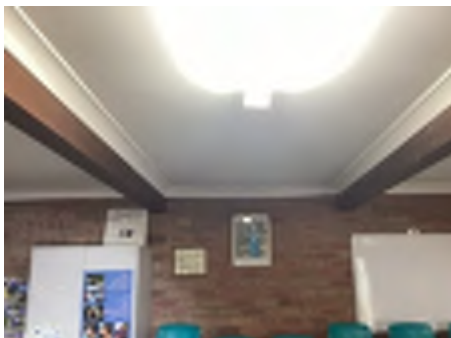
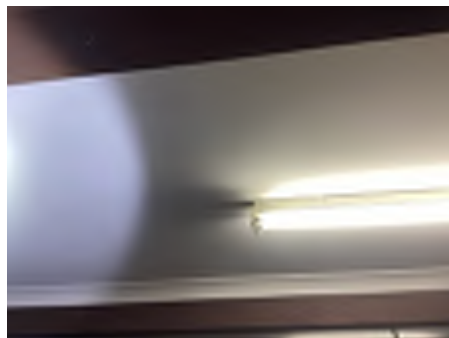
<p>D1 Serious safety hazards: Evidence of any item or matter (within the Consultant's expertise) that may constitute a present or imminent serious safety hazard:</p>	<p>The following evidence was found</p>
<p>Additional Comments:</p>	<p>Sagging ceiling to the main room ceilings. Recommend engaging a plasterer to repair to reduce the risk of further deterioration or possible failure of the ceiling, The freestanding oven is not visibly secured with an anti tilt chain or bracket - recommend engaging an appliance installer to repair to reduce the risk of damage and personal injury., Ceiling vents open directly from the ceiling void which contains suspected asbestos materials into the main internal space of the building. It is recommended to engage an asbestos technician to investigate and advise on potential hazards and a builder to conduct repairs to reduce the risk of illness to occupants</p>

Showing examples of ceilings

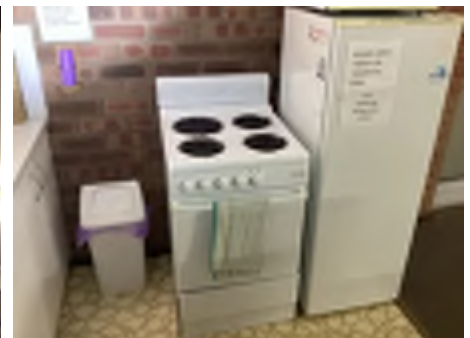
Showing oven

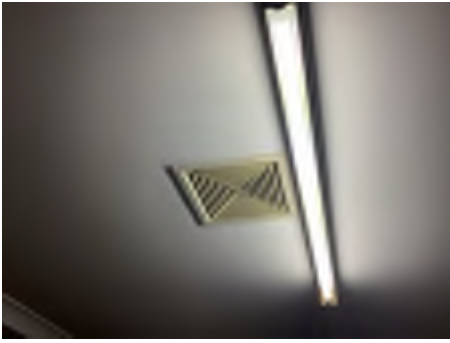
Showing example of ceiling vents

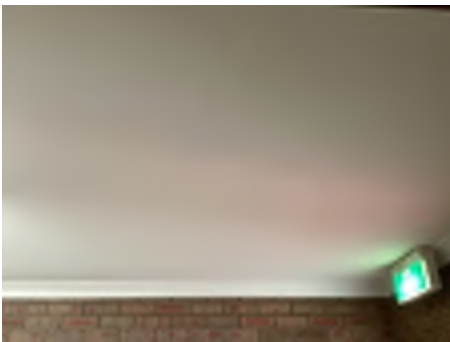
Safety issue only (non structural). It is a requirement of the inspection standard to report observed safety issues within the main body of the report. Sagging ceilings - recommend engaging a plasterer to repair/replace to prevent further deterioration.

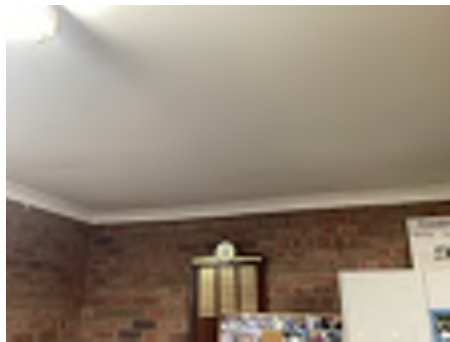
Safety issue only (non structural). It is a requirement of the inspection standard to report observed safety issues within the main body of the report. Sagging ceilings - recommend engaging a plasterer to repair/replace to prevent further deterioration.
