ORDINARY COUNCIL MEETING

Wednesday, 22nd of March 2023

STRUCTURAL BUILDING INSPECTION REPORT

FERGUSON HALL

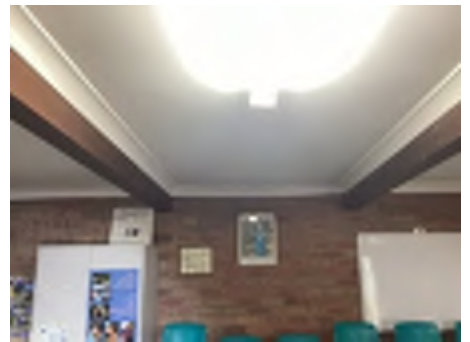
Safety issue only (non structural). It is a requirement of the inspection standard to report observed safety issues within the main body of the report. Sagging ceilings - recommend engaging a plasterer to repair/replace to prevent further deterioration.

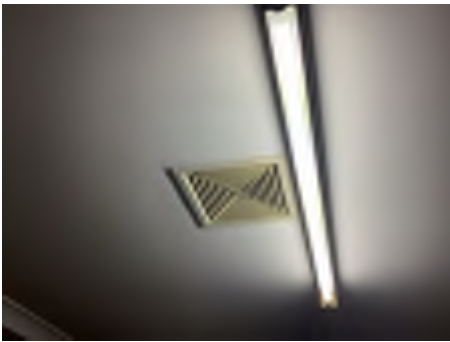
Safety issue only (non structural). It is a requirement of the inspection standard to report observed safety issues within the main body of the report. Ceiling vents open directly from the ceiling void which contains suspected asbestos materials into the main internal space of the building. It is recommended to engage an asbestos technician to investigate and advise on potential hazards and a builder to conduct repairs to reduce the risk of illness to occupants.

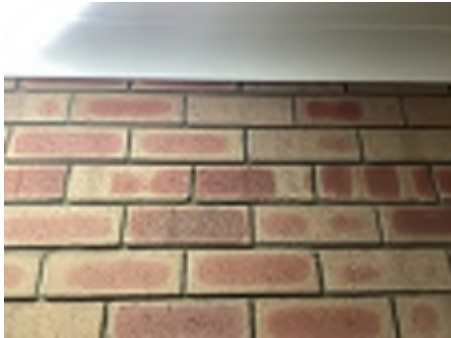
Cracking observed to parts of the internal walls. Recommend a structural engineer be engaged to inspect and provide appropriate advice and recommendations to reduce the risk of further deterioration to the building.

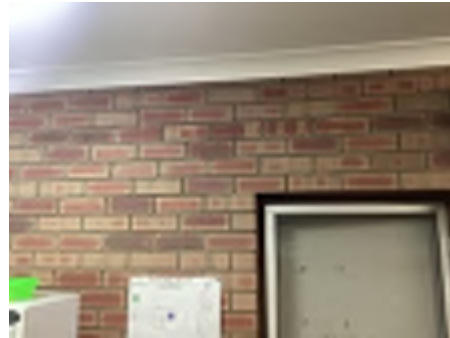
Cracking observed to parts of the internal walls. Recommend a structural engineer be engaged to inspect and provide appropriate advice and recommendations to reduce the risk of further deterioration to the building.

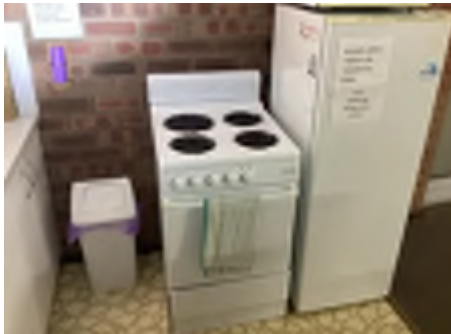
Safety issue only (non structural). It is a requirement of the inspection standard to report observed safety issues within the main body of the report. The freestanding oven is not visibly secured with an anti tilt chain or bracket - recommend engaging an appliance installer to repair to reduce the risk of damage and personal injury.

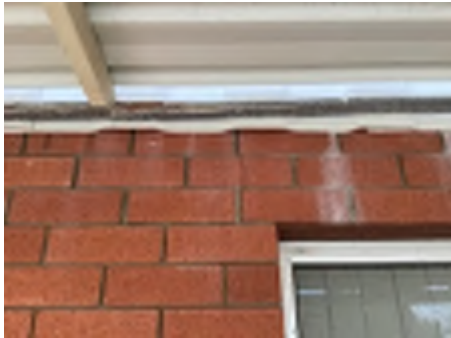
Cracking observed to parts of the external walls. Recommend a structural engineer be engaged to inspect and provide appropriate advice and recommendations to reduce the risk of further deterioration to the building.

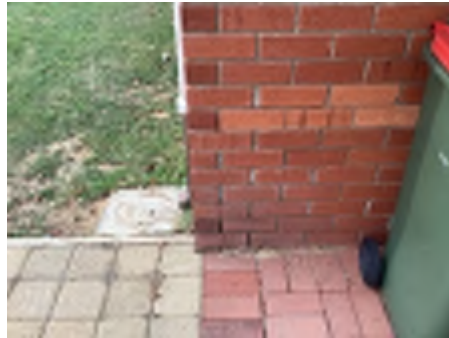
Cracking observed to parts of the external walls. Recommend a structural engineer be engaged to inspect and provide appropriate advice and recommendations to reduce the risk of further deterioration to the building.

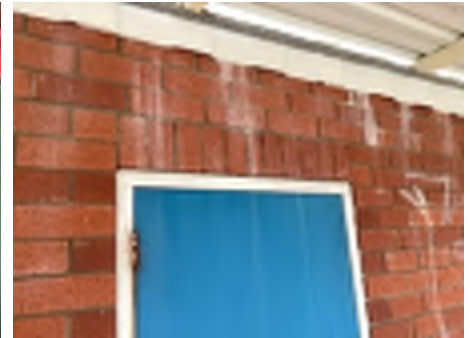
Cracking observed to parts of the external walls. Recommend a structural engineer be engaged to inspect and provide appropriate advice and recommendations to reduce the risk of further deterioration to the building.

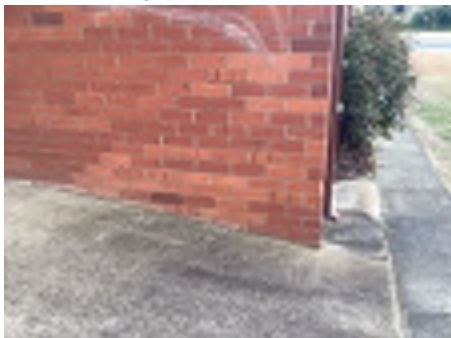
Cracking observed to parts of the external walls. Recommend a structural engineer be engaged to inspect and provide appropriate advice and recommendations to reduce the risk of further deterioration to the building.

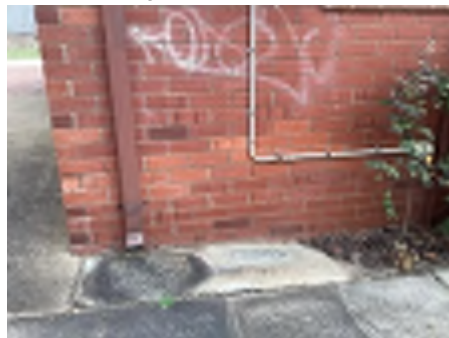
Cracking observed to parts of the external walls. Recommend a structural engineer be engaged to inspect and provide appropriate advice and recommendations to reduce the risk of further deterioration to the building.

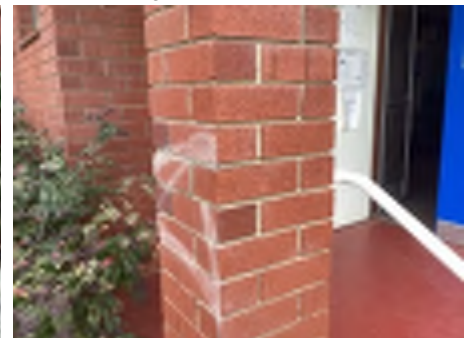
Cracking observed to parts of the external walls. Recommend a structural engineer be engaged to inspect and provide appropriate advice and recommendations to reduce the risk of further deterioration to the building.

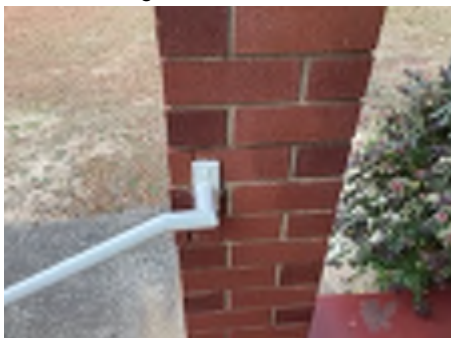
Cracking observed to parts of the external walls. Recommend a structural engineer be engaged to inspect and provide appropriate advice and recommendations to reduce the risk of further deterioration to the building.

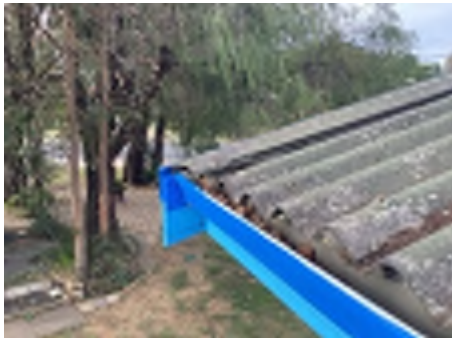
A few loose fixings. Needs repair/replacing to reduce the risk of water leaks and damage and to prevent the sheeting from blowing off. Lifted and damaged roofing material with a high risk of asbestos content due to the age and appearance. Recommend engaging a builder to repair or replace to reduce the risk of further deterioration.

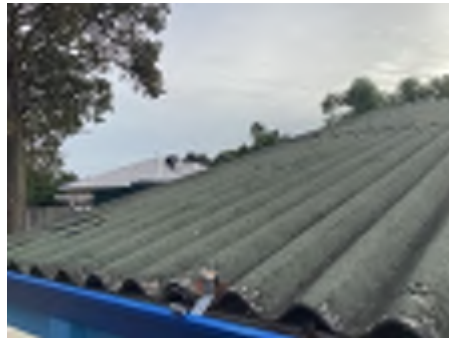
A few loose fixings. Needs repair/replacing to reduce the risk of water leaks and damage and to prevent the sheeting from blowing off. Lifted and damaged roofing material with a high risk of asbestos content due to the age and appearance. Recommend engaging a builder to repair or replace to reduce the risk of further deterioration.

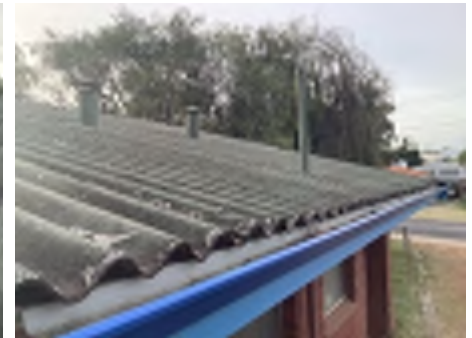
A few loose fixings. Needs repair/replacing to reduce the risk of water leaks and damage and to prevent the sheeting from blowing off. Lifted and damaged roofing material with a high risk of asbestos content due to the age and appearance. Recommend engaging a builder to repair or replace to reduce the risk of further deterioration.

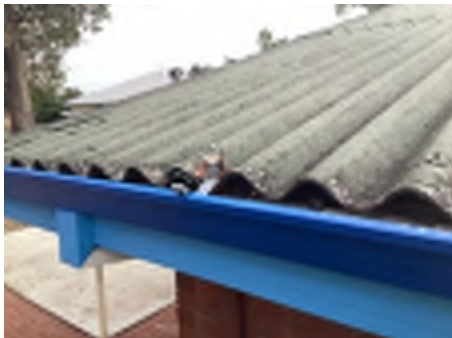
A few loose fixings. Needs repair/replacing to reduce the risk of water leaks and damage and to prevent the sheeting from blowing off. Lifted and damaged roofing material with a high risk of asbestos content due to the age and appearance. Recommend engaging a builder to repair or replace to reduce the risk of further deterioration.

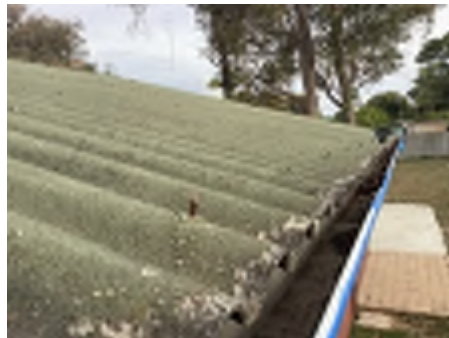
A few loose fixings. Needs repair/replacing to reduce the risk of water leaks and damage and to prevent the sheeting from blowing off. Lifted and damaged roofing material with a high risk of asbestos content due to the age and appearance. Recommend engaging a builder to repair or replace to reduce the risk of further deterioration.

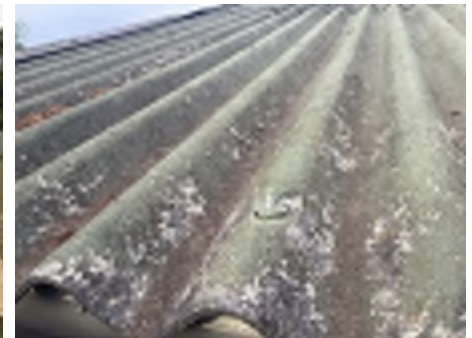
A few loose fixings. Needs repair/replacing to reduce the risk of water leaks and damage and to prevent the sheeting from blowing off. Lifted and damaged roofing material with a high risk of asbestos content due to the age and appearance. Recommend engaging a builder to repair or replace to reduce the risk of further deterioration.

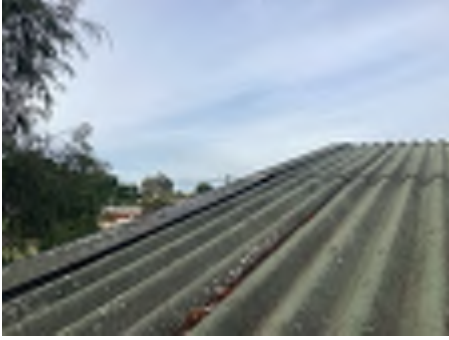
A few loose fixings. Needs repair/replacing to reduce the risk of water leaks and damage and to prevent the sheeting from blowing off. Lifted and damaged roofing material with a high risk of asbestos content due to the age and appearance. Recommend engaging a builder to repair or replace to reduce the risk of further deterioration.
