Shire of Dardanup

## ORDINARY COUNCIL MEETING

**SDev CP513 – STRATEGIC WATER TANKS FOR FIRE FIGHTING PURPOSES IN NON-RETICULATED AREAS**

Drawn | Checked | B FEWSTER |  
Plot Date: 11/3/2024  
Project NO: 2021-12  
Project Status: DESIGN  
Client: KATHERINE & ALEX WILLIAMS  
Site: 566 CROOKED BROOK ROAD  
CROOKED BROOK WA 6232

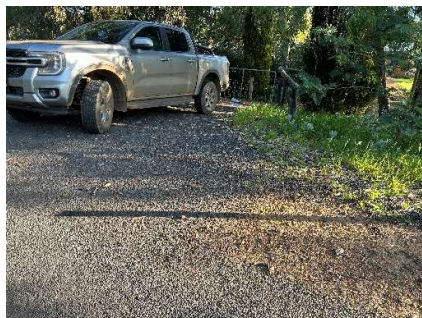
The existing access is sealed from the traffic lane to the boundary and is in good condition.

Photo 8 - Existing sealed access.

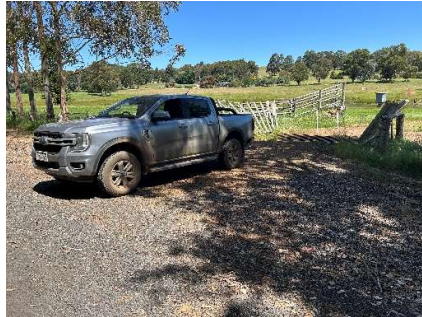
The existing entry access is sealed from the traffic lane to the boundary and is in good condition.

**Photo 13 - Existing sealed access.**

Crooked Brook Road has an 85<sup>th</sup> percentile speed of 90 km/h at the access point, using the table above the Minimum Safe Sight Distance is 130 m which is achieved in both west and east directions.

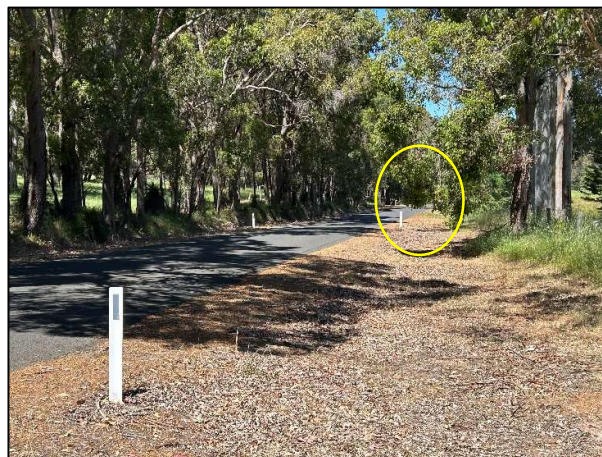
The existing main crossover is sufficient. The existing eastern crossover requires to be sealed and a small branch under pruned.

**Photo 15 – Small branch needs to be under pruned.**

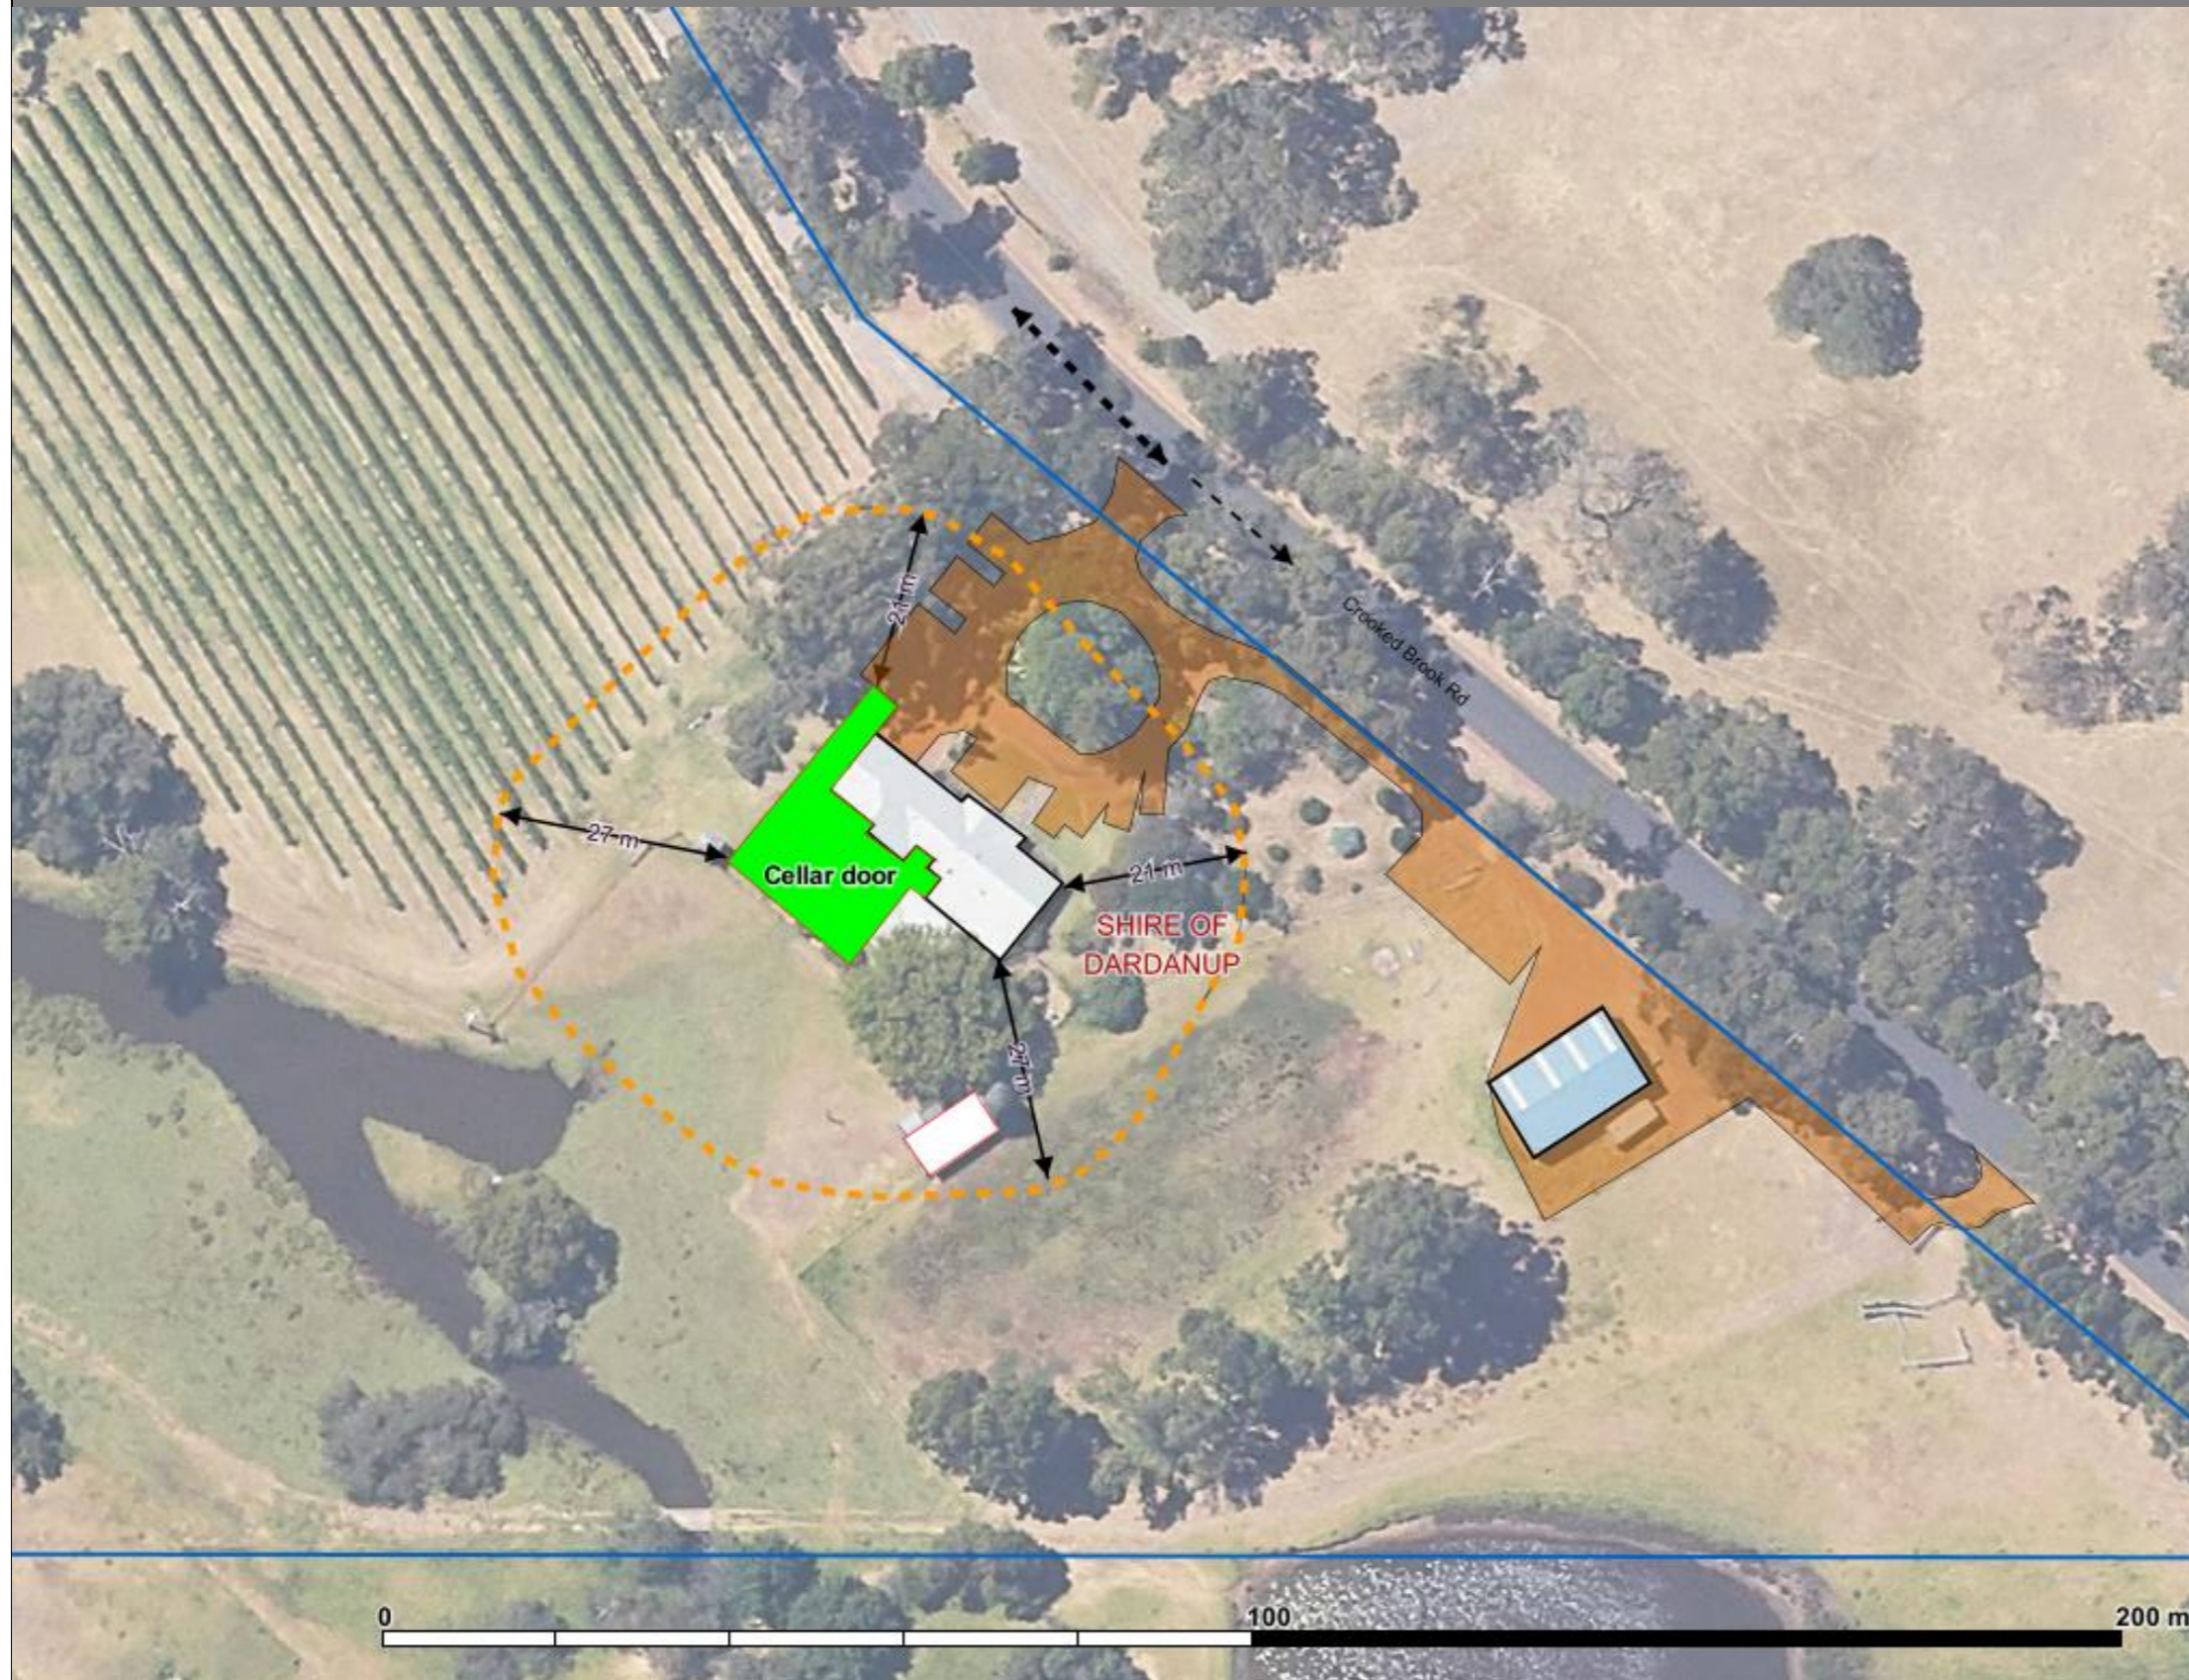
Figure Ex 1 - Spatial representation of the proposed risk management strategies at 566 Crooked Brook Road Crooked Brook

1. The establishment of an Asset Protection Zone (APZ) and low-threat area, as demonstrated in the Spatial Representation of Bushfire Management Strategies and in accordance with the Standards for Asset Protection Zones at Schedule 1 Guidelines for Planning in Bushfire Prone Areas v1.4 and include maintaining grasses in either a non-cured condition or less than 100 mm in height.
2. The construction standard s.3 and 7 AS3959:2028 applies to the Cellar door additions (to avoid increasing the risk to the existing dwelling).
3. The provision of a 10 000 L water tank reserved for emergency services and isolated from the domestic water supply. The water tank is to be provided compliant with the technical requirements described in Element 4 Schedule 2 in the Guidelines or Planning in Bushfire Prone Areas v1.4.

The recommended APZ, is 27 m south and 21 m to other elevations, measured from the building at completion; this is the distance required to achieve BAL 29 set from forest. A separation distance from forest provides a certainty for vegetation to change outside the APZ without exceeding BAL 29 at the building.

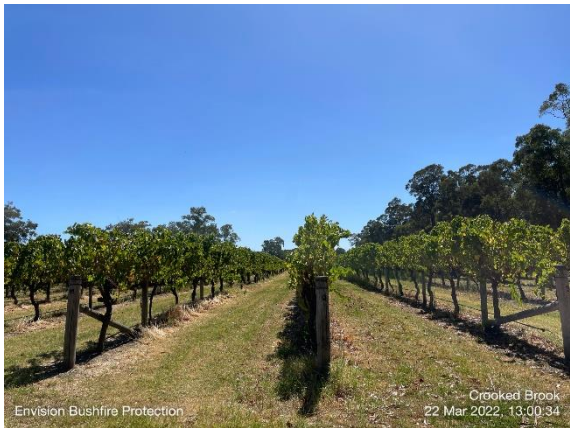
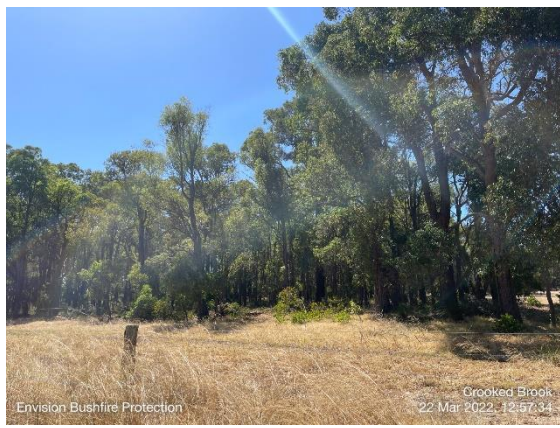
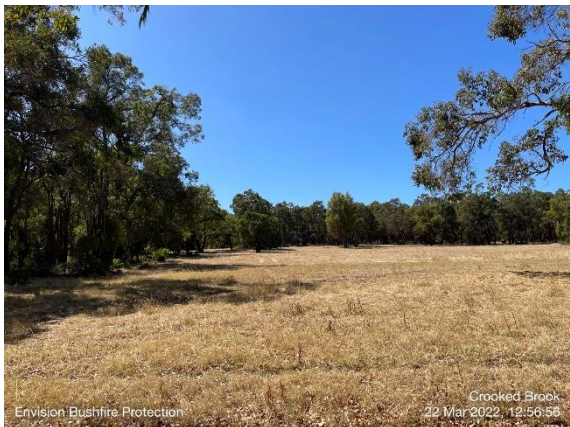
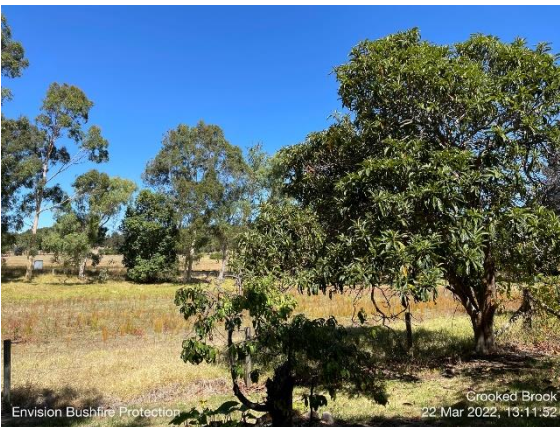
PLOT 2				
Vegetation Classification		Slope		
Class G Grassland – Spare open tussock G-24		Upslope		
Observation/Justification for classification				
Fuel Hazard	Surface	Near surface	Elevated	Bark
Low		✓	✓	✓
Moderate				
High	✓			
Very High				
Extreme				
Vegetation Description (AS 3959)				
All forms (except tussock moorlands) including situations with shrubs and trees if the overstorey foliage cover is less than 10%. Includes pasture and cropland.				
Post development				
Grassland retained

Photo 2.1 Grass under vineyard, west of Cellar door		Photo 2.2 Grass foreground to forest

Photo 2.3 Grass north of site.		Photo 2.4 Grass east of Cellar door

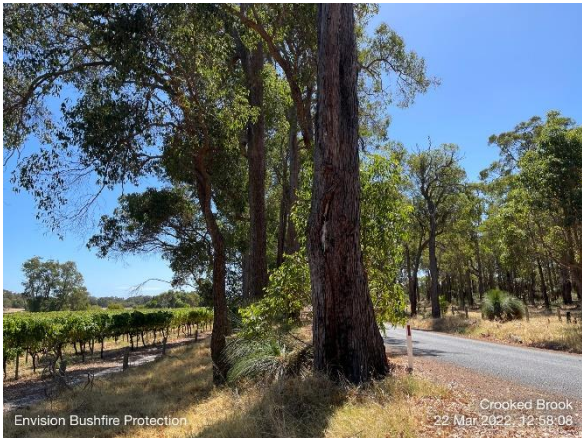
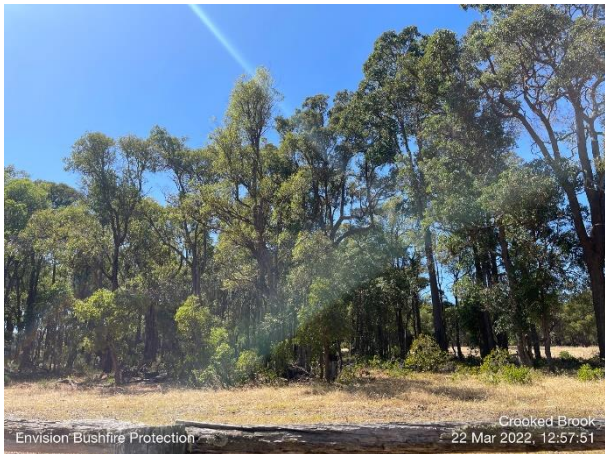
PLOT 3				
Vegetation Classification			Slope	
Class A Forest - Open forest A-03			Flat	
Observation/Justification for classification				
Fuel Hazard	Surface	Near surface	Elevated	Bark
Low				
Moderate	✓			
High		✓		✓
Very High			✓	
Extreme				
Vegetation Description (AS 3959)				
Trees up to 30 m high; 30%-70% foliage cover (may include understorey of sclerophyllous low trees or shrubs). Typically dominated by eucalypts, melaleuca or callistemon (may include riverine and wetland environments) and callitris. Includes eucalypt plantations.				
Post development				
Forest retained

Photo 3.1 Roadside vegetation			Photo 3.2 Forest in west section

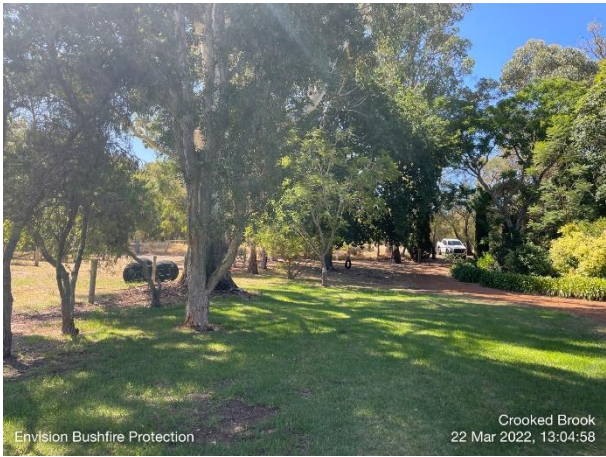
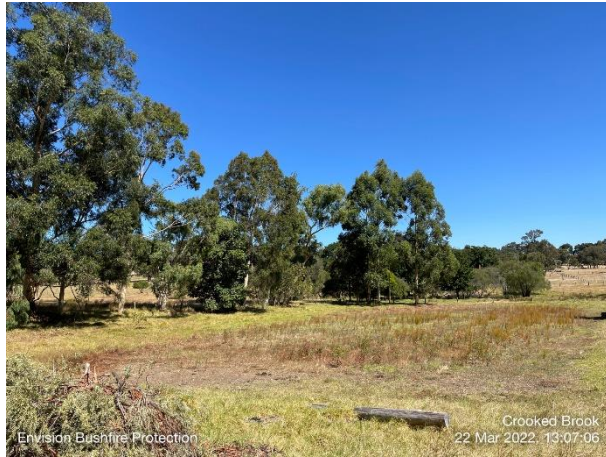
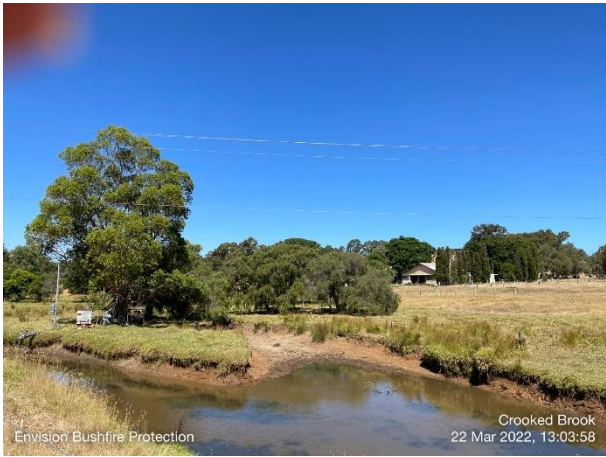
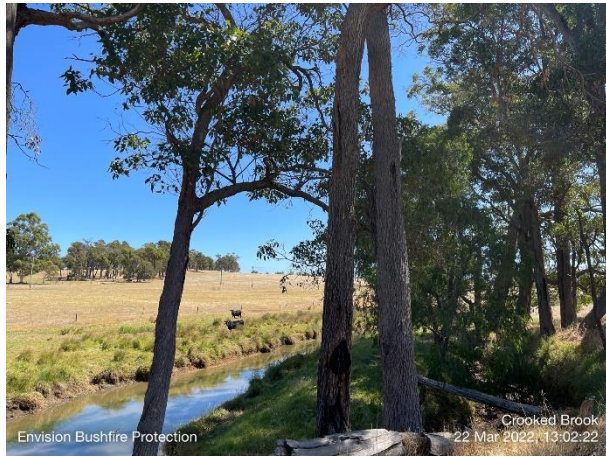
PLOT 4				
Vegetation Classification		Slope		
Class B Woodland - Woodland B-05		Flat		
Observation/Justification for classification				
Fuel Hazard	Surface	Near surface	Elevated	Bark
Low		✓		
Moderate	✓			✓
High			✓	
Very High				
Extreme				
Vegetation Description (AS 3959)				
Trees 10 m - 30 m high; 10% - 30% foliage cover dominated by eucalypts and/or callistris with a prominent grassy understorey. May contain isolated shrubs.				
Post development				
Woodland retained

Photo 4.1 Woodland – garden north of dwelling		Photo 4.2 Woodland east of cellar door

Photo 4.3 Woodland south of cellar door		Photo 4.4 Woodland west of cellar door

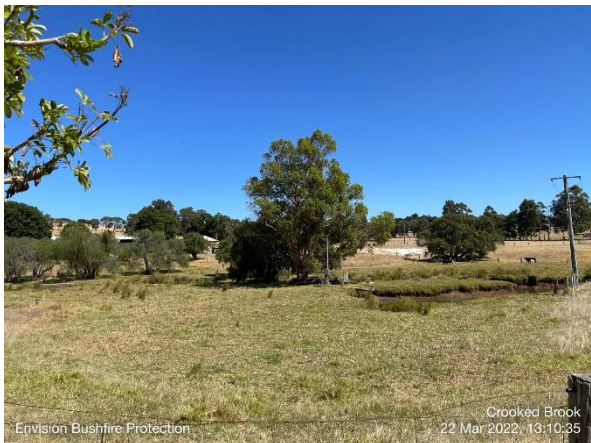
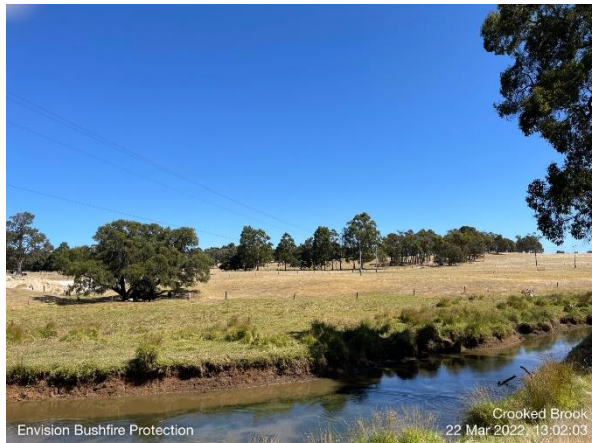
PLOT 5				
Vegetation Classification		Slope		
Class G Grassland – Spare open tussock G-24		Downslope 0-5		
Observation/Justification for classification				
Fuel Hazard	Surface	Near surface	Elevated	Bark
Low		✓	✓	✓
Moderate				
High	✓			
Very High				
Extreme				
Vegetation Description (AS 3959)				
All forms (except tussock moorlands) including situations with shrubs and trees if the overstorey foliage cover is less than 10%. Includes pasture and cropland.				
Post development				
Grassland retained, except where displaced by the cellar door and APZ.

Photo 5.1 Grassland down slope, south east of cellar door		Photo 5.2 Grassland down slope south of cellar door

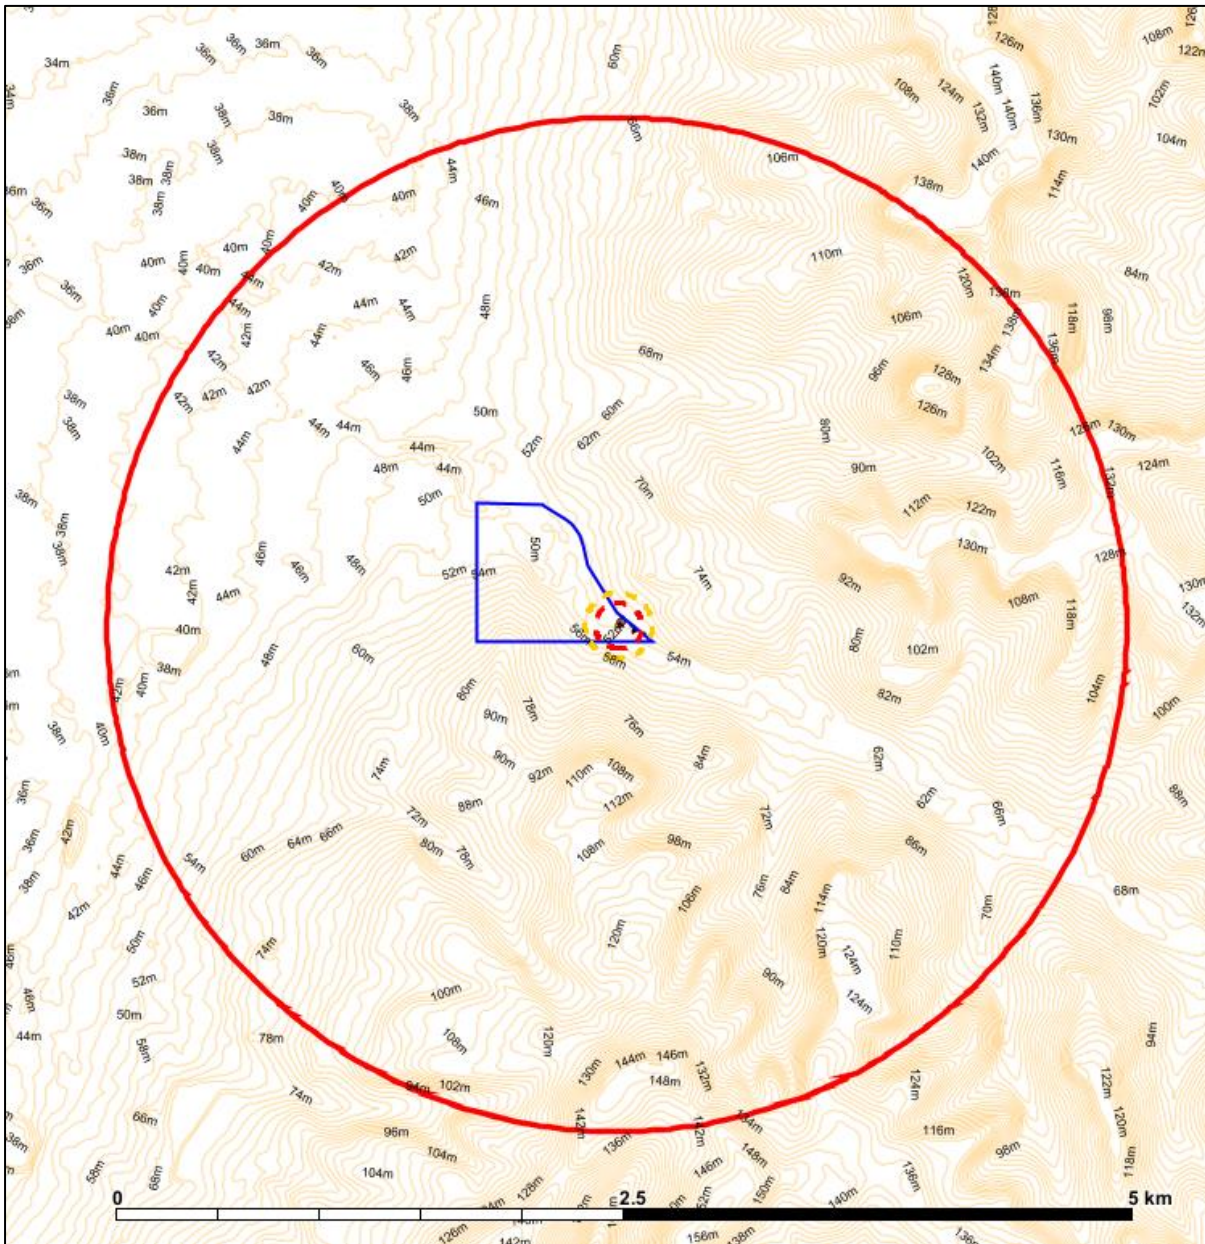
*Plate 8: The site is at the foot of the Darling Ranges (east) and within a low valley that runs from east to west.*
